Service Bulletin

PRELIMINARY INFORMATION

Subject: MIL On With DTC P0016 And/Or P0017 Setting On A Properly Timed Engine Or Crank No Start

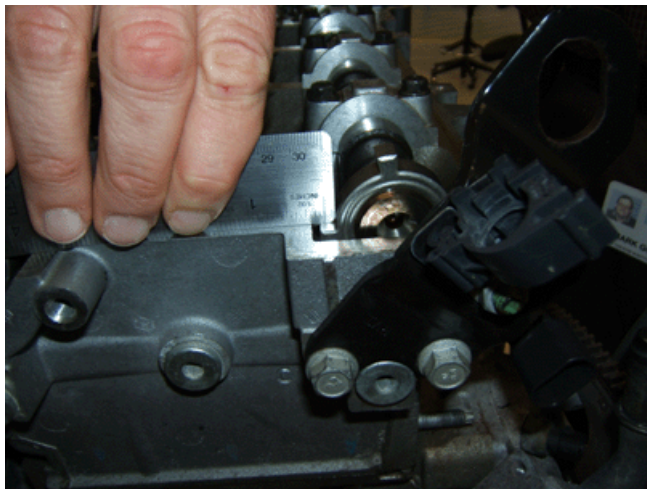
To check the Exhaust Cam reluctor position LE5 ONLY:

With the exhaust camshaft positioned so that the valves for #4 cylinder are at maximum lift (fully opened valves), the reluctor should be flush/parallel to the rocker cover gasket surface as shown in the photo below. If the reluctor position does not line up correctly, the exhaust camshaft must be replaced.

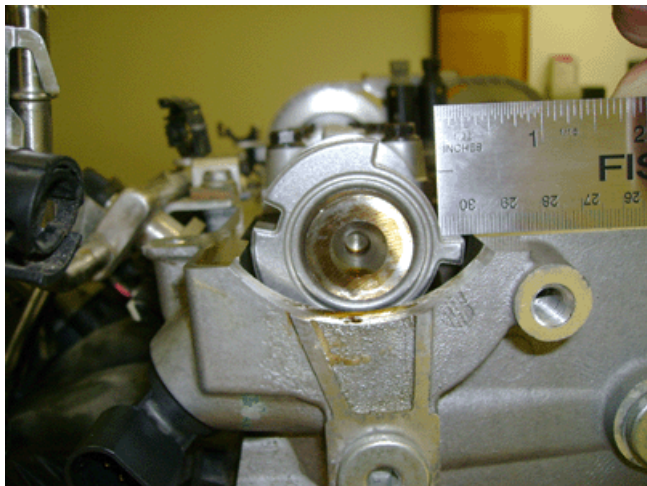
To check the Intake Cam reluctor position LE5 ONLY:

With the Intake camshaft positioned so that the valves for #1 cylinder are at maximum lift (fully opened valves), the reluctor should be flush/parallel to the rocker cover gasket surface as shown in the photo below. If the reluctor position does not line up correctly, the intake camshaft must be replaced.
