Service Bulletin

Subject: Diagnostic Tips - Water Leaks

Models: 2015 - 2016 Chevrolet Colorado
2015 - 2016 GMC Canyon

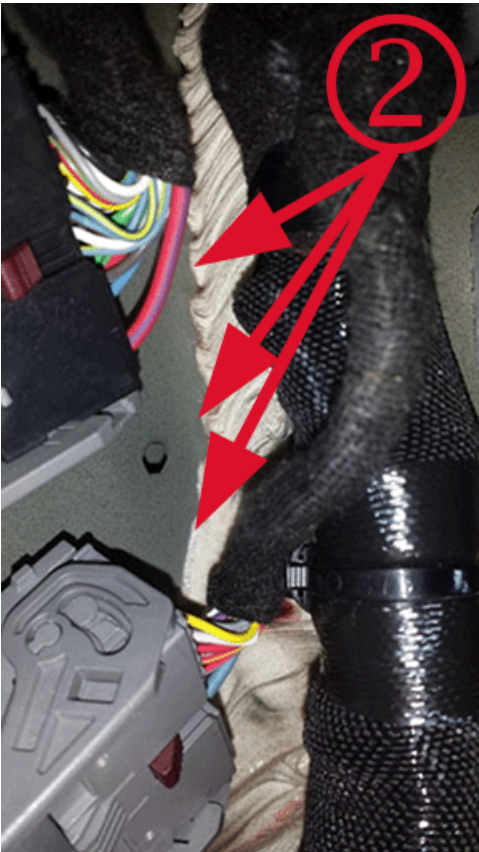
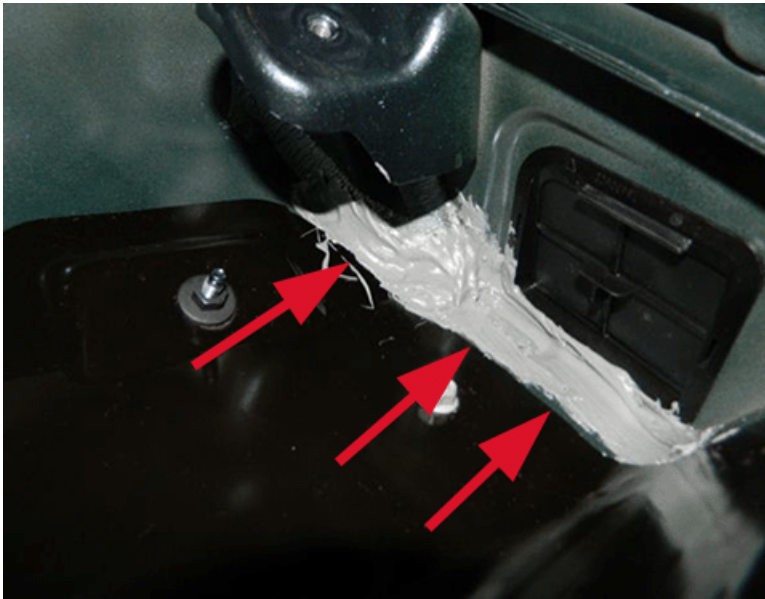
The other area is under dash in the left and right side vertical seams. Reseal as needed
