Service Bulletin

Bulletin No.: 16-NA-183

Subject: Transmission May Not Shift Out of Park, Shifter Knob Indicators May Not Illuminate, DIC Messages May Say to Service Transmission, Service Transmission Now, Unable to Shift Soon

| Brand: | Model: | Model Year: | | VIN: | | Engine: | Transmission: |
|---|---|---|---|---|---|---|---|
| Cadillac | XT5 | 2017 | 2017 | | | | |

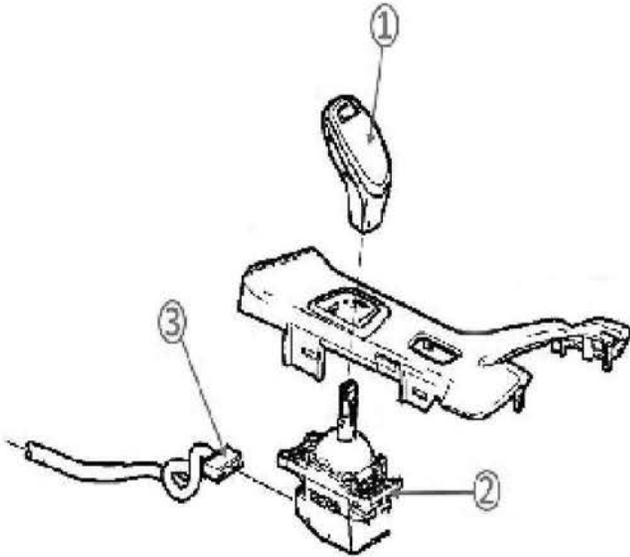
4528887

| Cause | <p>This may be caused by the following conditions:</p> <ul style="list-style-type: none"> • Transmission Control Lever Knob assembly not fully seated onto the shifter. • Electrical connector not fully engaged into the Automatic Transmission Electronic Control. |

1. While pressing downward on the shifter knob (1) firmly with both hands, validate any movement felt and the bottoming out of the knob to shifter (2).
 - If movement was confirmed while pressing downward on the shifter knob, an audible click may be heard.
 - Verify the shift knob lighting is illuminated and the shifter assembly moves freely.
2. Clear the codes set in the Chassis Control Module and test drive the vehicle.
 - If the codes did not return, no further repairs are needed.
 - If the codes return, validation of the wiring harness connector (3) for the transmission electronic control (2) needs to be done.

3. Remove the Transmission Electronic Control. Refer to *Transmission Electronic Control Replacement* in SI.
4. Press the electrical connector firmly into the Transmission Electronic Control.
5. Validate that the CPA is in the locked position on the connector.
6. Install the Transmission Electronic Control. **Tighten** the bolts to 9 N•m (80 lb in).
7. Verify the shift knob lighting is illuminated and the shifter assembly moves freely.
