# Service Bulletin

Bulletin No.: 16-NA-189

**Subject: Water Leak Under Back Glass from Power Sliding Window**

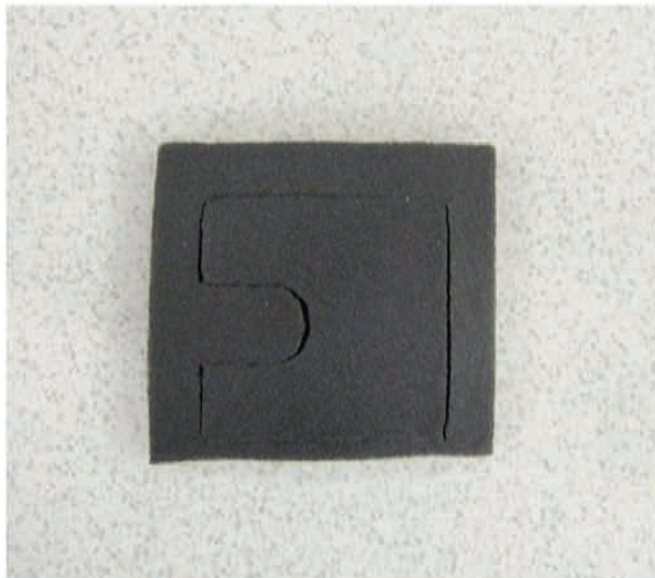
4529815

<b>Involved Region or Country</b>	North America
<b>Additional Options (RPO)</b>	Equipped with Power Sliding Window (RPO A48)
<b>Condition</b>	Some customers may comment on finding water under the rear seat area and/or noting a musty smell in the vehicle cabin.
<b>Cause</b>	This condition may be caused by water overrunning the rear slider window channel. This condition most commonly occurs during very heavy rain storms or if the truck is parked, facing a seven degree or higher downward angle.

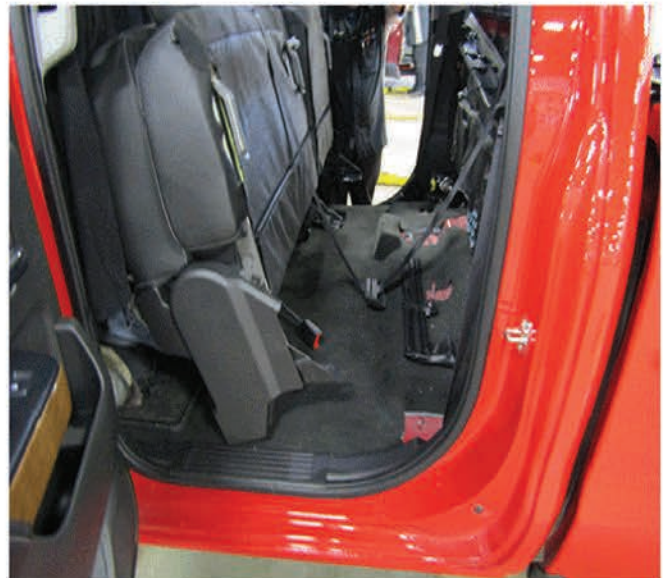
4529817

Inspect the rear floor for signs of water. If water is found, install the foam end cap seal listed in the part table below to the rear sliding window regulator using the service procedure below.
