# Service Bulletin

Bulletin No.: 16-NA-190

**Subject: Radio Volume and Tune Knobs Broken, Missing or Will Not Stay Attached**

| Brand: | Model: | Model Year: | | VIN: | | Engine: | Transmission: |
|---|---|---|---|---|---|---|---|
| Chevrolet | Impala (VIN 1) | 2014 | 2017 | | | All | All |

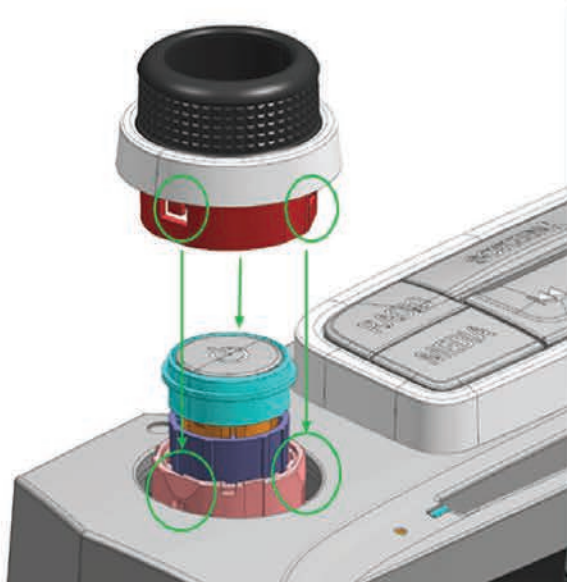
4533361

| <b>Condition</b> | Some customers may comment the Volume and/or Tune knob is broken, missing or will not stay attached to the control assembly. |
| <b>Cause</b> | The cause of the condition may be improper retention of the original knobs, which can be removed. |

Replace the affected Volume and/or Tune knob(s) with service kit listed in the parts table below.

To prevent damage during installation, make sure the orientation of the knob is as shown in the illustration above. The three clips on the knob should align with the three retention features on the control assembly. No added force should be needed to turn the knobs, if the parts are installed properly.
