Service Bulletin

File in Section: -
 Bulletin No.: 15-NA-058
 Date: August, 2016

Subject: Squeak, Squawk, Creak or Popping Noise Originating from Rear Axle

Brand:	Model:	Model Year:		VIN:		Engine:	Transmission:
		from	to	from	to		
Chevrolet	Volt	2016	2017			All	All

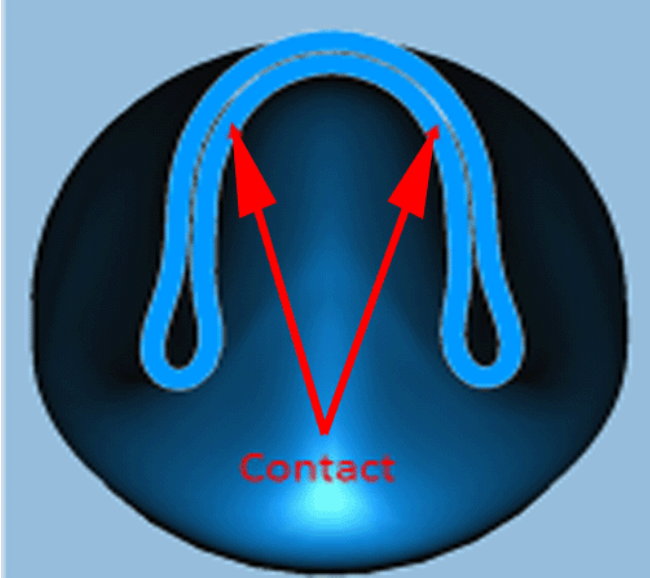
Involved Region or Country	North America and Korea
Condition	Some customers may comment on a squeak, squawk, creak or popping noise in the rear of the vehicle when cornering or pulling into driveways.
Cause	<div style="text-align: center;">

</div> <p style="text-align: right; font-size: small;">4336326</p> <p>The creak noise is created from the manufacturing process when the rear axle round tube is compressed to a U shape pattern. When the rear axle twists, the inner axle tube wall rubs on the outer wall. To fix the creak noise, a dry lubricant has been added during manufacturing. See the red arrows in the illustration above for rubbing areas.</p>

3. Pull down on one side to get the axle to twist. The creak noise should be heard or felt as indicated in the above illustration areas.
4. If the noise is verified, replace the rear axle. Refer to Rear Axle Replacement in SI.
