Service Bulletin

Bulletin No.: 16-NA-268

Subject: Windshield Wipers May Become Erratic and/or Inoperative

Brand:	Model:	Model Year:		Breakpoint:		Engine:	Transmission:
		from	to	from	to		
Buick	Envision	2016	2016	SOP	April 19, 2016

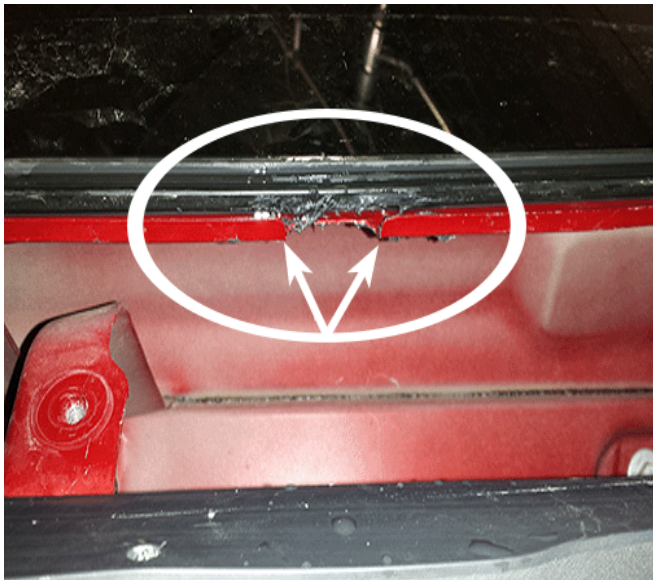
4568454

Involved Region or Country	North America and China
Condition	Some customers may comment that the windshield wipers may become erratic and/or inoperative.
Cause	This condition may be due to the windshield wiper transmission linkage becoming separated.

Replace the wiper motor, transmission/linkage and modify the upper plenum cutout, which is located just inboard of the steering column assembly as shown above, following the procedure listed below:

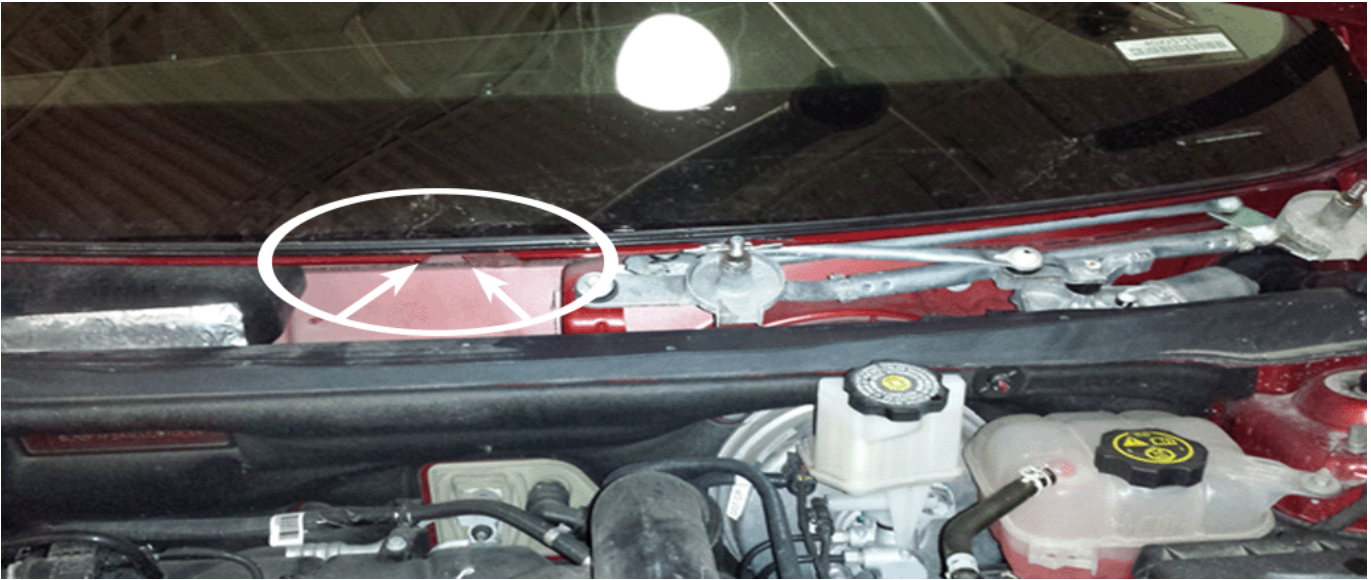
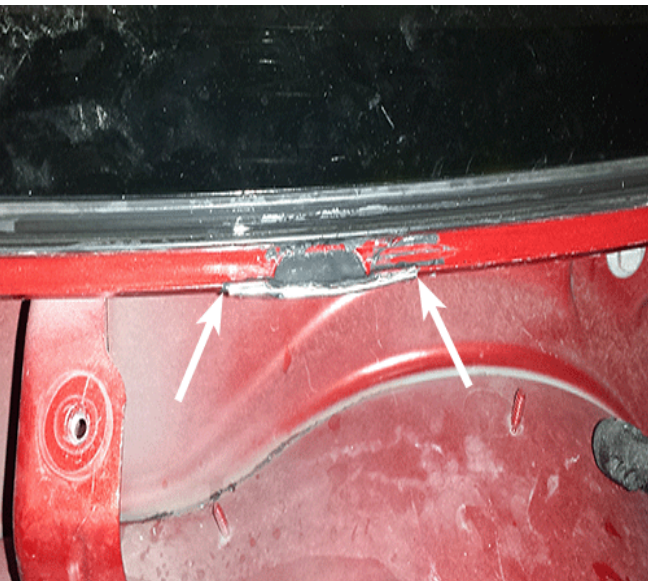
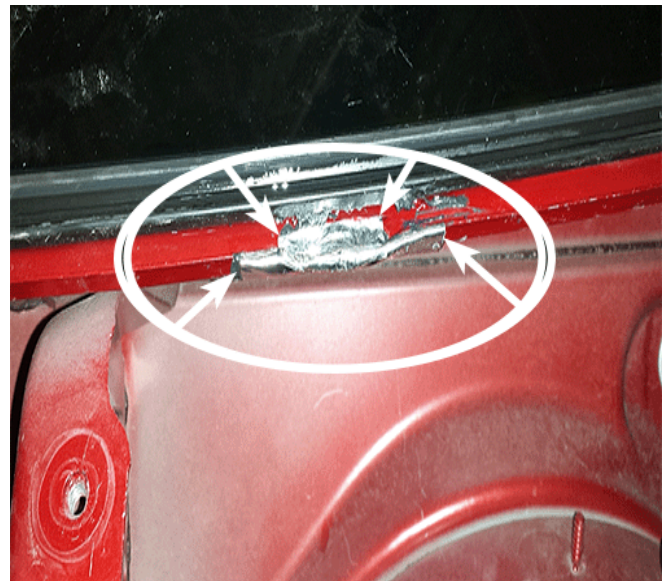
Note: The plenum cutout should now be flush with the gutter so that water will run down away from the wiper motor.

2. Cut one strip from the deadener 60 mm X 40 mm (2.36 in X 1.57 in) and apply to the underside of the plenum, located just above the steering column area, as shown in the illustrations above, so that it wraps over and folds on itself.

3. Cut another strip from the deadener 50 mm X 15 mm (1.96 in X 0.59 in) and apply on the upper side of the cutout to protect the exposed adhesive surface.
4. Reinstall the windshield wiper motor.
