# Service Bulletin

## PRELIMINARY INFORMATION

**Subject:** Reduced Power Steering Assist Engine Stall IPC / Radio / HVAC Goes Blank Various DTCs

**Models:** 2015-2016 Cadillac Escalade Models  
2014 Chevrolet Silverado 1500  
2015-2016 Chevrolet Silverado, Suburban, Tahoe  
2014 GMC Sierra 1500  
2015-2016 GMC Sierra, Yukon Models

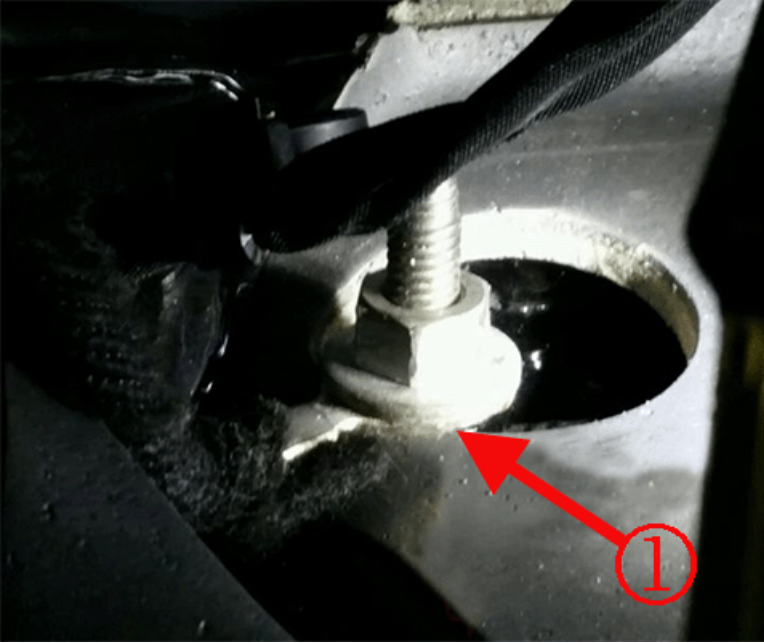
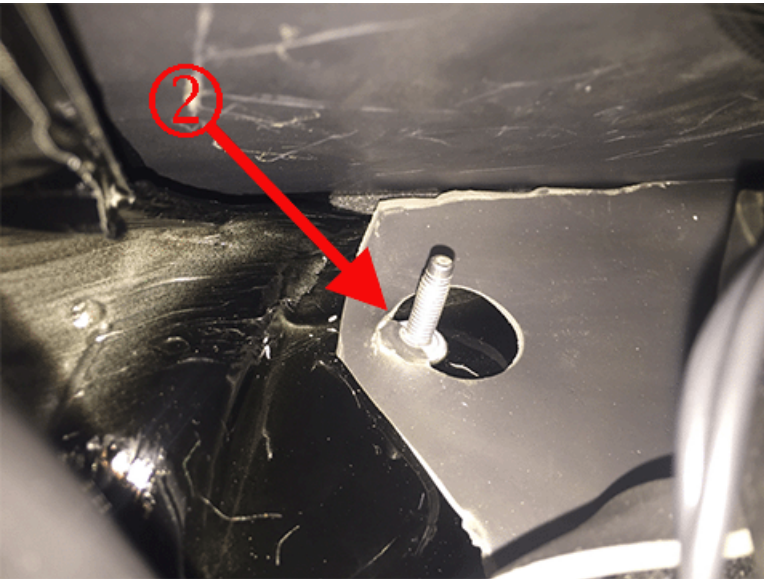
1. A poor BCM ground at G218.
2. A shorted B+ Battery cable (3) at the Starter Solenoid caused by:
  - A loose starter shield contacting the starter battery cable terminal ring
  - A starter cable ring terminal that has been mis-installed and/or rotated when installed on the starter solenoid.
3. Battery cables with high resistance and/or loose connections at the:
  - Battery fuse block
  - Positive or negative battery cables
4. A discharged or faulty battery.
5. A loose connection at the main power and ground 2-way connector (X183 or X133 depending on model) for the power steering rack.

1. Inspect G218 for a loose connection or the front of dash insulator mat (2) for being trapped between the ground eyelet and the body/stud as shown below (1). If the dash insulator mat is trapped, cut the mat away from the ground stud so it will no longer interfere. Reinstall the ground eyelet, the nut, and retighten
