Service Bulletin

Bulletin No.: 16-NA-195

Subject: Fuel Odor, Fuel Leak, Fuel Weeping from Top of Tank

Brand:	Model:	Model Year:		VIN:		Engine:	Transmission:
		from	to	from	to		
Chevrolet	Colorado	2015	2016			All	All
GMC	Canyon	2015	2016			All	All

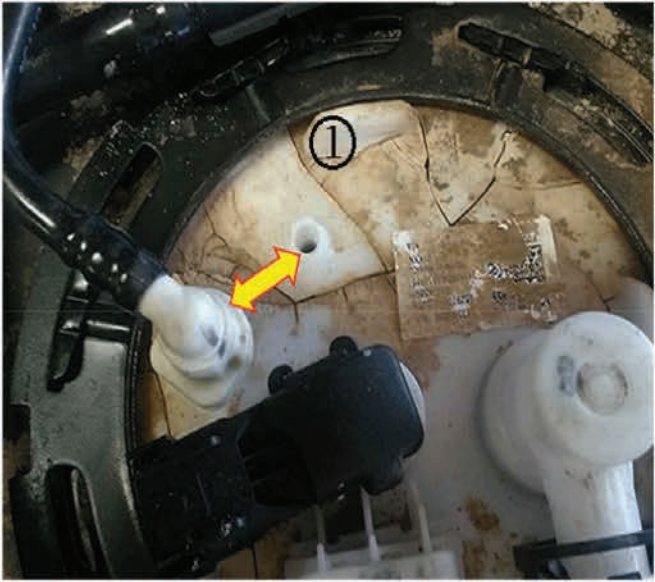
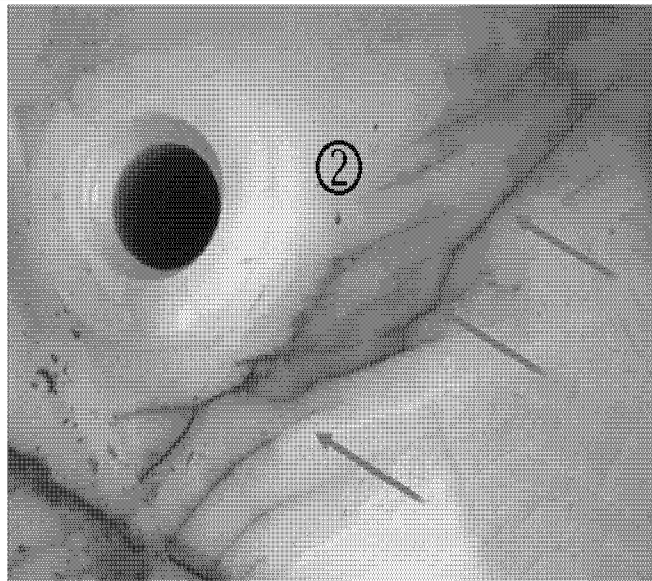
The cause may be sulfuric acid, or other such chemicals, placed in the bed of the truck that has either leaked or been washed through the holes in pickup box, and settled onto the top of the fuel tank. Examples of chemical damage to the fuel pump module such as a fractured port (1) and cracks in the plastic flange (2), are shown in the graphics above.

Verify fuel pump damage/failure and follow the Service Procedure below to replace the fuel pump and seal the pickup box.

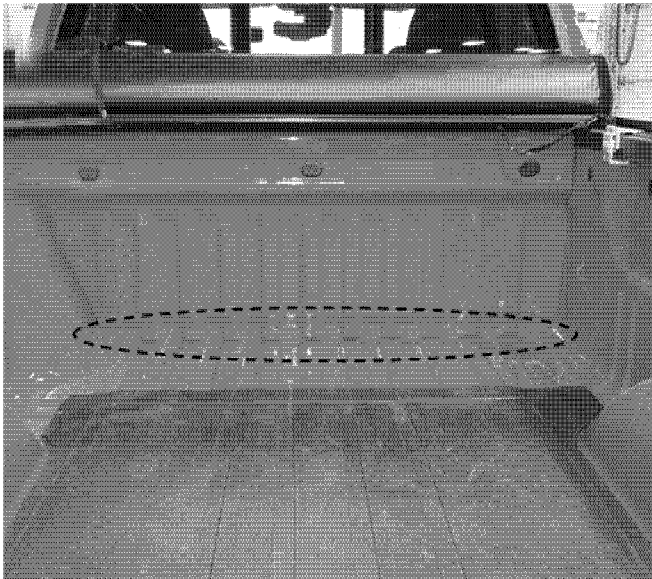
4539295

The top side front joint of the pickup bed floor and front panel, shown circled above, is the area that seam sealant will be applied.
