Bulletin No.: 15285  
Date: July 2015

# Service Bulletin

**SUBJECT: Special Coverage Adjustment - Excessive Engine Oil Consumption**

**MODELS: 2011 Chevrolet Equinox  
2011 GMC Terrain  
Equipped with 2.4L Engine (LAF)**

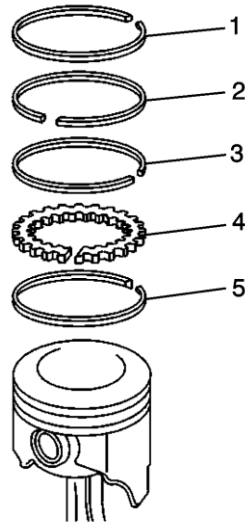
2146346

**Note:** The repair is to replace the pistons and rings. In some cases the bore surface may not have a uniform look to the finish (zebra stripes) as shown in Technical Service Bulletin 13-06-01-003F. As a result, some technicians may question whether the engine should be repaired or replaced. After careful evaluation, GM Powertrain has determined that the new pistons and rings will perform correctly in bores that have this appearance so engine replacement should not be necessary. The cylinder bores do not need any machine or honing work performed on them. Refer to Technical Service Bulletin 13-06-01-003F for more information.

- Engine Replacement
  - Technical Service Bulletin 13-06-01-003F
  - Piston and Connecting Rod Disassemble
  - Piston and Connecting Rod Assemble
  - Piston, Connecting Rod, and Bearing Installation (LAF, LAT, LE5, LE9, LEA, or LUK)
1. Remove the engine from the vehicle.
  2. Remove the pistons from the engine.
  3. Remove the pistons from the connecting rods.
  4. Discard the pistons and piston rings.
  5. Install the new piston rings onto the new pistons.
  6. Install the new pistons onto the connecting rods.
  7. Assemble the engine.
  8. Install the engine into the vehicle.
