# Service Bulletin

**SUBJECT: Special Coverage Adjustment - Excessive Engine Oil Consumption**

**MODELS: 2011 Chevrolet Equinox  
2011 GMC Terrain  
Equipped with 2.4L Engine (LAF)**

Subject: 15285B – Special Coverage Adjustment  
Excessive Engine Oil Consumption  
Revised Warranty Transaction Information

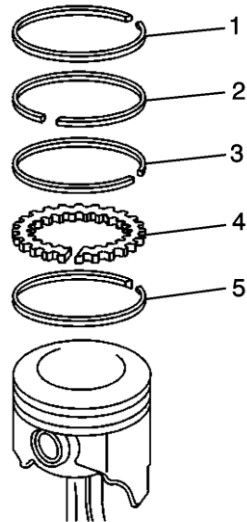
2146346

Some 2011 model year Chevrolet Equinox and GMC Terrain vehicles, equipped with a 2.4L engine, may exhibit excessive engine oil consumption (less than 2,000 miles per quart of engine oil), due to piston ring wear. If this condition is present, the oil can light may illuminate on the instrument panel or the following message may appear in the Driver Information Center: "Oil Pressure Low – Stop Engine".

- Engine Replacement
  - Technical Service Bulletin 13-06-01-003F
  - Piston and Connecting Rod Disassemble
  - Piston and Connecting Rod Assemble
  - Piston, Connecting Rod, and Bearing Installation (LAF, LAT, LE5, LE9, LEA, or LUK)
1. Remove the engine from the vehicle.
  2. Remove the pistons from the engine.
  3. Remove the pistons from the connecting rods.
  4. Discard the pistons and piston rings.
  5. Install the new piston rings onto the new pistons.
  6. Install the new pistons onto the connecting rods.
  7. Assemble the engine.
  8. Install the engine into the vehicle.
