## SERVICE BULLETIN

**APPLICABILITY:** 2014-15MY Forester 2.5L NA Models **NUMBER:** 11-148-14R  
**SUBJECT:** Reprogramming File Availability for Oil Level Detection **DATE:** 10/28/14  
**REVISED:** 03/25/15

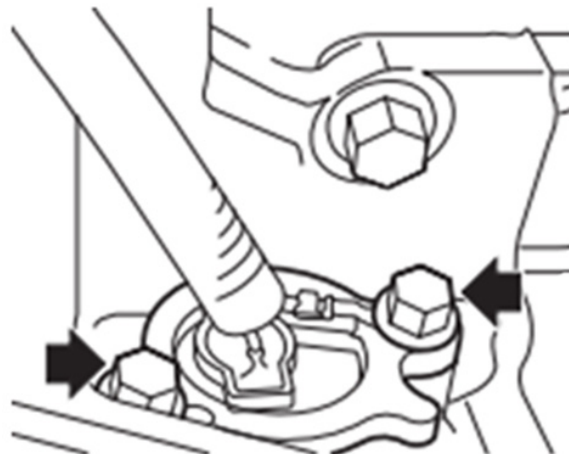
This bulletin announces the availability of reprogramming files and a revised oil level switch to optimize the ECM logic for engine oil level detection in the event of false or premature low engine oil level warning lamp illumination. Should a customer present a concern with a low engine oil warning lamp illumination and the diagnosis indicate the oil level is full or nearly full (oil level between the full and add marks/holes on the dipstick) and the customer has not added any engine oil, the ECM must be updated with this new logic and the oil level switch replaced. The new oil level switch part number supplied in this bulletin must be used. If the customer has added oil, determine how much was added. Based upon the information provided, estimate where the oil level was when the lamp illuminated in order to determine if additional action is required beyond what is described in this bulletin (e.g an oil consumption test). The ECM must still be updated with this new logic and the oil level switch replaced.

**Step 3** - Once the ECM reprogramming has been completed and the oil level switch wiring has been confirmed to be OK, proceed with replacing the oil level switch assembly shown in the illustration below following the procedure outlined in the applicable Service Manual. Torque the 2 retaining bolts to 6.4 Nm (56 inch-pounds).
