# **Service Bulletin**

Subject:	Bulletin No:	01-009/16
ROUGH IDLE WITH CHECK ENGINE LIGHT ON AND DTC P0015 / P0524	Last Issued:	06/16/2016
	Last issued.	00/10/2010

2012-2016 Mazda3 SKYACTIV 2013-2016 CX-5 SKYACTIV

2014-2016 Mazda6 SKYACTIV

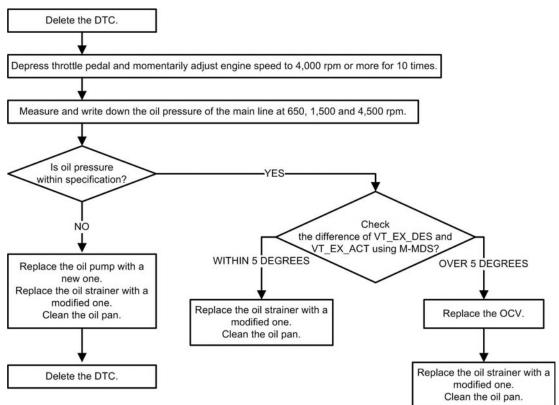
#### Only P0015 is stored:

This is caused by a drop in engine oil pressure due to a piece of foreign object stuck on the oil pump pressure relief valve or oil control valve (OCV). The temporary entry of the foreign object triggers a check engine light on, but rough idle will not be produced until a later time.

- 1. Delete the DTC.
- 2. Depress the throttle pedal and momentarily adjust the engine speed to 4,000 rpm or more for 10 times.
- 3. Measure the main line oil pressure at 650 rpm, 1,500 rpm and 4,500 rpm according to the instructions on MS3 (OIL PRESSURE INSPECTION).
  - a. Connect M-MDS to monitor ECT, OIL\_TEMP and RPM.
  - b. Start the engine and turn off all electrical loads such as A/C, headlights, etc.
  - c. Warm up the engine until ECT and OIL\_TEMP reach 90 °C (194 °F) or more.
  - d. Turn off all electrical loads such as A/C and headlights.
  - e. Wait until RPM on IDS becomes stable at 650 rpm. DO NOT read RPM on the tachometer in the vehicle.
  - f. Measure and write down the main oil line pressure at 650 rpm, 1,500 rpm and 4,500 rpm.

#### • If Abnormal oil pressure is observed:

1) Replace the oil pump with a new one and replace the oil strainer with a modified one according to the instructions on MS3 (OIL PAN REMOVAL/INSTALLATION [SKYACTIV-G 2.0, SKYACTIV-G 2.5]).

#### • If Normal oil pressure is observed:

1) Verify that the difference of VT\_EX\_DES (Exhaust valve opening angle - target) and VT\_EX-ACT (Exhaust valve opening angle - actual) is within 5 degrees (between 1,500 rpm and 2,000 rpm) using M-MDS.

#### • Within 5 degrees:

a) Replace the oil strainer with a modified one.

#### • Over 5 degrees:

- a) Replace the oil control valve (OCV).
- b) Replace the oil strainer with a modified one.
- c) Clean the bottom of the oil pan with a clean cloth.
- d) Replace the engine oil.
