<b>Subject:</b>  WHITE STAINS FROM UNDER OUTER MIRROR BASE	<b>Bulletin No:</b> 09-046/16
	<b>Last Issued:</b> 08/02/2016

2014-2016 Mazda3 (Mexico built)

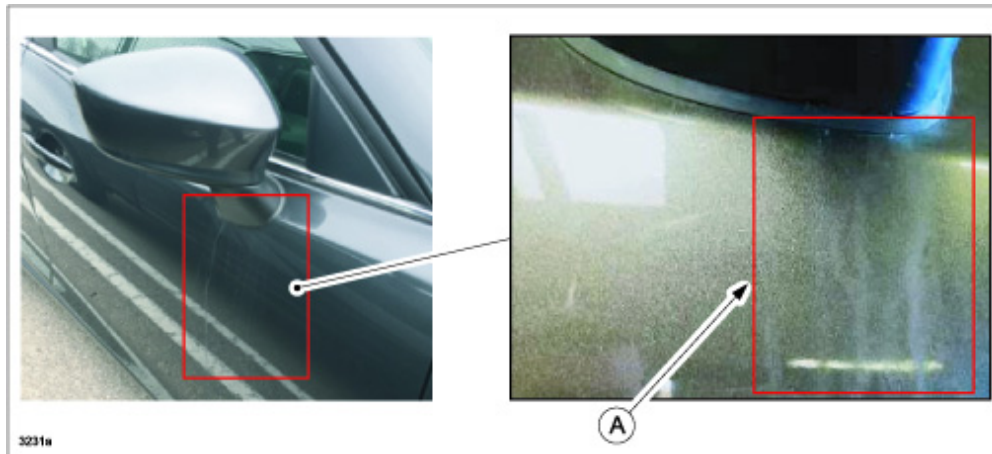
Some vehicles may exhibit white stains (A) running down the front door(s) from the base of the outer mirror, causing a poor appearance. This is caused when water enters the mirror base and corrodes the aluminum die cast inside the mirror. To eliminate the concern, the aluminum die cast inside the mirror base has been painted to prevent corrosion.

1. Verify customer concern.
2. Replace the power outer mirror assembly (both sides) with one used for HOFU plant (Japan built) models according to the instructions on MS3 online (POWER OUTER MIRROR REMOVAL/INSTALLATION).
3. Verify repair.
