Service Bulletin Mazda North American Operations

Bulletin No: 04-005/16 NOISE FROM REAR BRAKES DUE TO BRAKE DRAG Last Issued: 08/05/2016

2016 CX-5 vehicles with VINs lower than JM3KE*****781350 (produced before Feb. 22, 2016)

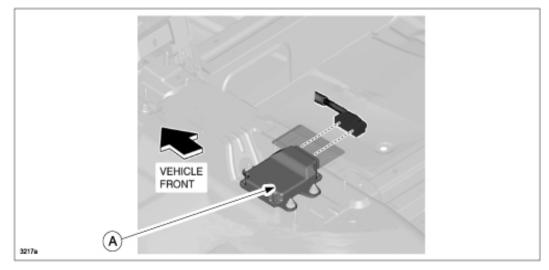
Some vehicles may exhibit rear brake dragging, resulting in brake noise and abnormal outer brake pad wear.

This may be caused when the Electronic Parking Brake (EPB) does not release completely. To eliminate this concern, the EPB control module logic has been modified.

- 1. Verify the customer concern.
- 2. Replace the electric parking brake control module (A) with a modified one according to the instructions on MS3 online (ELECTRIC PARKING BRAKE CONTROL MODULE REMOVAL/INSTALLATION).
