Subject: VIBRATION FELT THROUGH FLOOR / SEAT / STEERING WHEEL AT APPROX. 25 - 30 MPH	Bulletin No: 03-003/16
	Last Issued: 08/11/2016

2013-2016 CX-5 vehicles equipped with automatic transmission

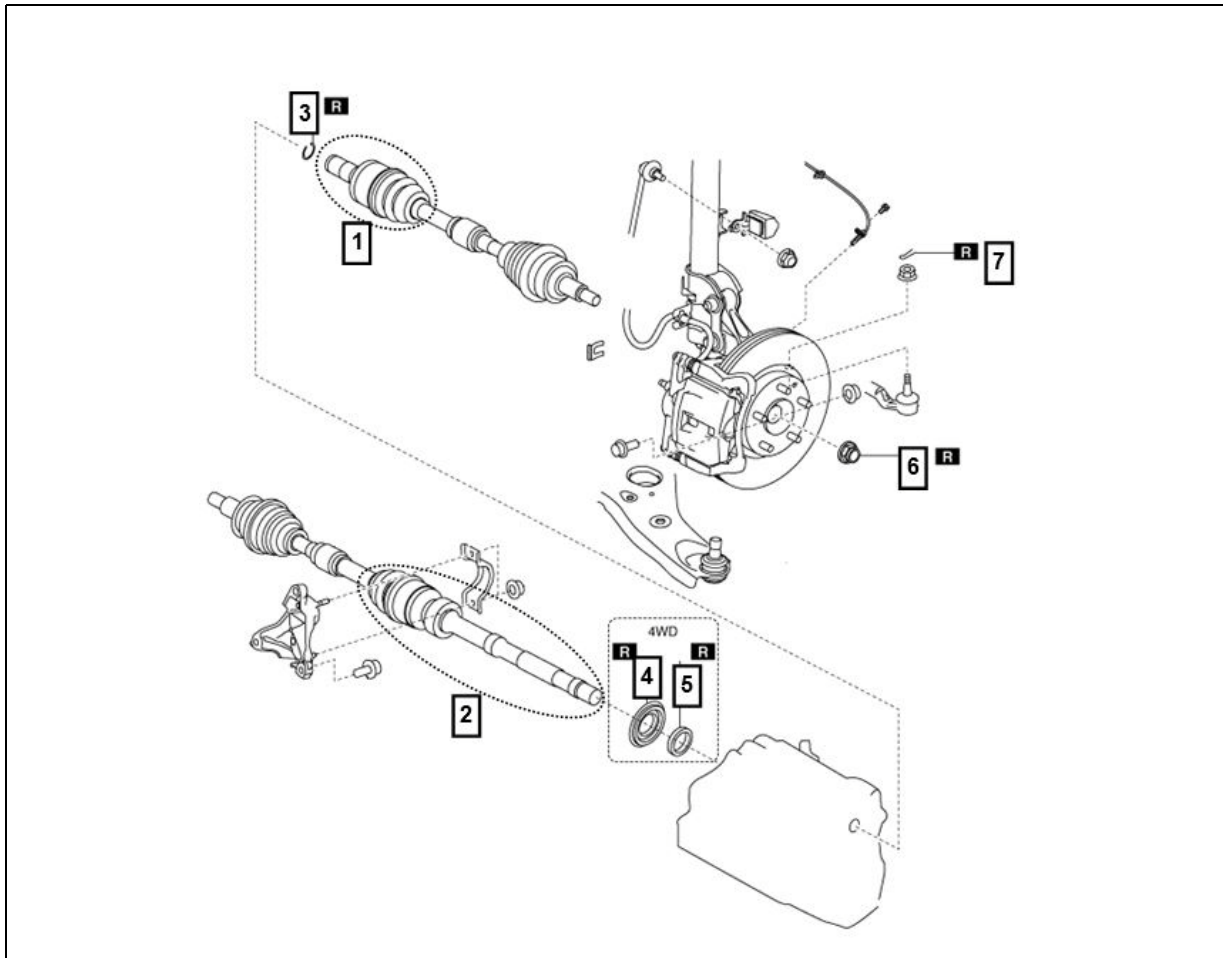
Parts Location:

The vibration may be caused by wear on the inner surface of the tripod joint case (inner side of front drive shaft). To eliminate this concern, a coating has been applied to the inner surface of the tripod joint case to improve wear resistance.

1. Verify the customer concern.
2. Replace the inner joint set for the left and right drive shafts with modified service parts according to the instructions on MS3 online (FRONT DRIVE SHAFT REMOVAL/INSTALLATION) and (FRONT DRIVE SHAFT (TRIPOD JOINT) DISASSEMBLY/ASSEMBLY).
3. Verify the repair.
