Subject: WATER PUMP COOLANT LEAK	Bulletin No: 01-016/16
	Last Issued: 08/26/2016

2004-2017 Mazda3	2016-2017 Mazda CX-3	2007-2017 Mazda CX-9
2006-2015 Mazda5	2013-2017 Mazda CX-5	2004-2005 Mazda Miata
2003-2017 Mazda6	2007-2012 Mazda CX-7	2006-2017 Mazda MX-5

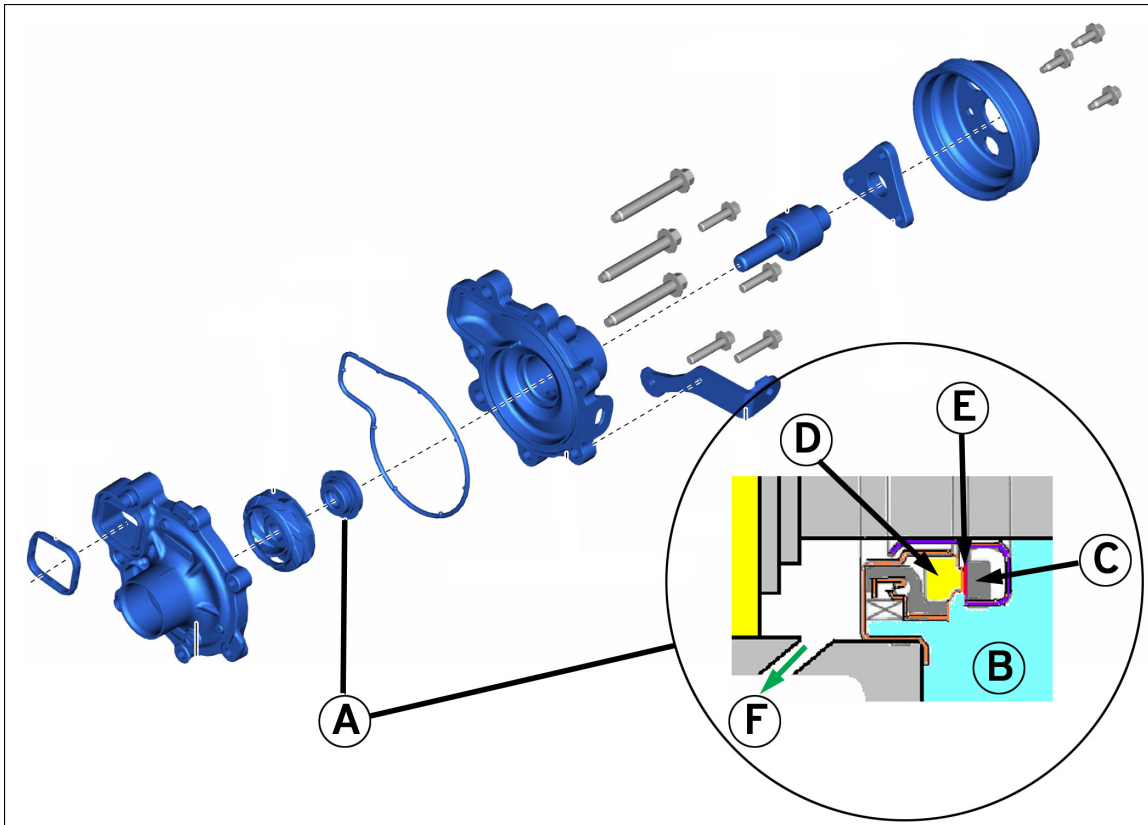
A mechanical seal (A) is used for the water pump. This mechanical seal can seal coolant (B) by sliding a mating ring (C) against a seal ring (D). When the sliding surface temperature of the mechanical seal is more than 248 °F (120 °C) while driving, a small amount of steam (E) is leaked and bleeds through the bleeding hole (F). After drying, the steam leaves a green coolant deposit near the water pump bleed hole (F). This is a normal condition and does not require water pump replacement. The water pump should only be replaced if there is an accumulation of crystallized coolant near the bleed hole.

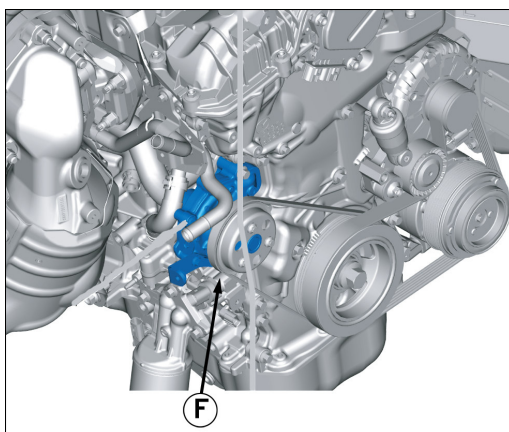
Bleed hole (F) is located under water pump

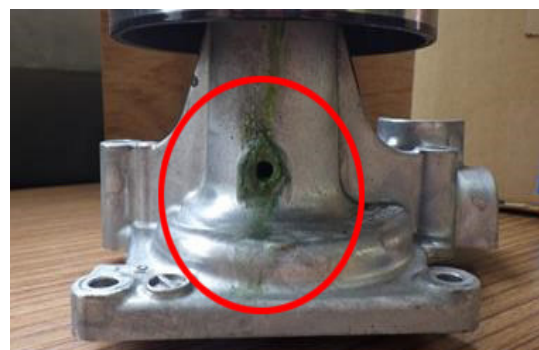
Dried coolant steam shows as green-color deposit at bleed hole.

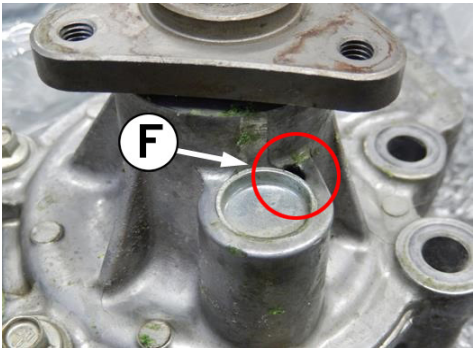
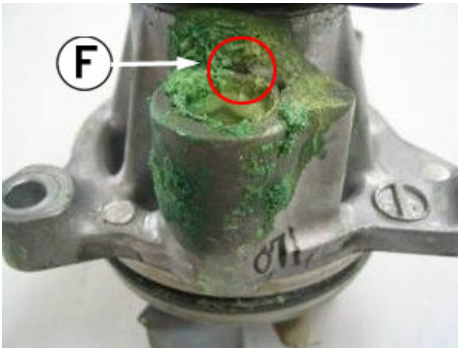
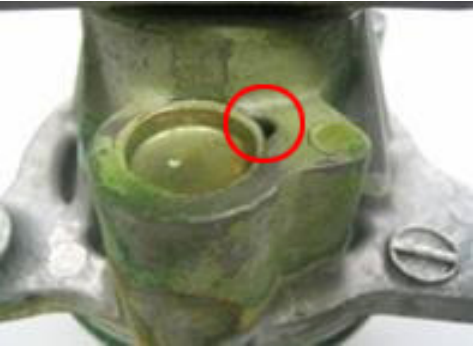
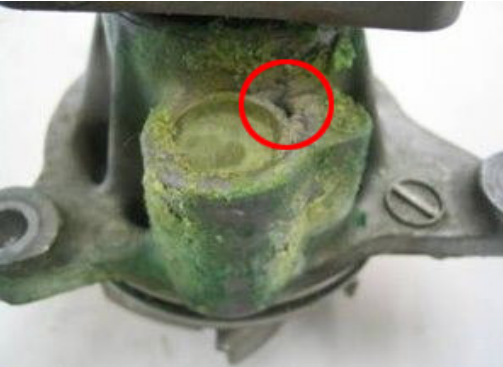
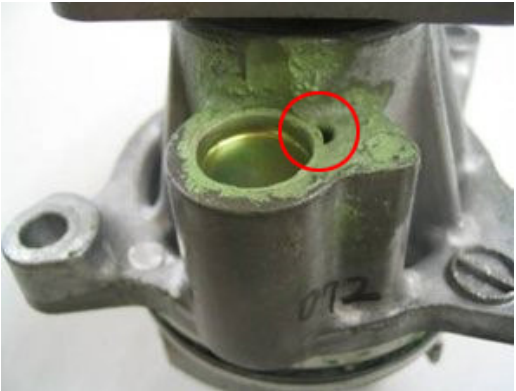
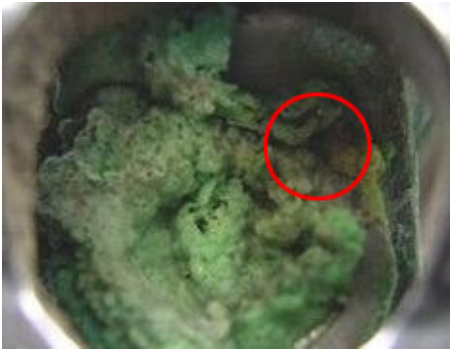
Water Pump Samples:

<p>GOOD No accumulation of crystallized coolant. DO NOT replace the water pump.</p>	<p>NG Accumulation of crystallized coolant near the bleed hole (F). Replace the water pump.</p>
