Subject: SUNROOF OPENS BY ITSELF	Bulletin No: 09-040/16
	Last Issued: 06/24/2016

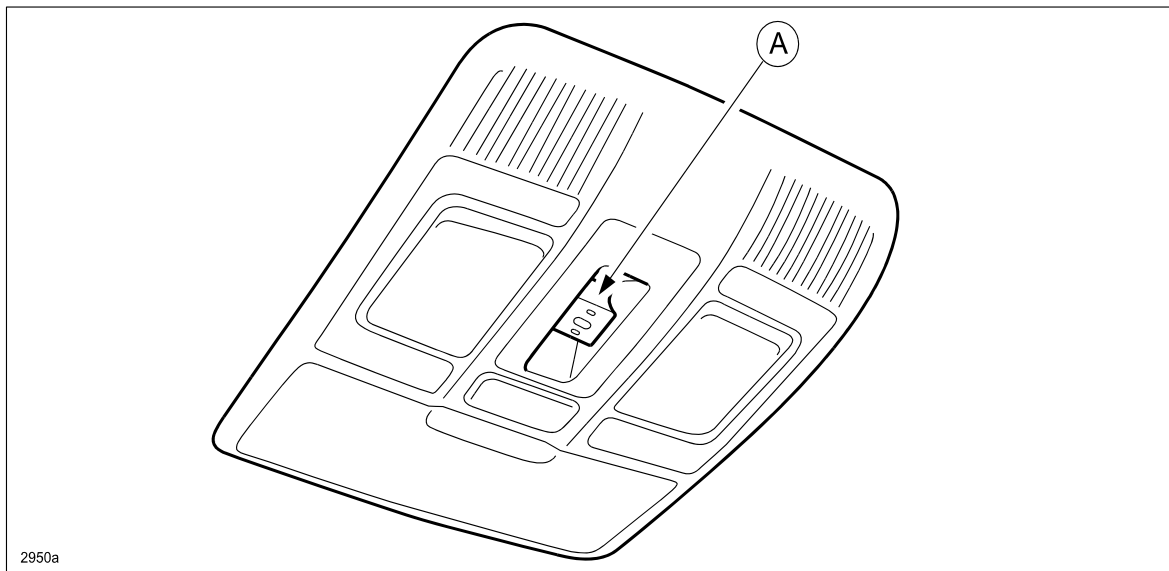
Some customers may complain that in extreme cold weather conditions, the sunroof may suddenly open by itself when the heater is on. This concern may be due to a short in the sunroof switch (A) caused from condensation generated between the roof panel and the seal.

To eliminate this concern in the future, a protective film has been installed to the switch and a pad installed to the harness.

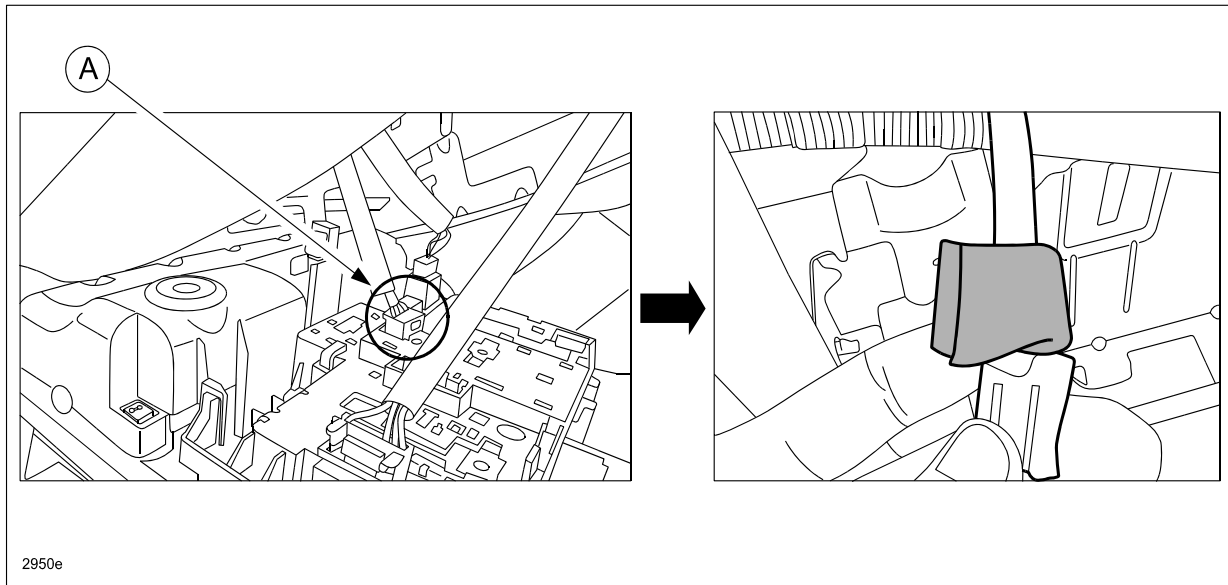
NOTE: The sunroof connector is located in the center of the map light.

1. Remove the front map light (with sunroof switch) according to the instructions on MS3 (MAP LIGHT REMOVAL/INSTALLATION).
2. Cut a 20 mm x 50 mm piece from the urethane pad.
NOTE: One (1) pad can repair ten (10) vehicles.
3. Attach the 20 mm x 50 mm piece of urethane pad around the sunroof connector harness (A), as shown below.
