© 2016 Mazda Motor of America, Inc.

Subject: NOISE FROM BOTTOM OF A-PILLAR	Bulletin No: 09-025/16
	Last Issued: 04/19/2016

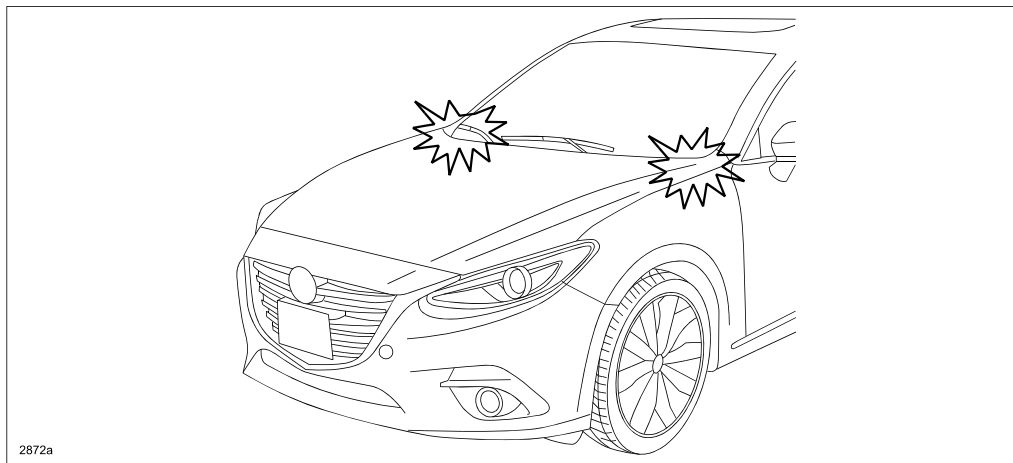
Some vehicles may exhibit a noise from the bottom of the A-pillar when driving on rough roads or over bumps. This is caused by the cowl upper plate and/or dash upper panel interfering with the wiper bracket. For the affected vehicles, a clearance needs to be created between the wiper bracket and cowl upper plate and between the wiper bracket and dash upper panel. To correct the concern, additional sealing and welding have been applied to the wiper bracket.
