Subject: ACCELERATOR PEDAL HINGE BROKEN AT BASE	Bulletin No: 01-013/16
	Last Issued: 05/19/2016

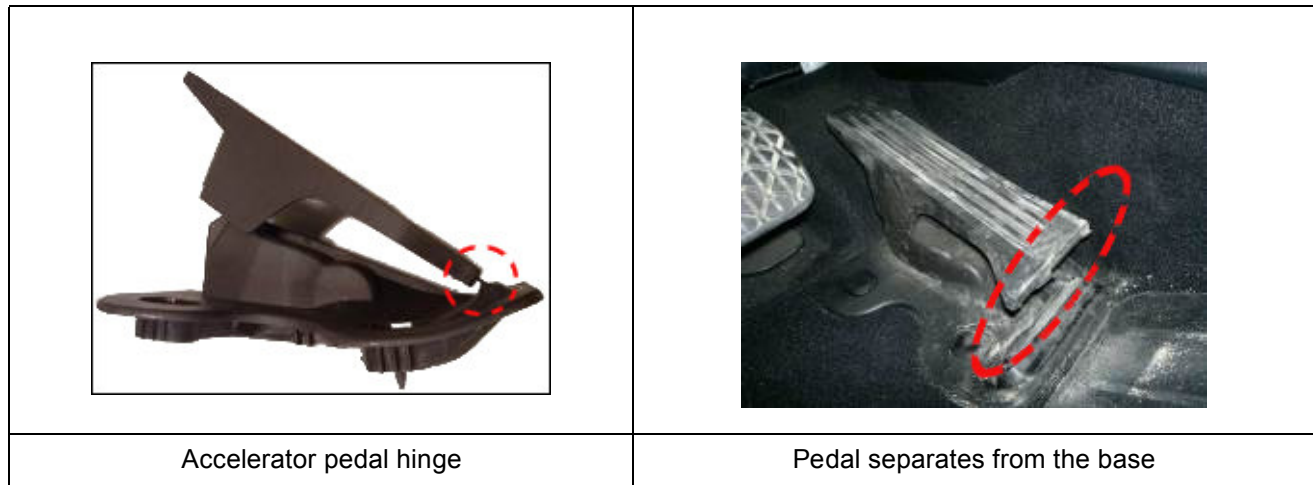
Some vehicles may exhibit the accelerator pedal hinge separating from the base in cold temperatures below 32 degrees Fahrenheit (0 degrees Celsius).

The accelerator pedal has been changed to increase durability.

1. Verify customer concern.
2. Replace the accelerator pedal. Refer to MS3 online Workshop Manual section 01-13:
 - CX-3 - ACCELERATOR PEDAL REMOVAL/INSTALLATION
 - CX-5 - ACCELERATOR PEDAL REMOVAL/INSTALLATION
 - Mazda2 - ACCELERATOR PEDAL REMOVAL/INSTALLATION
 - Mazda3 - ACCELERATOR PEDAL REMOVAL/INSTALLATION
 - Mazda6 - ACCELERATOR PEDAL REMOVAL/INSTALLATION
3. Verify repair.
