SERVICE BULLETIN

APPLICABILITY: 2015-16MY Legacy and Outback Models

NUMBER: 15-177-14R

SUBJECT: New “Gen 2” Fujitsu Ten (F10) SD Card Audio / Navigation (AVN) System Operating Tips

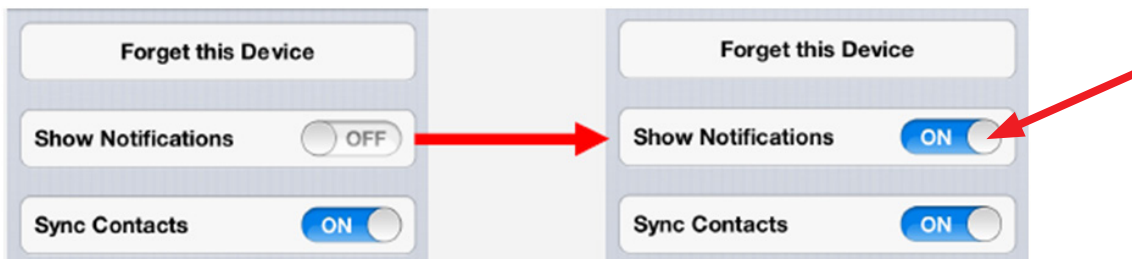
CONDITION #1: Cannot receive incoming text messages on the head unit when using an iPhone.

“Show Notifications” is not activated in the iPhone’s Bluetooth Settings menu.

4. Slide “Show Notifications“ button to “ON”.

New incoming text messages will now be displayed on the head unit as they are received.

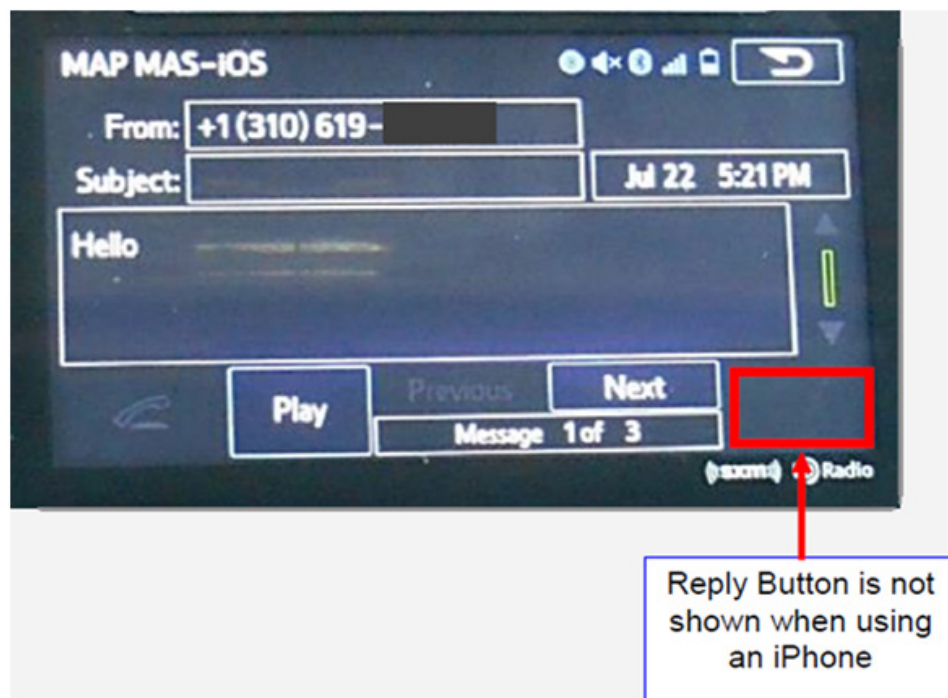
CONDITION #2: Unable to reply to received text messages from the head unit when using an iPhone.

The MAP (Mail Access Profile) does not always allow the user to read and reply (both) to text message content from the smartphone connected to the head unit. Function of MAP profile varies by phone manufacturer. The iPhone provides the MAP (Text Message) feature via Bluetooth. As per Apple specifications, the iPhone’s MAP does not support the reply function, only read is supported.

Inform the customer when their iPhone is paired to the head unit, the head unit will be able to display and read aloud the incoming text messages. However, the “Reply” message function will not be available.

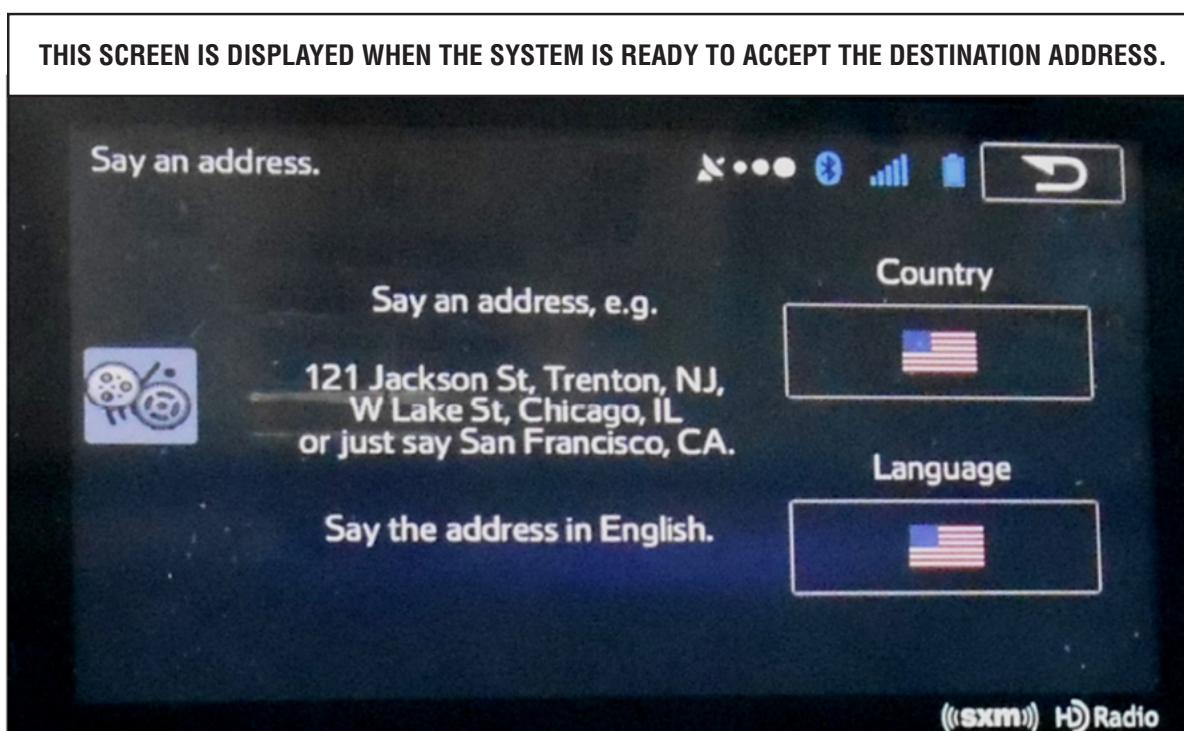
CONDITION #3: Unable to set up the “Destination Address” using voice command.

Voice commands are not spoken with the correct pause, timing or cadence between “House Number”, “Street Name”, “City Name” and “State” which the head unit can understand.

Say the Destination Address with the correct pause, timing or cadence as shown in the example. Below are examples of incorrect and correct commands:

Incorrect command: 121[pause] Jackson [pause] Street [pause] Trenton [pause] NJ

Correct command: 121JacksonStreetTrentonNJ

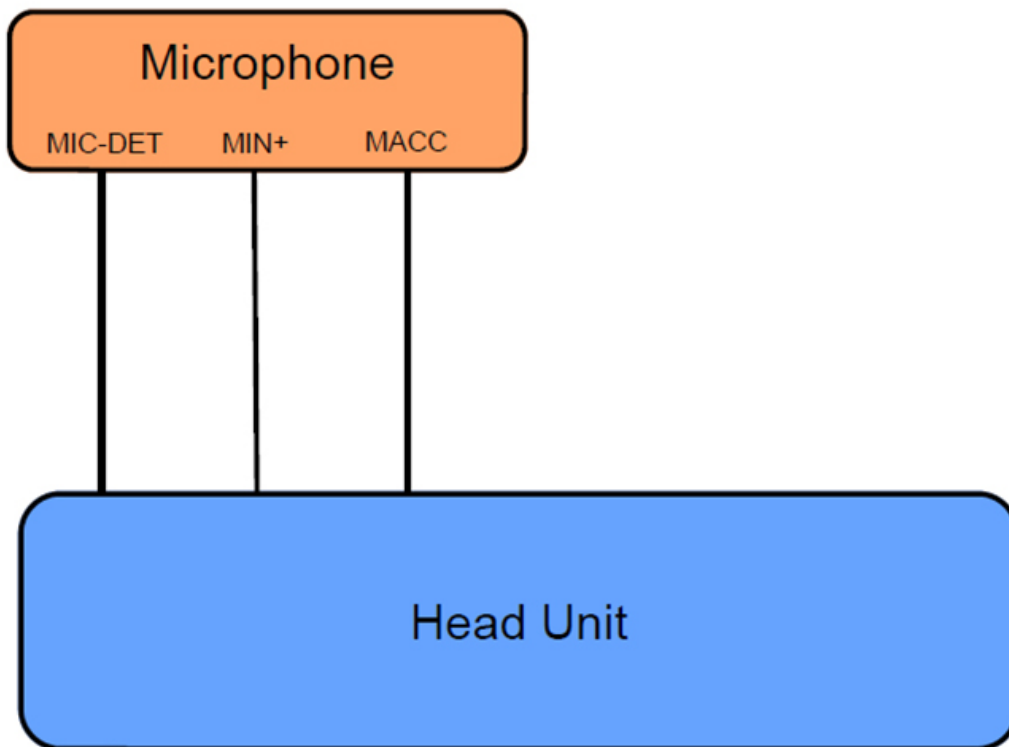
CONDITION: #5: A “Phone” button is not displayed on the HOME screen.

- Microphone is not properly connected to the head unit
- Microphone detection wiring (MIC DET) is open
- Microphone unit is defective

- Confirm the microphone wiring is securely connected to the head unit.
- Confirm there is not an open circuit or short in the Microphone detection (MIC DET) wiring.
- After the wiring has been confirmed to be OK, replace the microphone if necessary.

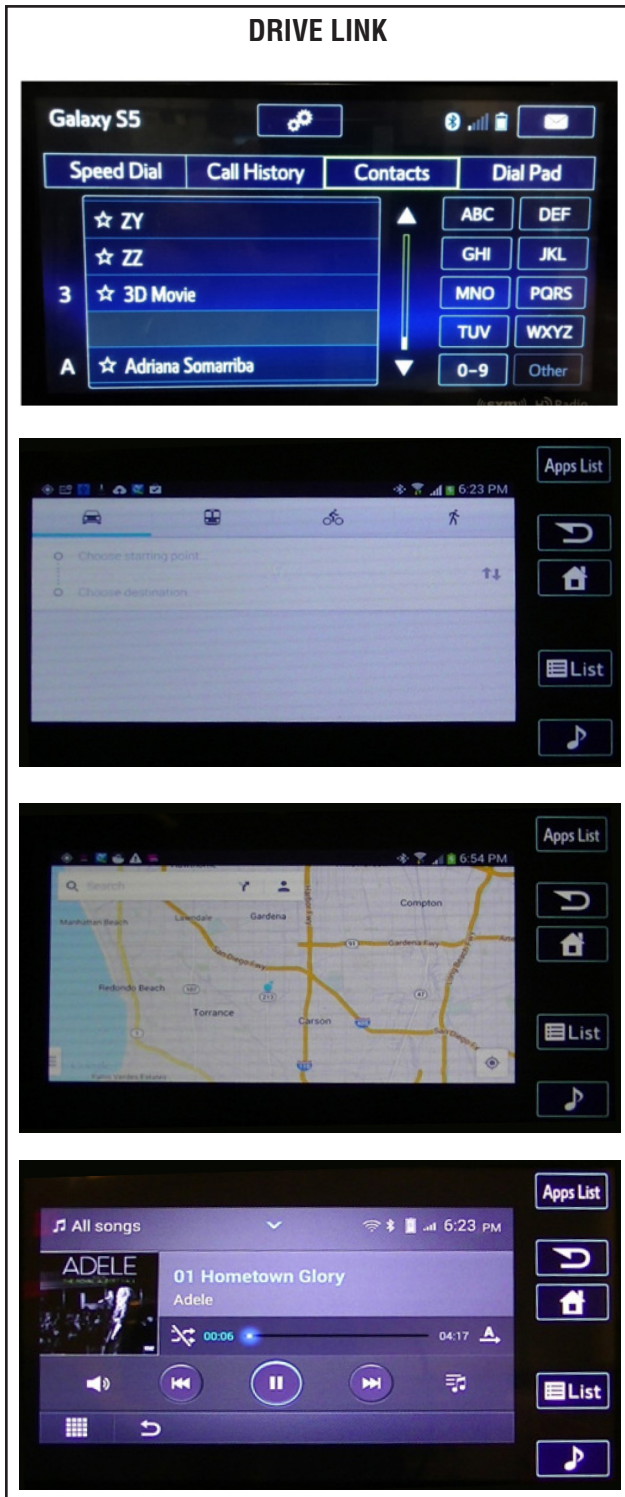
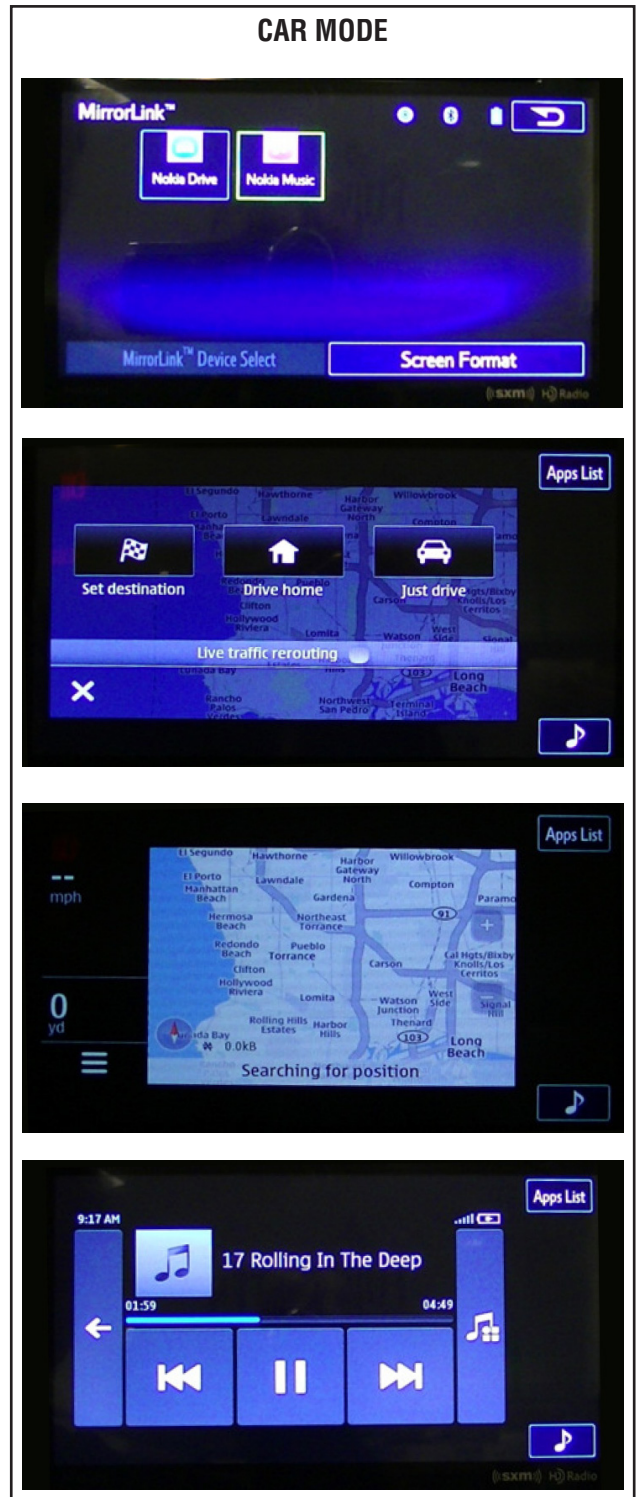
CONDITION #6: MirrorLink screen does not look the same when using “Drive Link” and “Car” mode.

Drive Link and Car mode display screen information on the head unit differently.

Explain to the customer, Drive Link and Car modes will display information differently when accessing the MirrorLink feature of the head unit. Examples of each are shown in the screen shot photos below.

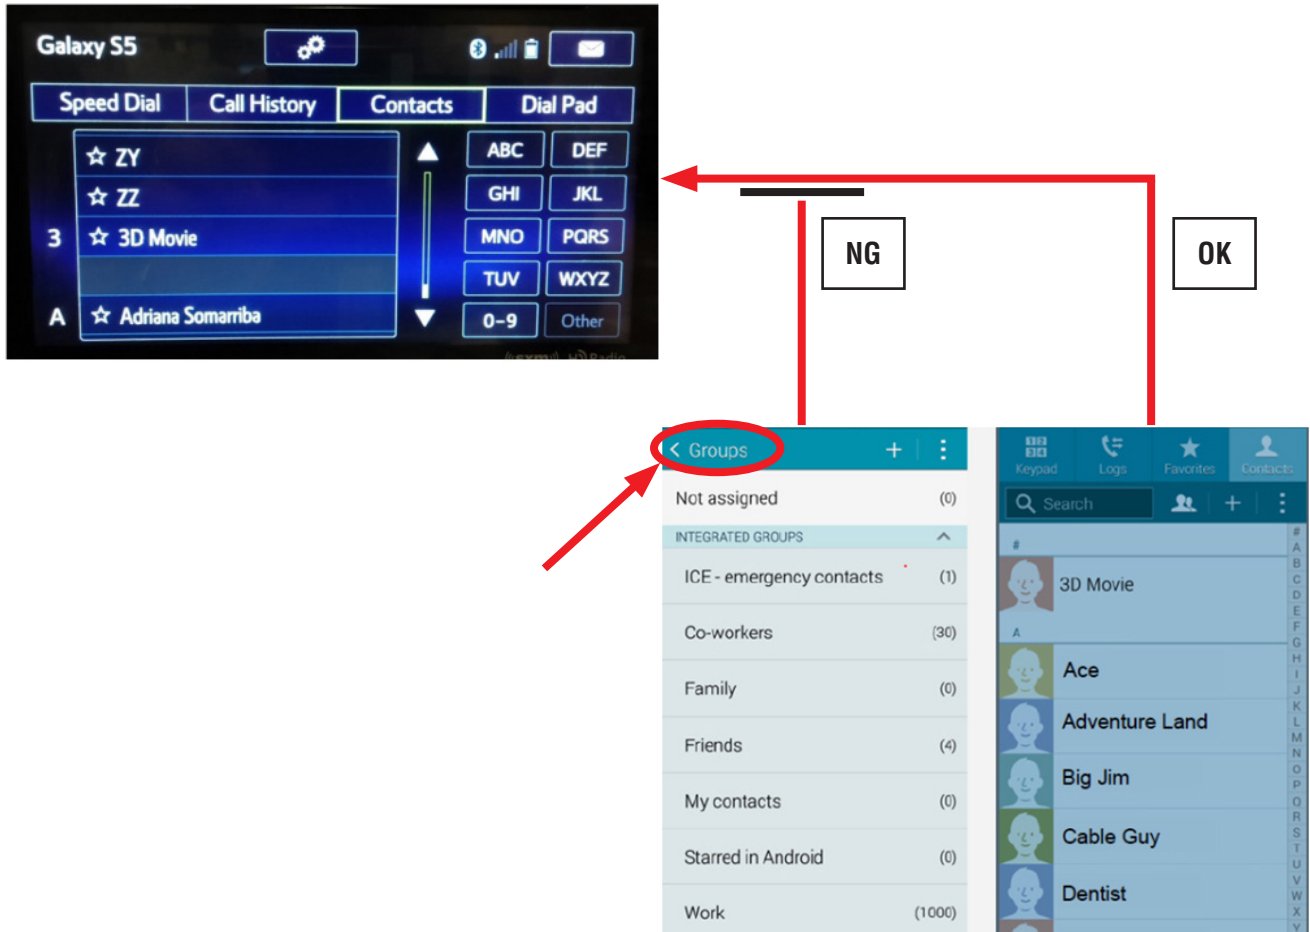
CONDITION #7: Individual contacts will transfer to the head unit from the smartphone, but group folders will not.

Although the head unit can retrieve individual contacts, it does not have the capability to retrieve group folders from the smartphone.

Explain to the customer, the head unit does not support the transfer of group folders from their smartphone.

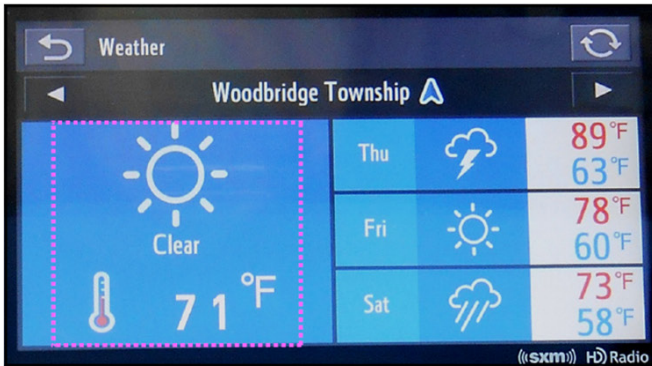
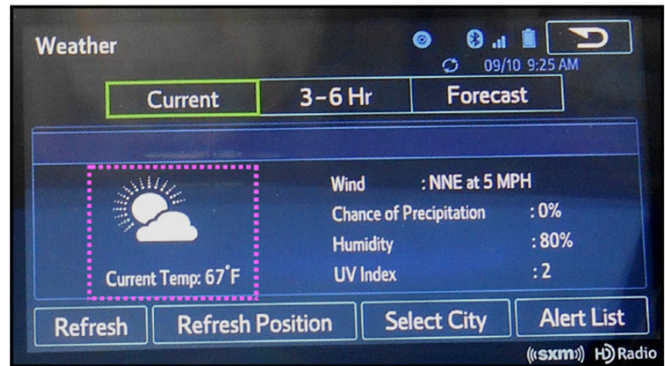
CONDITION #11: Weather information from the “STARLINK” and “INFO” function appears to be different even when the time of day and location are exactly the same.

In the examples shown below, the temperature displayed is different even though the time of day and location are the same.

The source of the weather information is different between STARLINK and INFO. STARLINK utilizes weather information provided by Weather Underground while INFO utilizes Sirius XM.

Explain to the customer that the STARLINK and INFO functions utilize different sources to provide the displayed weather information as shown in the illustrations below.

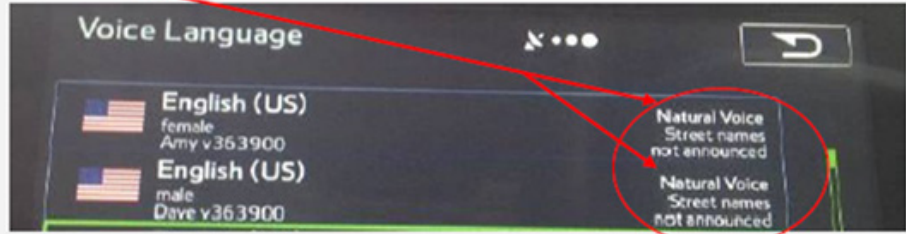
Figure 1

CONDITION #12: When using the voice command to operate navigation system functions, the following message is displayed: “This feature cannot be used with the selected guidance voice profile”.

“Natural Voice” (Figure 1) is selected from the Voice Language menu when “Text To Speech” (TTS) is required (Figure 2) for proper voice command operation.

- Follow the steps below to change from Natural Voice to TTS:
 1. Select “Home”.
 2. Select “Settings”.
 3. Select “General”.
 4. Select “Language”.
 5. Select “English (US) TTS Voice”.

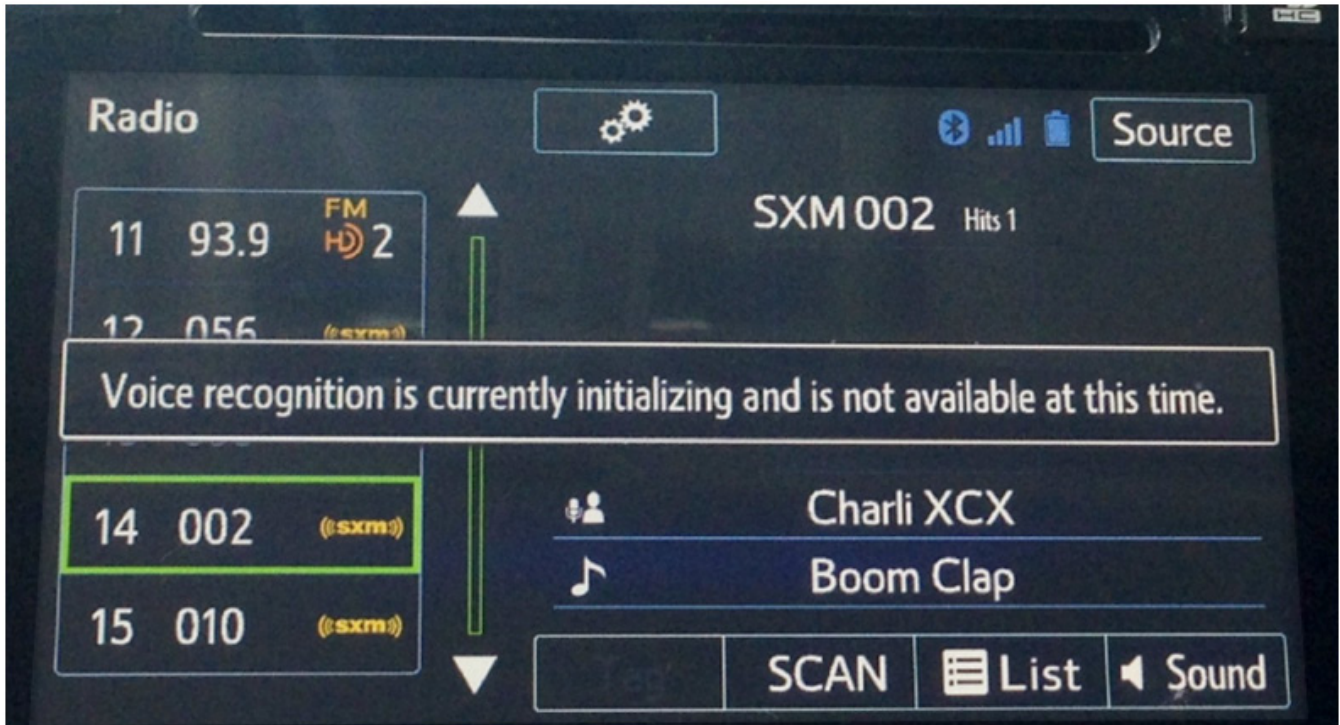
CONDITION #15: The message “Voice recognition is currently initializing and is not available at this time” appears on the screen.

When the head unit is turned on, the system scans XM stations along with every song (digital file) on the currently loaded CD, connected USB device and / or Bluetooth Audio player. It also scans the phone contacts stored on all Bluetooth-connected Smartphones. The system then creates voice tags for all the XM station names, artists, songs, albums, playlists, podcasts, genres, and contacts. During this process, the head unit will also display “Voice Recognition is currently initializing and is not available at this time” (see picture below).

Wait a few minutes then try using the Voice Recognition System again. Once the system has had enough time to complete the procedures described above, normal operation should resume.

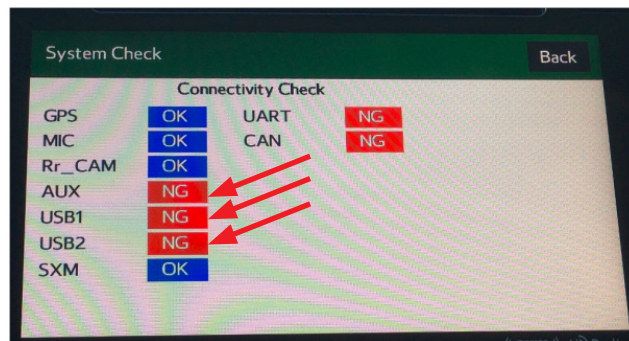
CONDITION #18: When in Diagnostic Mode, AUX, USB1 and USB2 all show as being NG

There is no device connected to either the AUX port or either of the USB ports.

To change the display for AUX from “NG” to “OK” insert an AUX cable connected to a compatible device (e.g. MP3 player) into the AUX port.

To change the display for USB1 and/or USB2 from “NG” to “OK” insert a compatible USB device into the USB port. **NOTE:** you will need to insert 2 USB devices to test both USB ports at the same time.

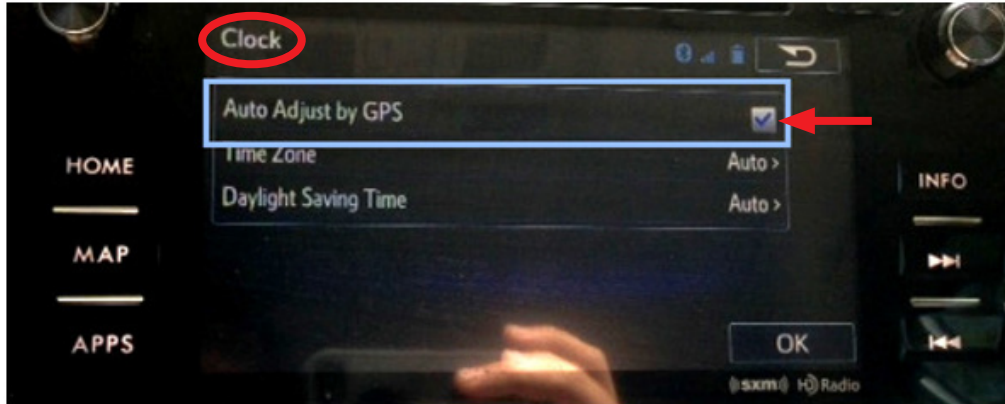
CONDITION #23: The clock display on HVAC panel is incorrect even when “Auto Adjust by GPS” is selected on the Clock settings menu.

The correct time is 4:59 pm but HVAC display shows 8:59 pm.

When a map SD card is removed from the AVN unit or the map SD card cannot be read properly by the AVN unit, the time displayed on the HVAC panel will automatically default to Greenwich Mean Time (GMT). In this case, the GMT is 4 hours “ahead” of local time.

1. If the user wants to operate the AVN unit without the map SD card installed and still have the correct time shown on the HVAC panel, access the Clock settings menu, uncheck “Auto Adjust GPS” then manually reset the correct time using “+” and “-” buttons to the left of the clock display as shown below.

2. If the map SD card is installed in the AVN unit, but the maps and / or time is not being displayed correctly, it may be due to a defective map SD card or possibly a faulty AVN unit.

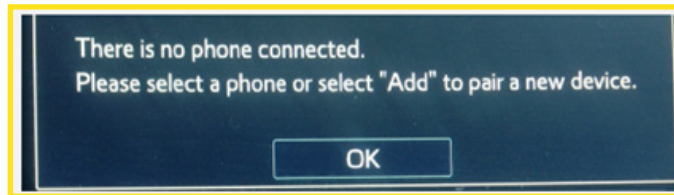
Pic 1

1. The message shown in (Pic 1) will display when there is no phone paired with the unit.

Pair a Siri-compatible phone with the unit via Bluetooth and enable the “Siri” function on the phone.

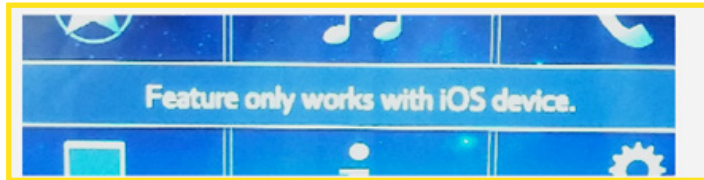
Pic 2

2. The message shown in (Pic 2) will display when an “Android” Device is paired to the unit.

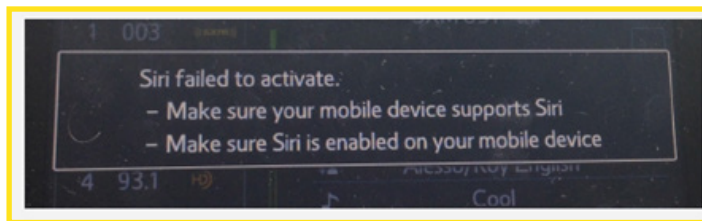
Pic 3

3. The message shown in (Pic 3) will display when a Siri-compatible phone is paired but “Siri” has not been enabled on the phone.

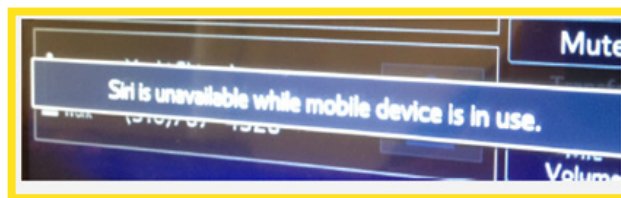
Pic 4

4. The message shown in (Pic 4) will display when Siri is initiated during a call. Siri will not operate while a call is in progress.
