Service Bulletin

Bulletin No.: PI1294B

Subject: Intermittent Service Power Steering Message Displayed on DIC, DTC C056D, C0475 or U0131 May Be Set

Models: 2013-2016 Buick LaCrosse

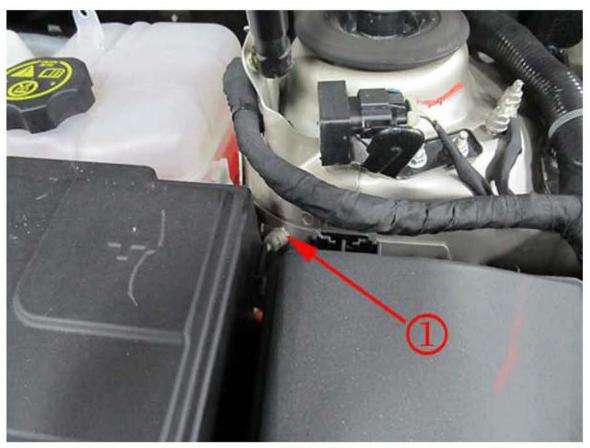
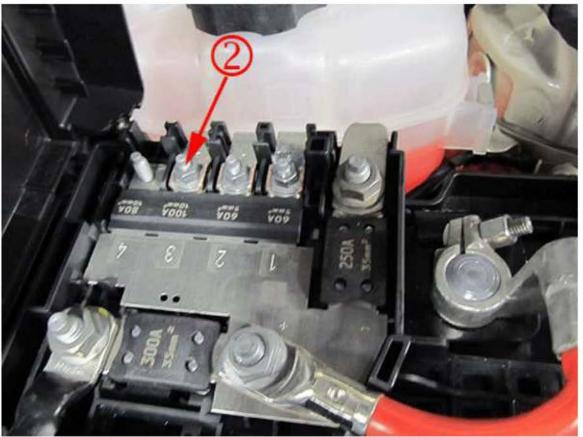
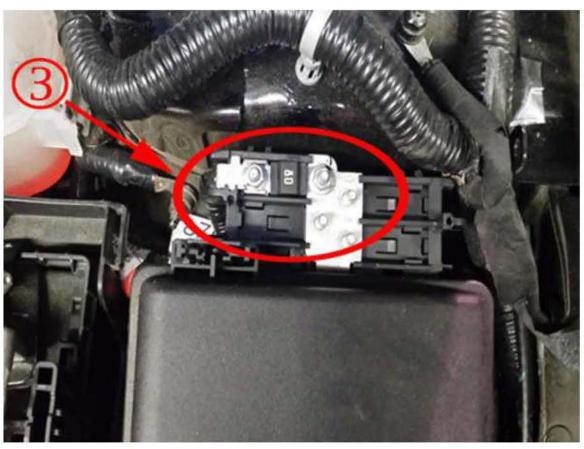
1. Inspect the G111 ground (1) and the 100A F3UB fuse (2) (LaCrosse, Regal, Impala) or 80A F72UA fuse (3) (XTS) for proper connection. Ensure the ground is free of paint and both connections are tight.

- Tighten the G111 ground to 9N•m (80 lb in).
- Tighten the F3UB fuse to 4.7 N•m (42 lb in).
- Tighten the F72UA fuse to 4.7 N·m (42 lb in).
- 2. Fully charge the battery using the GR-8 Tool (EL-50313).
- 3. Reprogram the power steering control module using the Service Programming System (SPS) with the latest calibrations available on TIS2WEB. Refer to the Power Steering Control Module Programming and Setup (NJ2) procedure in SI.
