Service Bulletin

Subject: Information on Vibration Analysis and Diagnostic

Models: 2014 Chevrolet Silverado 1500
 2015-2016 Chevrolet Silverado
 2014 GMC Sierra 1500
 2015-2016 GMC Sierra

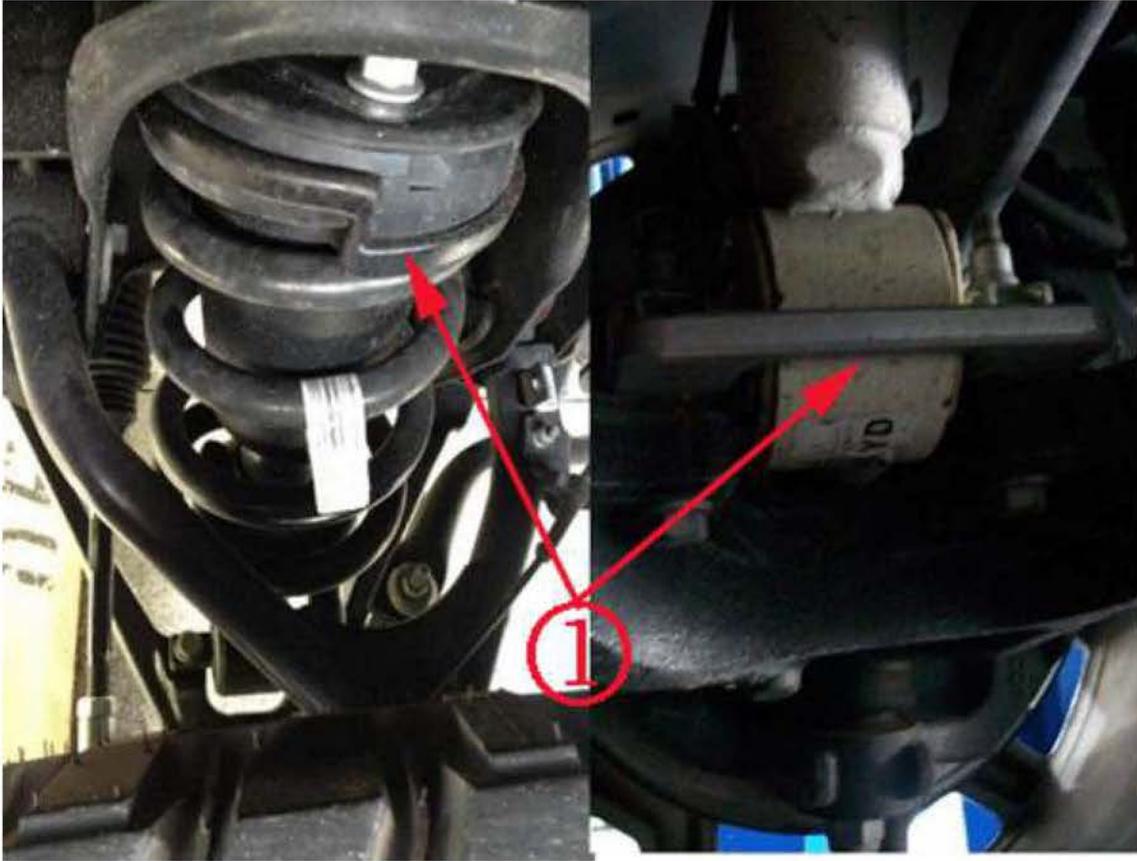
1. Inspect the truck for any aftermarket equipment installations. For example: non factory tires, wheels and/or lift kits or leveling kits – shims(1) installed as shown above. Aftermarket equipment does include running boards, bug deflectors, and window shades, etc. Remove any aftermarket that might cause vibration transmission paths.
2. Mark each tire valve stems location on the tire. This will be utilized to check for tire slippage on the rim.

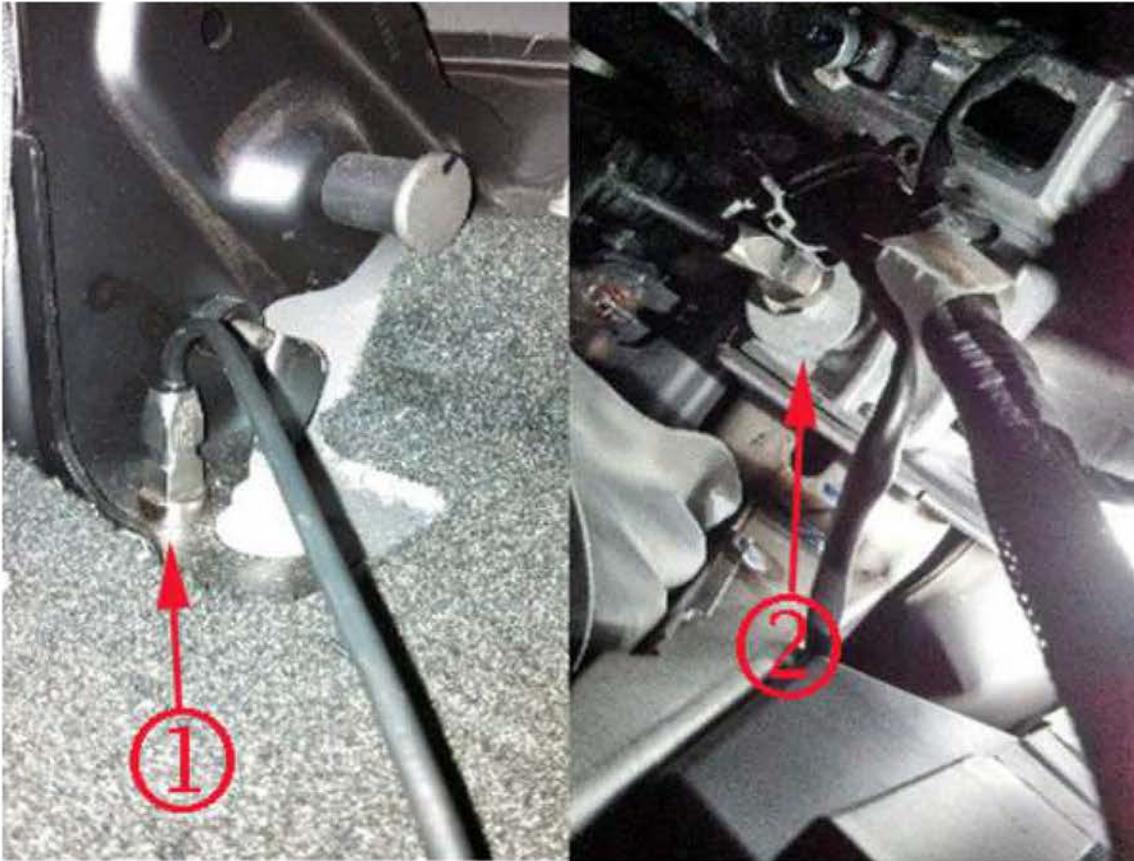
3. Using a Pico Oscilloscope Diagnostic Kit, mount the PicoScope vibration sensor on one of the two locations shown above.

- Seat Vibration – mount the sensor to the front right corner of the driver's seat bracket (1).
- Steering Wheel Vibration – mount the sensor to the steering wheel bracket (2) under dash.

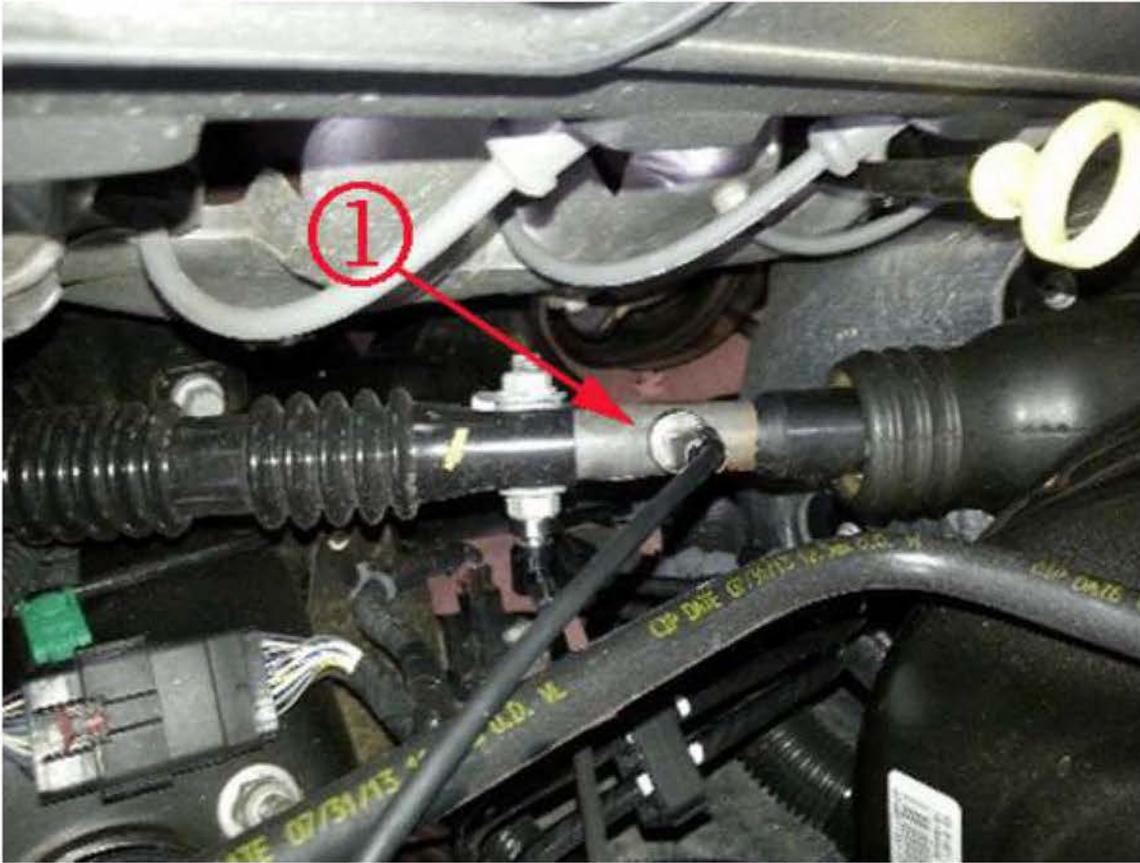
4. This step should be only be used if the vibration can be felt while running the vehicle on the rack. Mount the sensor on the steering shaft(1), under the hood as illustrated above.

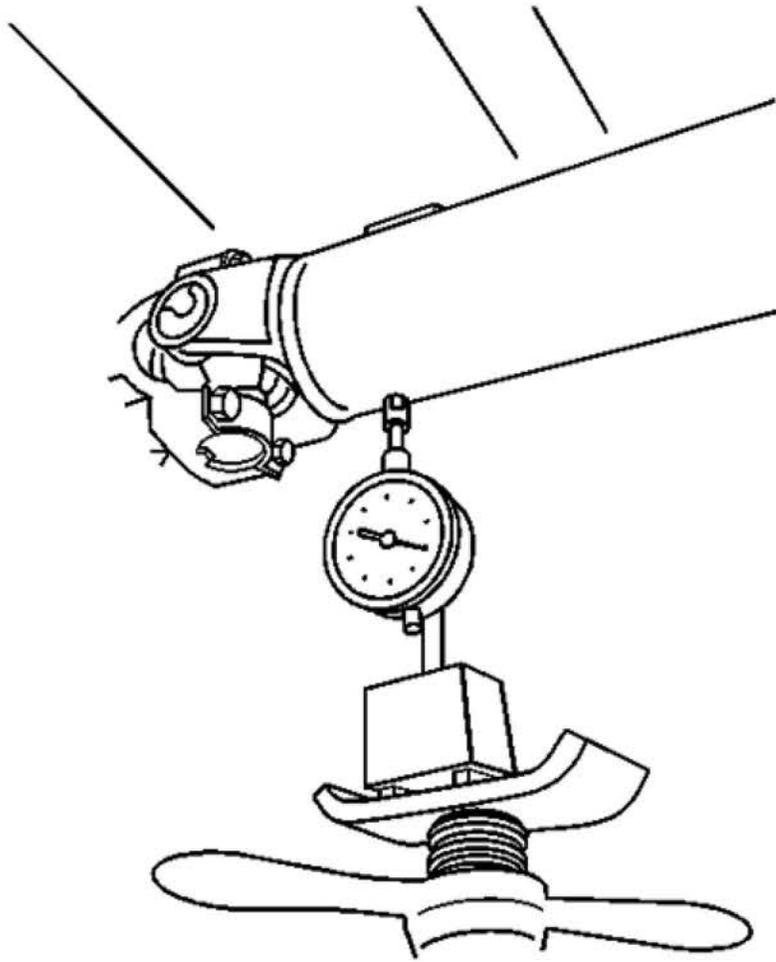
5. Mount the GE-7872 Magnetic Base Dial Indicator Set, or equivalent, or the GE-8001 Dial Indicator Set, or equivalent, to the vehicle underbody or to a service stand positioned just clear of the U-joint yoke weld on the prop shaft.

6. Rotate the drive pinion axle flange, torque tube input flange, transmission output, or transfer case output flange by hand while take runout measurements of the prop shaft. The prop shaft will rotate more easily in one direction than in the other. If necessary, the tire and wheel assemblies and even the brake caliper assemblies can be positioned and supported aside, or the brake drums can be removed from the drive axle to provide axle to provide easier rotation of the prop shaft.

9. Perform step six again.
10. If the high spot of the propeller shaft is in the same location as marked in the previous step and the measurement exceeds the maximum prop shaft runout specified, the prop shaft requires replacement before proceeding.

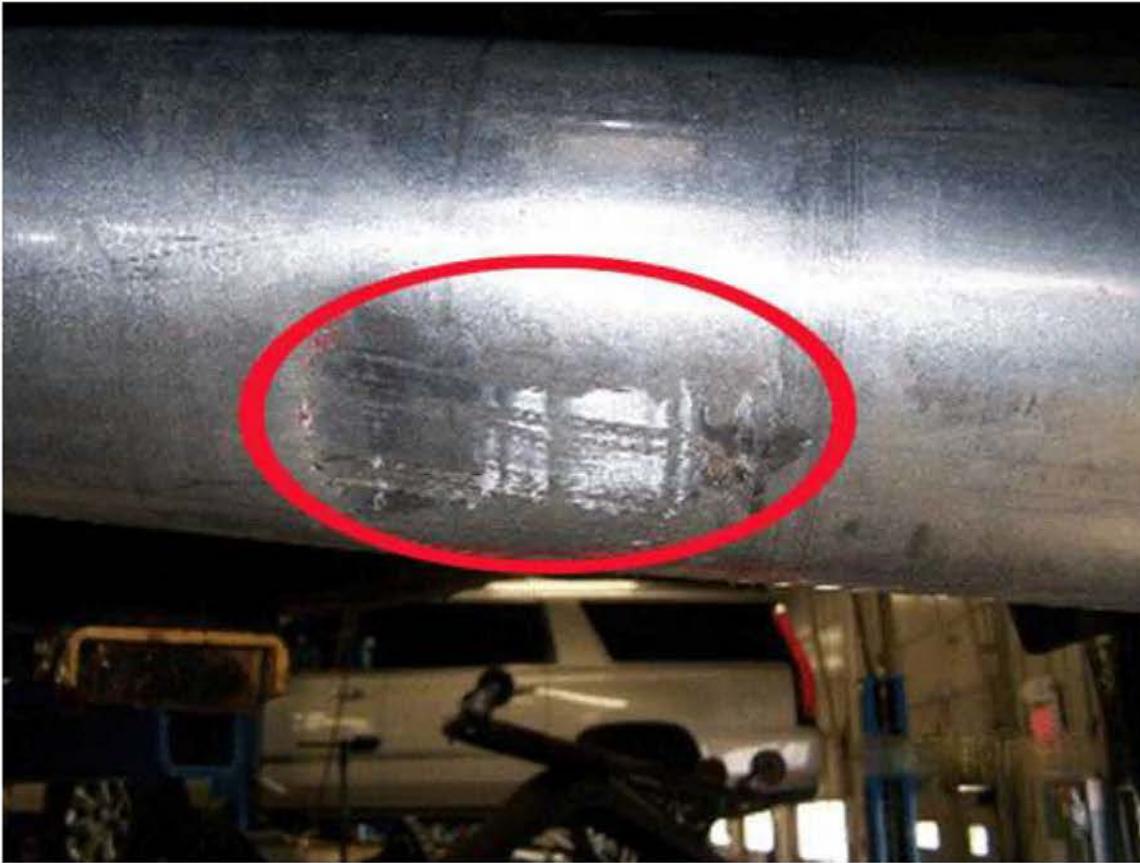
- Inspect the propeller shaft for dents or damage. There have been many cases of dented propeller shafts.
- For 4WD Trucks, remove the rear propeller shaft, seal output shaft and drive the vehicle in 4WD. If the vibration is gone, the rear prop shaft could be the problem.
- For vehicles with a 3:08 with a one-piece steel shaft, this can be replaced with a one-piece aluminum one that is utilized on all 3:42 and 3:73 ratios (K15543 and K15753 Models only).
- PIP5140: Low Speed Vibration 30-35 mph (48-56 km/h).
- Inspect the transmission output shaft bushing for irregular wear.

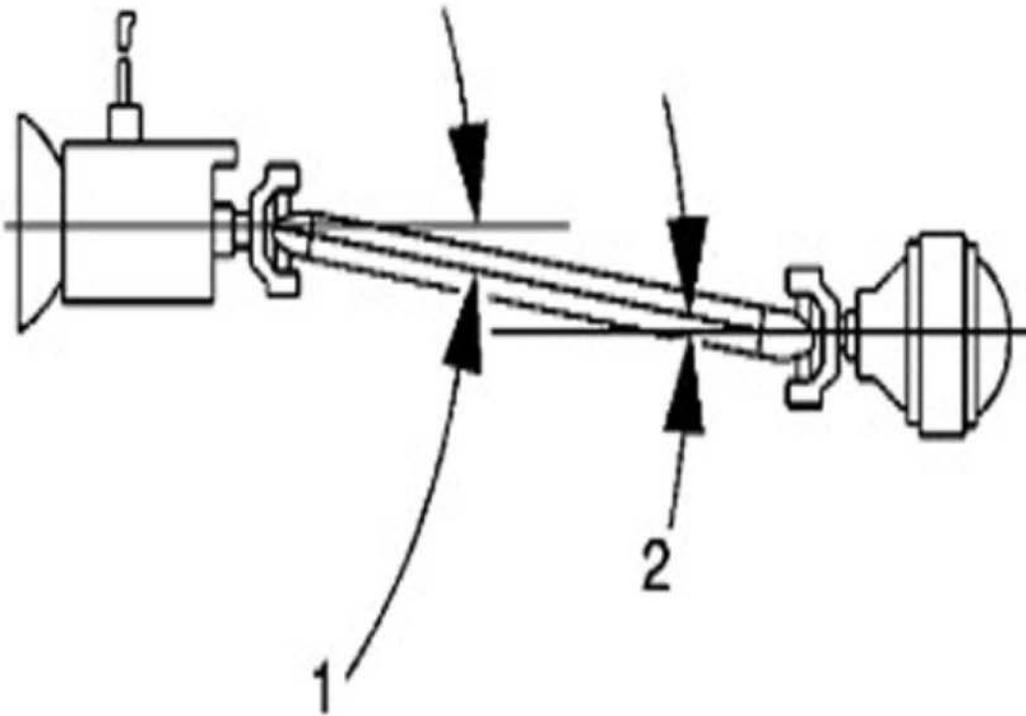
Measurement	Notes:
Yoke to Shaft		The first (forward most) U-joint action on a two piece driveshaft system is not canceled out by another U-joint. Because of this, the first U-joint working angle should be between 0.5 and 0.75 degrees.
Front Shaft to Center Support Bearing (if equip)		U-joint pairs cancel each other. Neither U-joint working angle should exceed 4 degrees, nor the allowable range of difference between cancelling U-joint working angles is 0.00 to 1.0 degrees.
Shaft to Diff Yoke

Propeller systems containing only 1 U-joint: The U-joint working angle should be between 1/2 and 3/4 degrees.

Allowable range of difference between cancelling U-joint working angles: 0.25 to 1.0 degrees.

1. Trucks were built prior to 1/1/2015 had a 14 mm spacers under the transfer case (4WD only). Starting with 1/1/2015. The shim was reduce to 7 mm shim which may correct the condition.
2. A 2 degree axle shim (P/N 23469809 – Qty 2) can be placed between the leaf spring pack and the axle perch. To rotate the pinion up to correct this; the “fat end” of the shim must face backwards, to the rear of the truck.

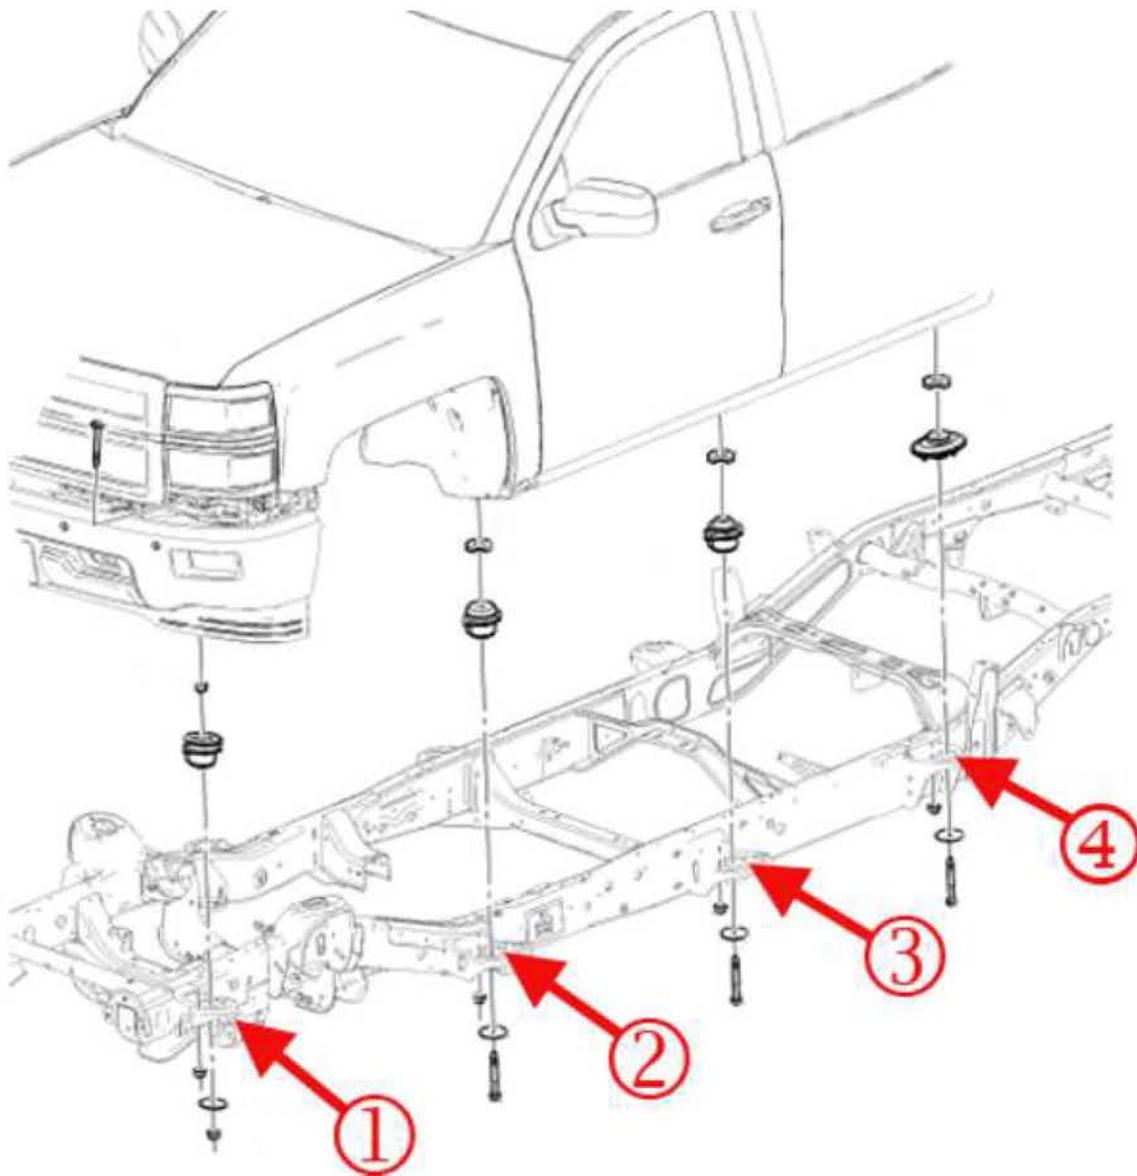
The numbers in the picture below indicate the specific mount position. The mounts on the passenger side of the vehicle are identified the same way. This will assist the technician to identify the correct location of each mount so they can be torque to the proper specification.

- 1 = body mount cushion front
- 2 = body mount cushion position number 1
- 3 = body mount cushion position number 2
- 4 = body mount cushion position number 3

Visually verify that the cab to box alignment is correct before re-torquing all mounts to specification found in Service Information, body repair, frame and under body section.

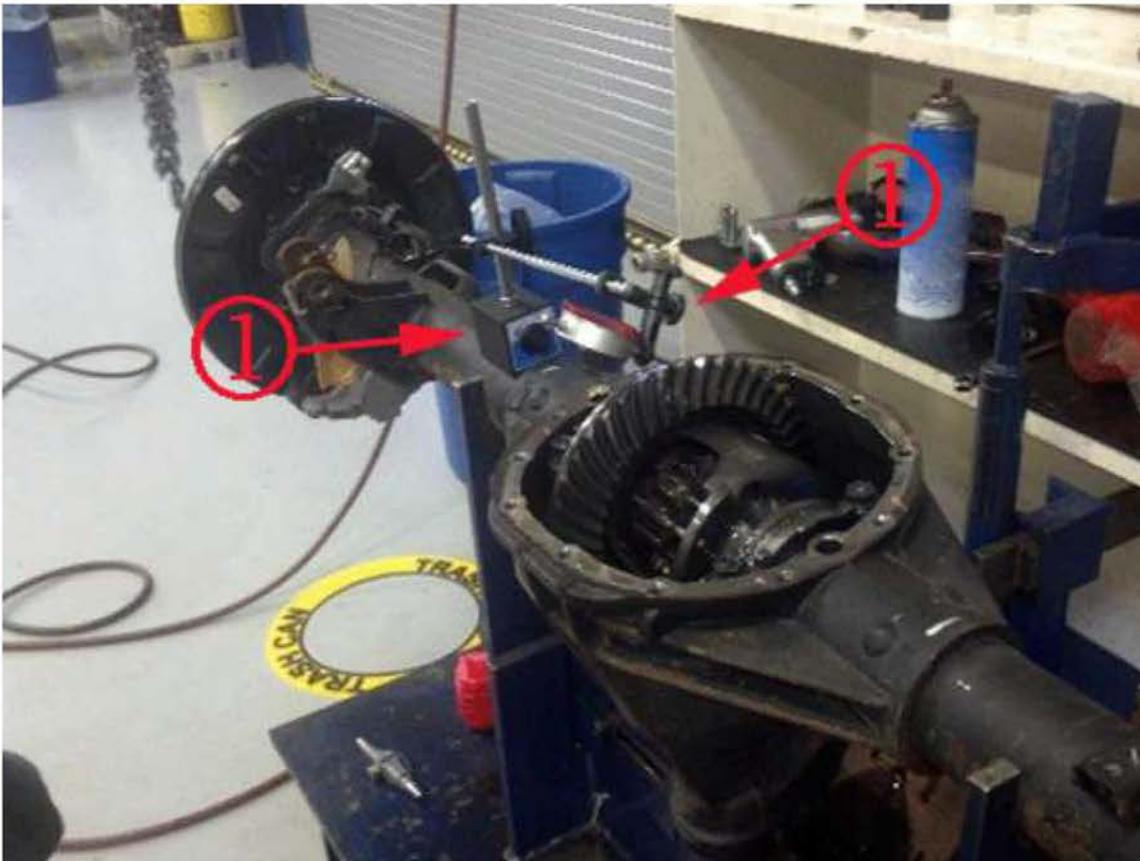
Note: The illustration above is for reference only. The differential does NOT need to be removed from the vehicle.

3. Set the J-8001-3 indicator (1) so that the stem is aligned with the gear rotation (1) and square to the tooth angle.
4. Hold the drive pinion stationary and move the ring gear back and forth.
5. Repeat the measuring procedure at **each tooth** around the ring gear.
6. The difference between the backlash at all of the measuring points should not vary by more than 0.05mm (0.002 in).
7. If the difference between the backlash at all of the measuring points varies by more than 0.05 mm (0.002 in), inspect for burrs, a distorted case flange or uneven bolting.
8. If the difference between all the measuring points is within specifications, the backlash at the minimum lash point measured should be 0.08-0.25mm (0.003-0.010 in) with a preferred backlash of 0.13-0.18 mm (0.005-0.007 in).

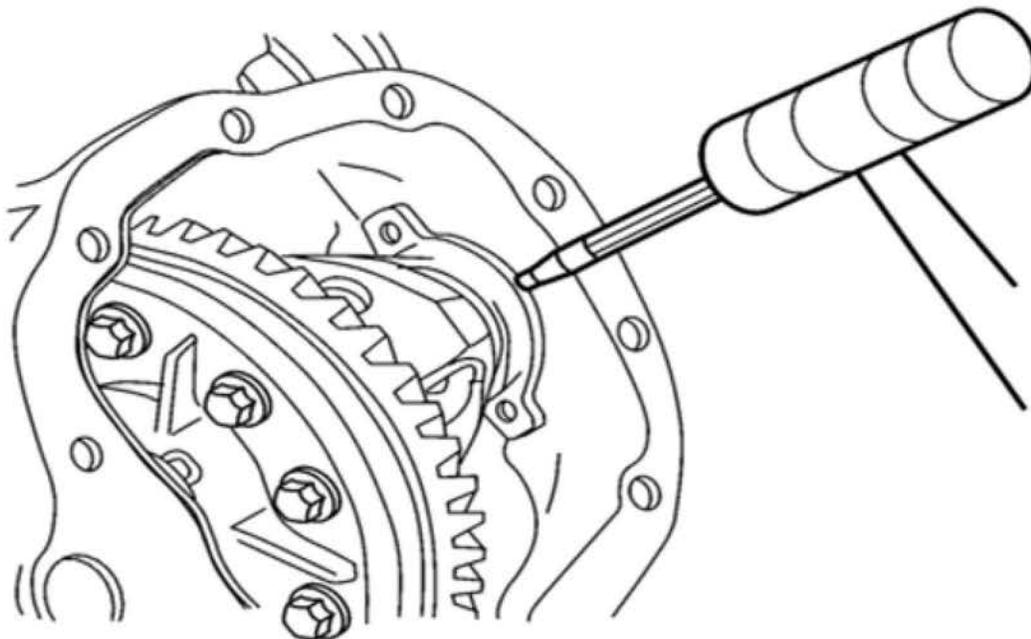
Note: The service spacers must be installed between the service shim(s) and the axle housing.

15. Using the brass drift for 9.5/9.76 axle, install the left side service spacer.
16. Recheck the backlash and adjust, if necessary.
17. Install the bearing caps and bolts and tighten to 85 N•m (63 lb ft).
18. Recheck the backlash and adjust, if necessary.
19. Once backlash is correct, perform a gear tooth contact pattern check in order to ensure proper alignment between the ring and pinion gears. Refer to the Gear Tooth Contact Pattern Inspection in SI.
