FORD:

2017 F-Super Duty

TSB 17-0022 (Continued)

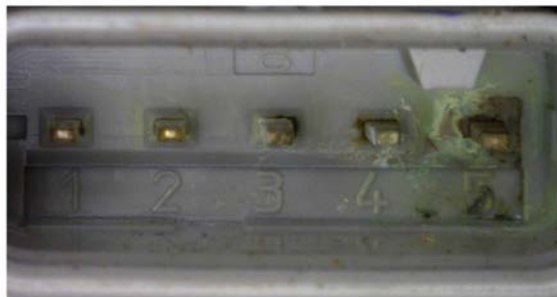
Figure 1 - Article 17-0022

Some 2017 F-Super Duty vehicles equipped with a 6.7L engine and built on or before 19-Dec-2016 may exhibit an illuminated MIL with diagnostic trouble code (DTC) U029D and/or P2209 in the powertrain control module (PCM) memory. This may be due to water intrusion.

1. Check the vehicle build date. Was the vehicle built on or before 19-Dec-2016?
 - a. Yes - proceed to Step 2.
 - b. No - this article does not apply. Refer to the Powertrain Control/Emissions Diagnosis (PC/ED) manual for normal diagnostics.
2. Connect the Ford Integrated Diagnostic System (IDS) service tool or equivalent scan tool to the data link connector (DLC). Check for DTCs. Is U029D and/or P2209 stored in the PCM memory?
 - a. Yes - proceed to Step 3.
 - b. No - this article does not apply. Refer to the PC/ED manual for normal diagnostics.
3. Disconnect the NOx sensor module 11 and inspect for moisture or corrosion on the pins of the harness and module. Is there any sign of moisture or corrosion present? (Figures 1 and 2)

- a. Yes - replace the NOx sensor module 11. Refer to Workshop Manual (WSM), Section 303-14. Proceed to step 4.
 - b. No - this article does not apply. Refer to the PC/ED manual for normal diagnostics.
4. Replace the 14406 wire harness assembly. Refer to Wiring, 152-1 component location charts.
- a. To assist in the removal of the existing harness and installation of the replacement harness, mark the location of the plastic channel that goes around the 3rd body mount from the front of the vehicle and remove it. This will allow the harness to be routed from behind the 2nd body mount from the front of the vehicle. (Figure 3)
