# **Service Bulletin**

**KNOCKING / SQUEAKING NOISE FROM FRONT STRUT BEARING**

**Bulletin No:** 02-003/15

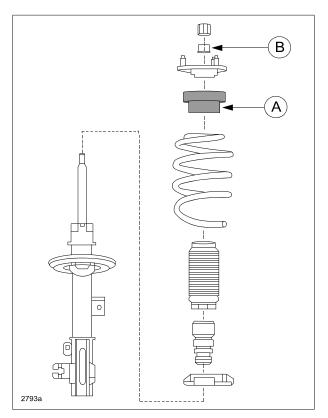
Some vehicles may exhibit a knocking / squeaking noise from the front strut bearing (A) when driving on rough roads and/or when turning the steering wheel while the vehicle is stopped.

The noise may be due to upper front strut bearing damage or it may be due to stick/slip between the front strut bearing and coil spring.

**NOTE:** The piston rod nut (B) requires replacement when the front strut bearing is replaced.

- 1. The material and production method of the front strut bearing has been changed.
- 2. A protector has been installed onto the coil spring.
