Service Bulletin

Bulletin No.: 16-NA-222

Subject: Information for Engine Concerns Resulting from Lack of Scheduled Maintenance, Improper Service or Aftermarket Calibrations

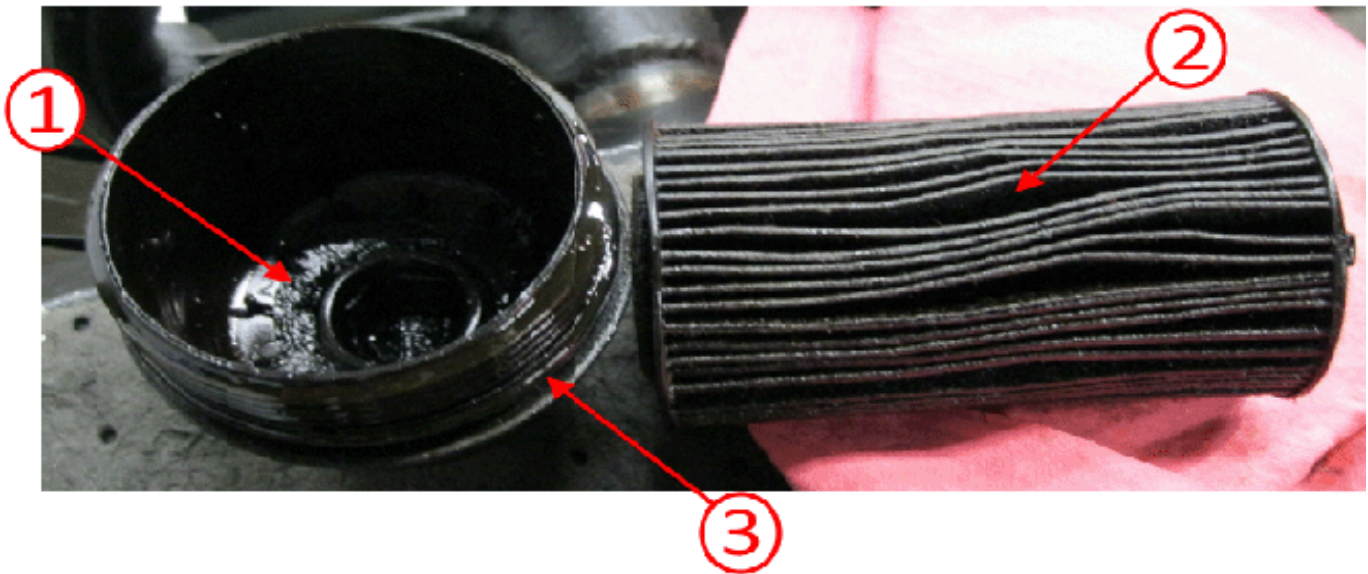
4543496

Oil filter blocked by debris and oil sludge.

- On vehicles equipped with an oil filter cartridge, inspect the cap (1) for sludge.
- Oil filter pleats (2) with heavy debris or sludge.
- Damage, holes, tears, improper installation, or missing seals (3).

Note: Using care, some oil filters may need to be cut open in order to validate the condition of the filter.

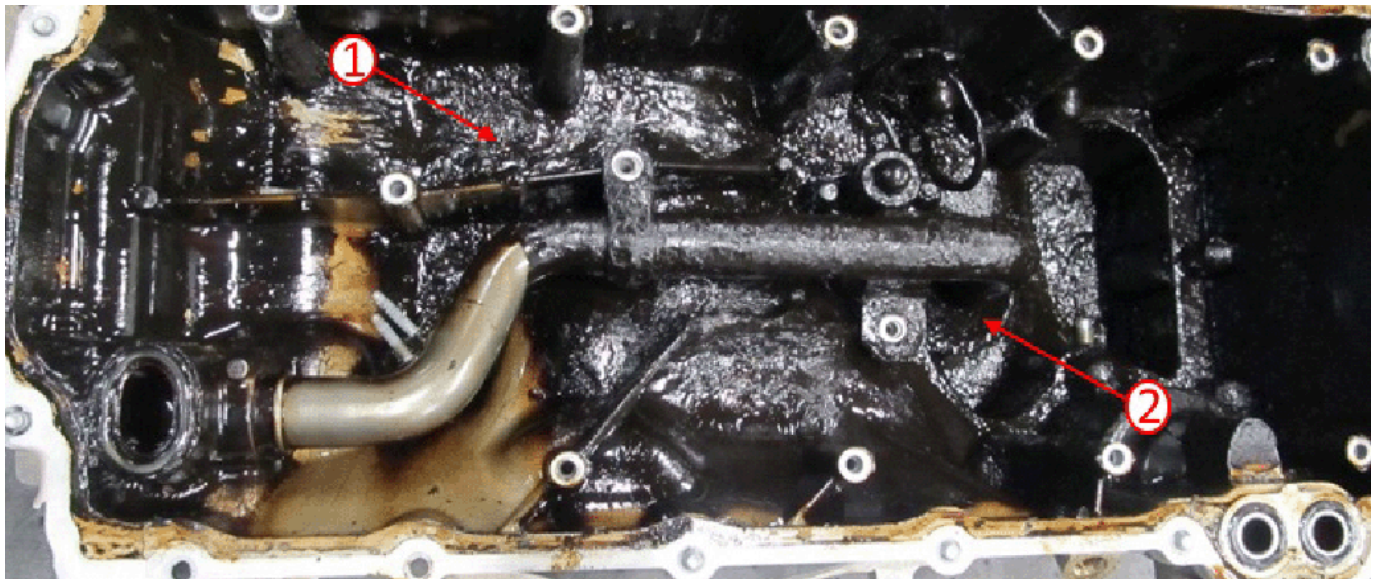
4543483

Sludge build up in the bottom of the oil pan.

- Sludge (1) or debris found in the bottom of the pan blocking the pick up tube (2) screen.
- Light debris in the oil pump pick-up tube screen is normal, from normal engine wear.
- Some determination must be used to validate what is or what is not considered normal wear.

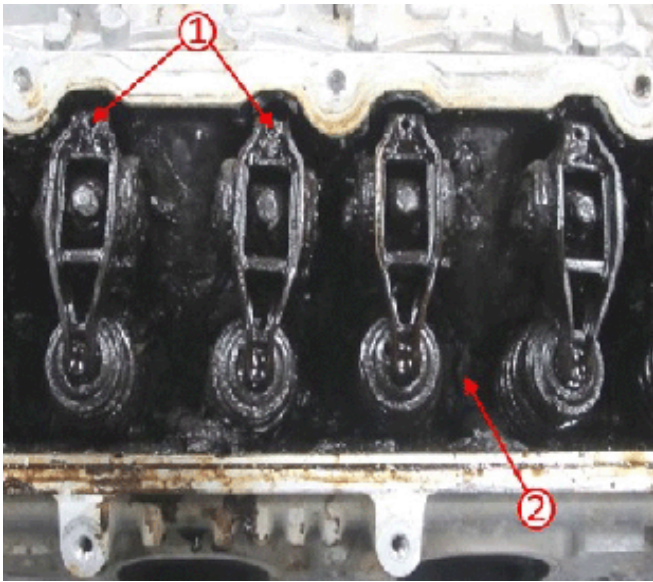
4543670

The valve covers blocked at the engine breather, vacuum or oil return ports.

- The rockers and rocker oil supply ports (1) blocked.
- The return ports blocked by sludge (2).

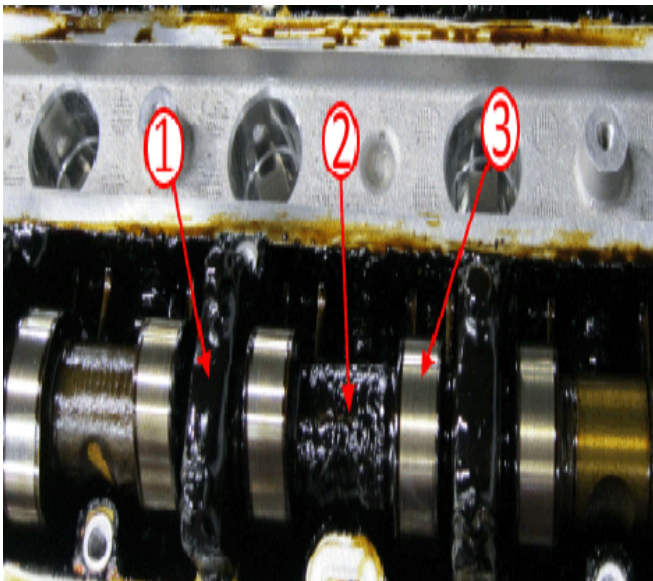
4544568

- Sludge build up on the camshaft (2) and camshaft caps (1).
- Scratches or gouges on the journals or lobes (3) of the camshaft causing a low or loss of oil pressure condition.
- Lack of oil on the lifter tappet creating ticking noise.

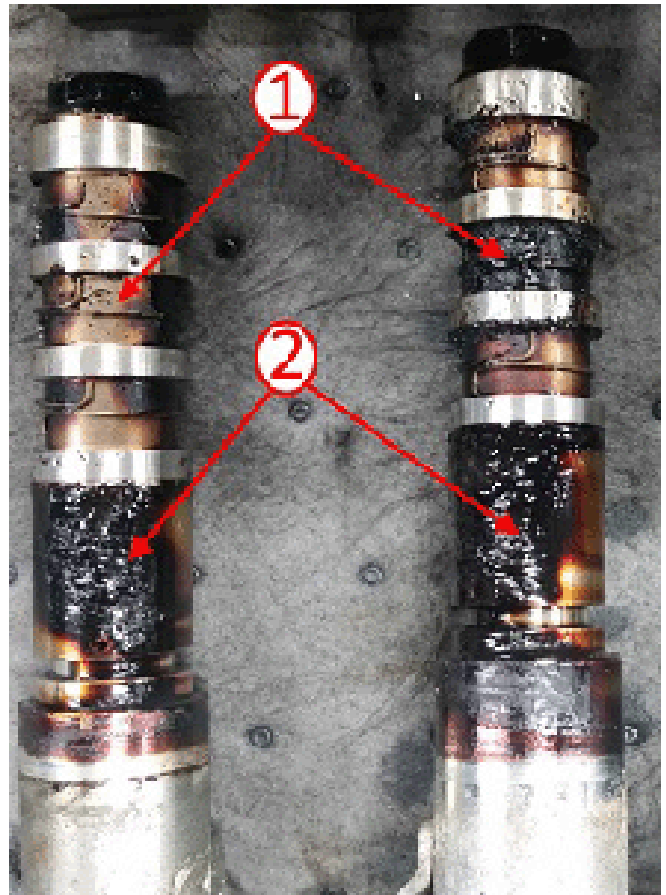
4548494

- Sludge (2) build up on the camshaft position actuator solenoids.
- Debris (1) on solenoid screen may cause engine performance concerns.

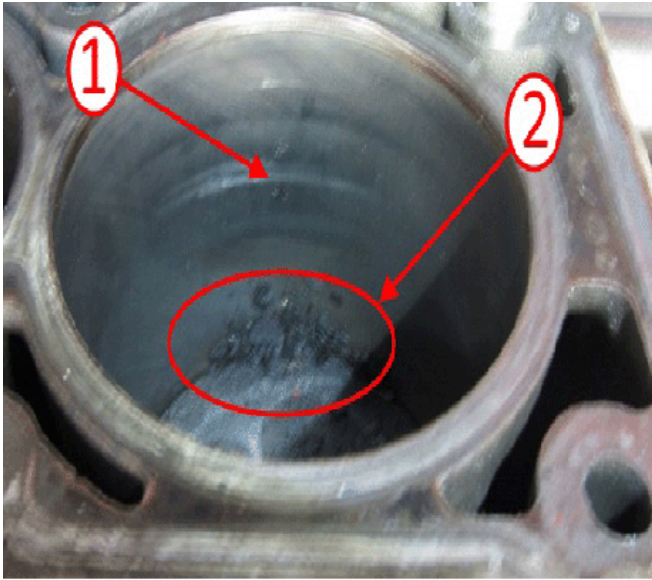
4543465

Improper installation of the air filter into the air filter housing or the use of aftermarket air filter.

- Foreign debris bypassing the air filter and/or the air filter housing outlet ducts.
- Faulty installation of the air filter in the air box housing causing the dirt and debris (2) to enter the combustion chamber.
- Damage to the piston and the piston cylinder wall (1).

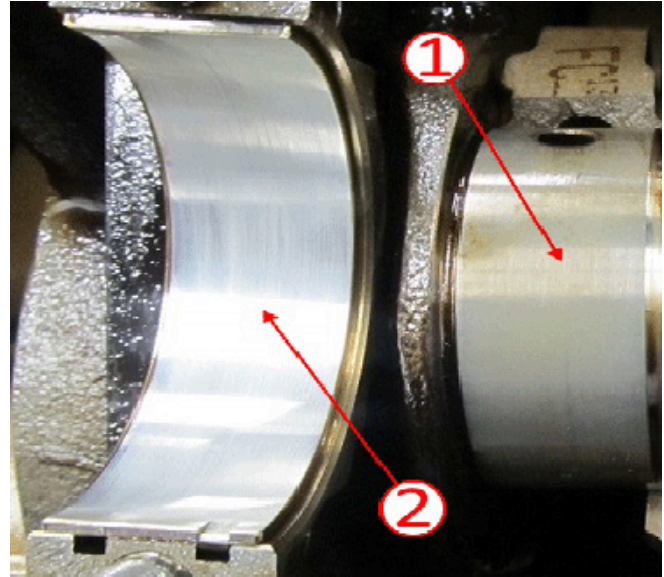
4543396

Main and rod bearing damage caused by foreign debris.

- Dust and debris on the crankshaft, crankshaft bearings, rods (1) or rod bearings (2) caused the chrome finish of the journals to prematurely wear away causing the clearance to increase, possibly causing low oil pressure or a knocking noise.
- Scratches or gouges on the journals result in low or loss of oil pressure condition.
- Possible previous engine repair may result in some debris entering the engine through open ports that are normally sealed or closed off.

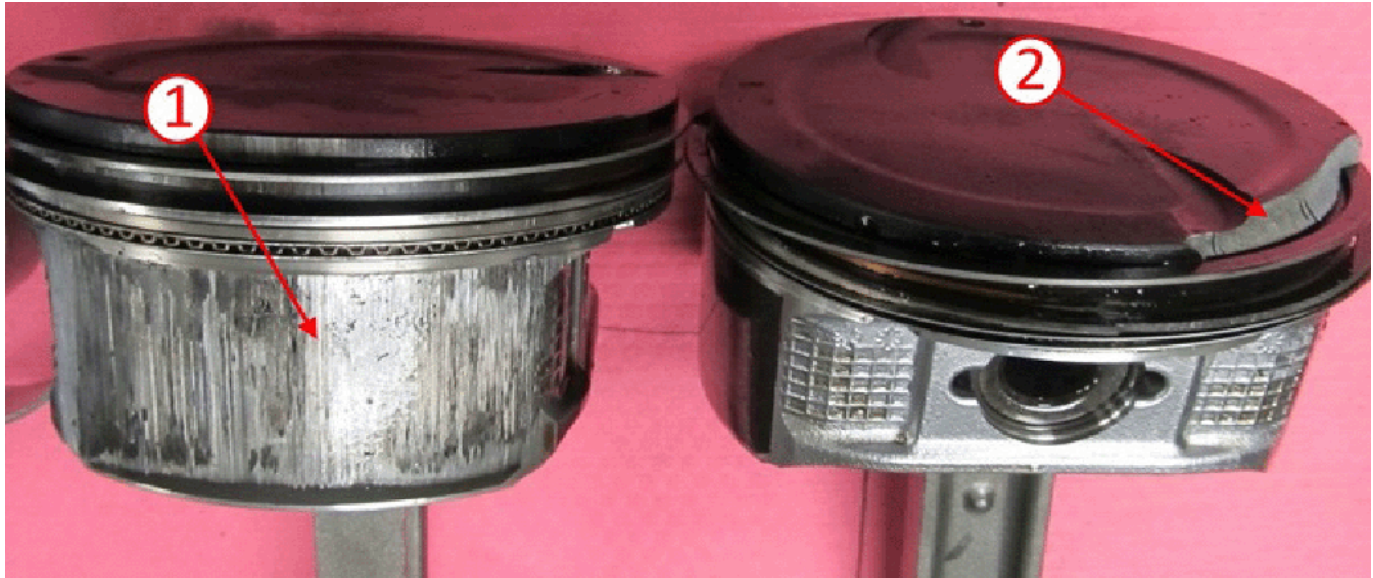
4547308

Incorrect calibrations or modifications that may cause engine damage.

- Piston damage (1) caused by a pre-detonation lean event.
- Improper engine warm up creates excessive heat to the piston causing them to seize to the cold cylinder walls cracking the piston lands (2).
- Aftermarket cold air filter, air filter housing and intake system not allowing proper engine warm up.
