Subject: RATTLE NOISE FROM FRONT DOOR GLASS	Bulletin No: 09-016/15
	Last Issued: 05/18/2015

2013-2016 CX-5

2014-2016 Mazda6

2014-2016 Mazda3

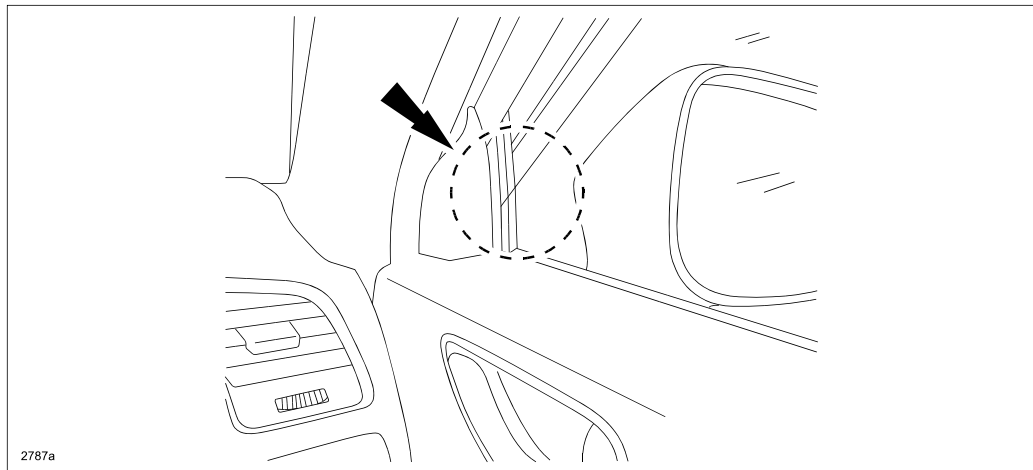
Some vehicles may experience a rattle noise from the front door glass when driving with the window open approx. 1/2 to 4 inches (1 - 10 cm).

The rattle noise may be caused by insufficient holding force of the glass run channel. To increase the holding force, the shape of glass run channel has been changed and non-woven pads have been attached to the glass run channel.

Customers having this concern should have their vehicle repaired using the following repair procedure.
