Subject: CREAKING NOISE FROM FRONT LOWER CONTROL ARM BUSHINGS	Bulletin No: 02-001/15
	Last Issued: 11/20/2015

2014-2016 Mazda3

2014-2016 Mazda6

2013-2016 CX-5

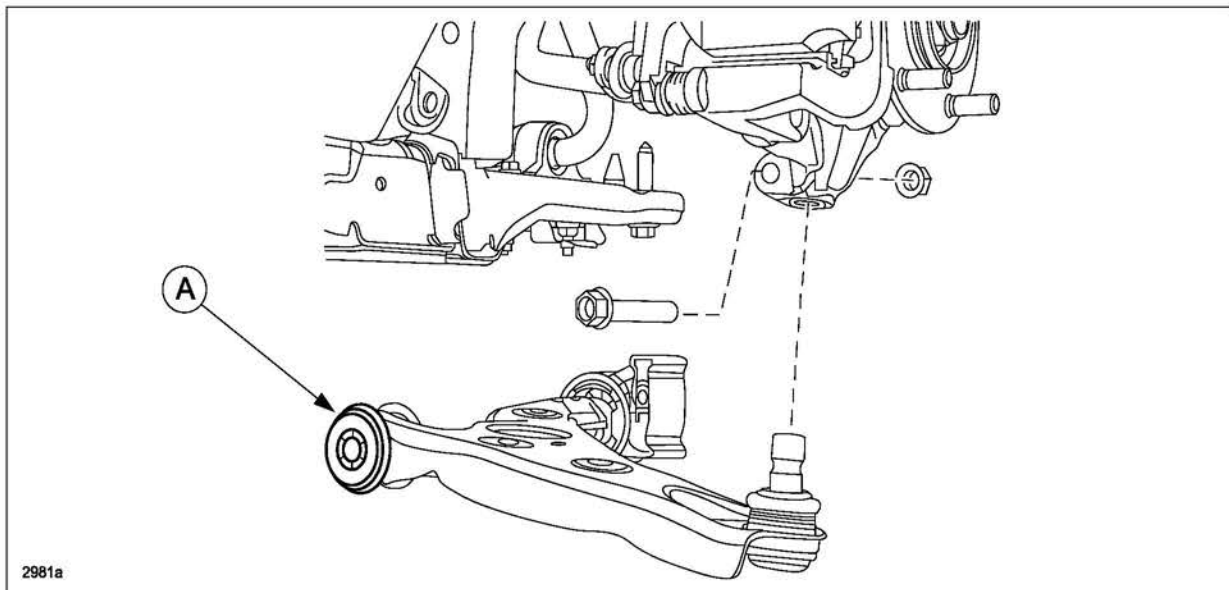
Some vehicles may exhibit a creaking noise from under the front of the vehicle when driving over bumps. The noise occurs at approx. 12 - 25 mph (20 - 40 Km/h) when the road surface is wet or after a car wash. The noise becomes more noticeable when driving over higher bumps.

The creaking noise is caused when the front lower control arm bushing(s) (A) become wet.

Customers having this concern should have their vehicle repaired using the following repair procedure.

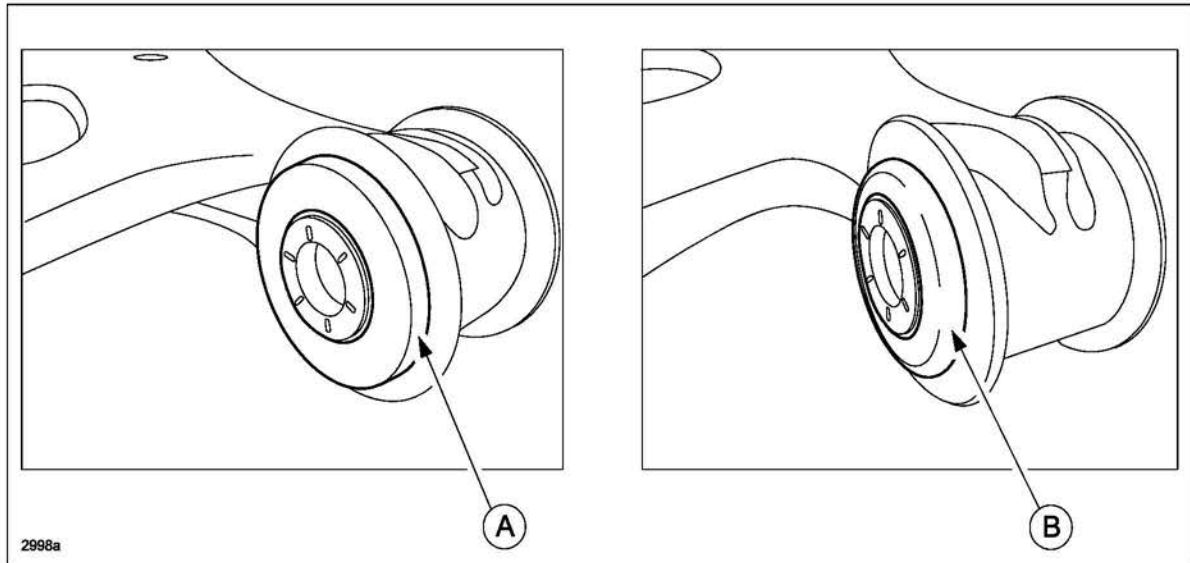
CAUTION: Make sure the bushing has been properly inserted by verifying that the bushing tab **IS FULLY EXPANDED**, as shown in the illustration to the left (A). The illustration to the right (B) shows an example of a bushing tab that **IS NOT FULLY EXPANDED**.
