Subject: AIR BUBBLES TRAPPED INSIDE WINDSHIELD	Bulletin No: 09-042/15
	Last Issued: 11/06/2015

2016 CX-5 vehicles with VINs between JM3KE*****711317 - 723521 (produced from Sept. 1, 2015 to Sept. 28, 2015)

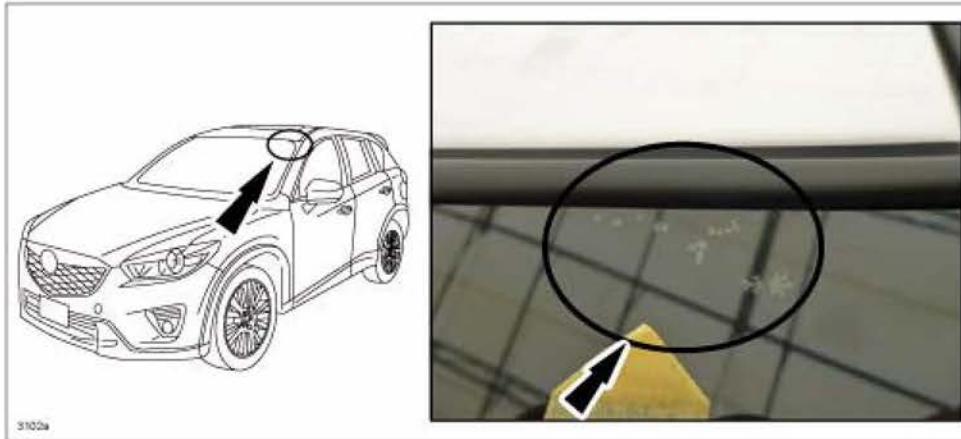
Some vehicles may exhibit small air bubbles around the upper left corner of the windshield. An improper production process caused remaining air to be trapped between the glass and the intermediate film.

1. Verify the customer concern.
2. Replace the windshield glass with a new one according to the instructions on MS3 online or the Workshop Manual (section 09-12 WINDSHIELD REMOVAL/INSTALLATION).
