# Service Bulletin

Bulletin No.: 16-NA-159

**Subject:** Squeak and/or Rubbing Noise from Steering Column Area

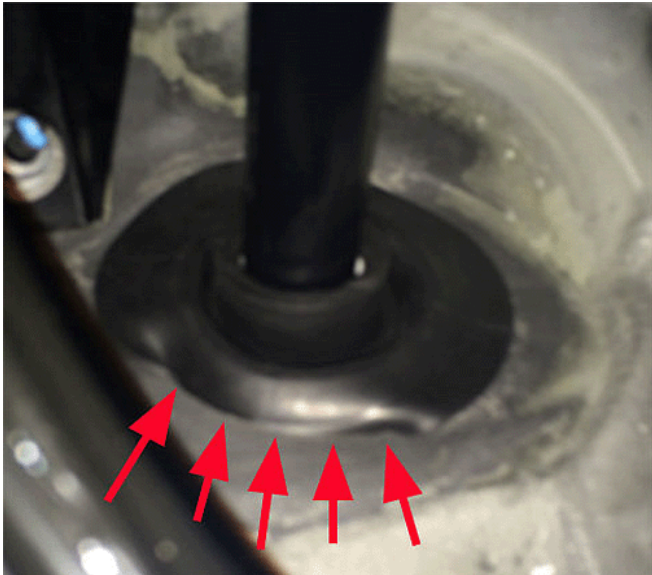
4512167

<b>Involved Region or Country</b>	North America
<b>Condition</b>	Some customers may comment on a squeak and/or rubbing noise coming from the steering column area.
<b>Cause</b>	This condition may be due to the inner and/or outer intermediate steering shaft boots (seals) being out of position.

Inspect the intermediate steering shaft inner and outer boots (seal) for being out of position as shown above. If the boots are out of position, use a flat trim stick to properly seat the boots.
