Service Bulletin

Bulletin No.: 16-NA-145

Subject: Service Airbag Light Illuminated and B0074 (0D or 0E) DTC Set

Brand:	Model:	Model Year:		VIN:		Engine:	Transmission:
		from	to	from	to		
Buick	Verano	2012	2016			All	All

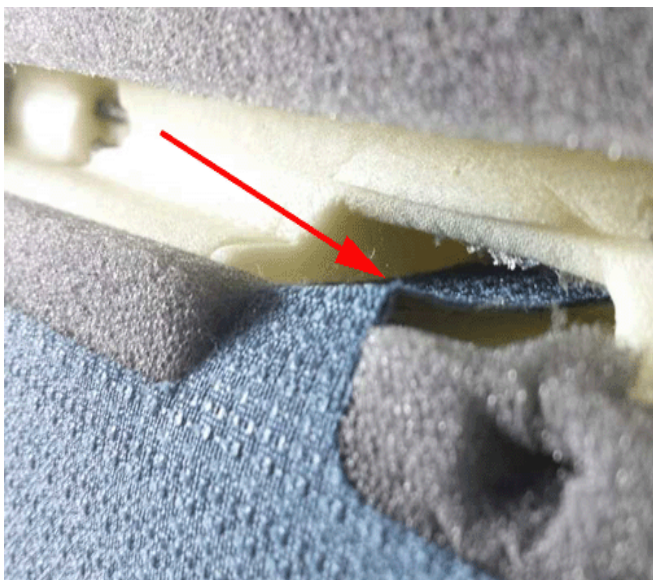
4502711

Note: Crease observed in tail area from top side.

If you encounter a vehicle with the above concern replace the front passenger presence sensor. Refer to *Airbag Front Passenger Presence Sensor Replacement* in SI.

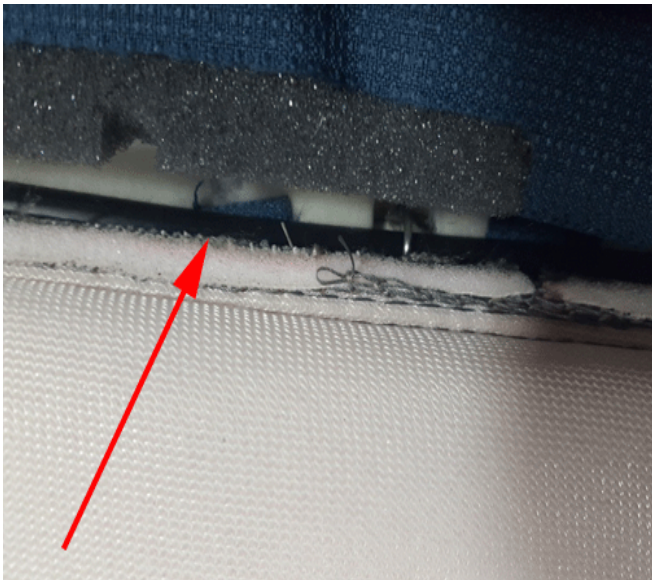
4505465

Note: Crease observed in tail area from bottom side.

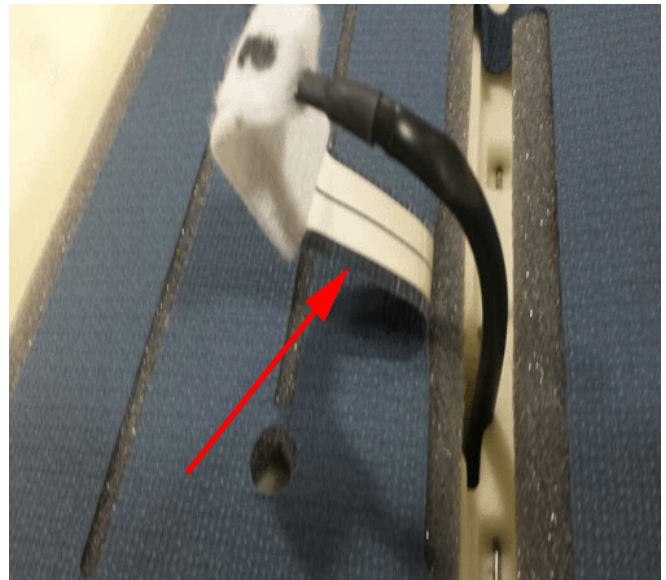
4505466

Note: Sensor tail observed trapped between seat trim tiedown feature and cushion pad.

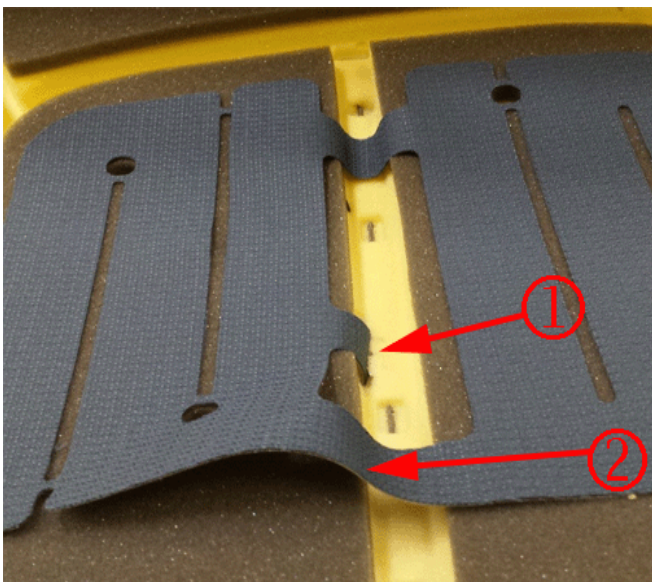
4520474

Important: Be sure to inspect the sensor tail area of the new service part to ensure no creases or other damage exists.

- (1) Sensor Tail
- (2) Loose Sensor Mat

Important: The service kit sensor mat may have come loose from the cushion pad during shipping of the service kit. If this is observed, re-center the mat on the cushion pad and using the palm of the hand, apply light pressure to re-adhere the sensor to the pad assembly taking care to not create any folds or creases in the mat or sensor tail. Once trim is re-installed, the sensor mat will retain it's position.
