TSB SB07-04-S003

Erratic Speedometer Operation Or Speedometer Needle Shakes Above 60 MPH

2003-2008 Isuzu Ascender with 4.2L Engine Only

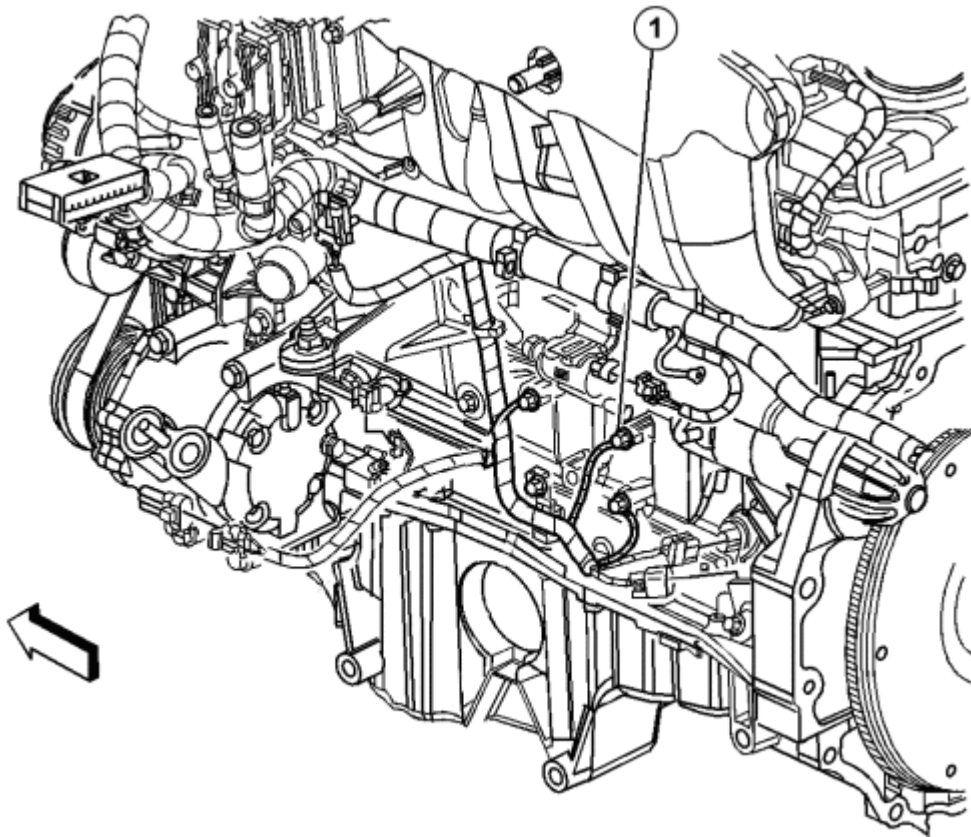
This condition may be caused by a loose or poor connection at Powertrain Control Module/Engine Control Module (PCM/ECM) ground G108.

Technicians are to inspect and repair ground G108 as necessary. Refer to callout 1 in the illustration for the location of G108. Refer to the Testing for Intermittent Conditions and Poor Connections and the Wiring Repair procedures in the Service Manual or ETM for more information.
