TSB SB07-11-S019

Windnoise Or High Pitched Whistle Noise Heard From Front Of Vehicle While Driving At Highway Speeds (This Bulletin Supersedes SB07-11-S018)

2007-2008 Isuzu i-290/i-370 (TI)

2006 Isuzu i-280/i-350 (TI)

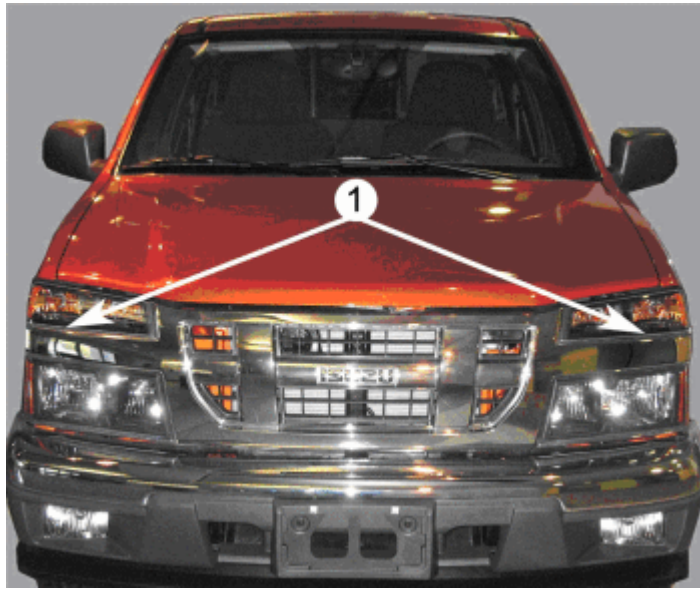
1. Use masking tape to tape off the gap (1) between the grille and the lower left and right park turn signal lens. Road test the vehicle and determine the source of the wind noise.

- If the park turn signal lamp is not the source of the wind noise, continue to diagnose and repair the wind noise. Refer to Interior and Exterior Wind noise in the Service Manual.
- If the wind noise is eliminated, return to the shop and proceed to Step 2.
