# Abnormal Metallic Knock Noise from Front of Vehicle

**Section** Hybrid Transmission/Transaxle

YEAR(S)	MODEL(S)	ADDITIONAL INFORMATION
2004 – 2008	Prius	Plant Code(s): 3, 7 WMI(s): JTD

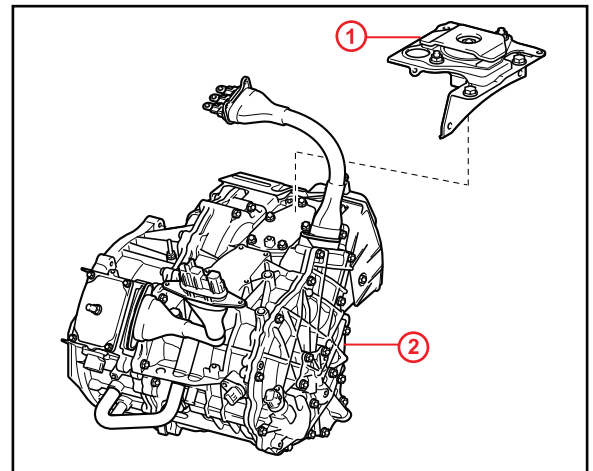
**Figure 1.**

<b>1</b>	<b>No. 3 Engine Mounting Bracket</b>
<b>2</b>	<b>Hybrid Vehicle Transaxle Assembly</b>

2. Support the hybrid transaxle assembly by using a transmission jack.
3. Remove and replace the engine mounting insulator LH.
  - A. Remove the engine mounting insulator sub-assembly LH from the vehicle.
