# Technical Bulletin

Section Title: Engine  
TSB No. TS 21 03259

**SUBJECT:** RUBBING NOISE COMING FROM FRONT (TIMING BELT COVER) AREA OF ENGINE  
**MODEL(S):** FORENZA, FORENZA WAGON, RENO (RQ420)  
**YEAR:** 2004~2008

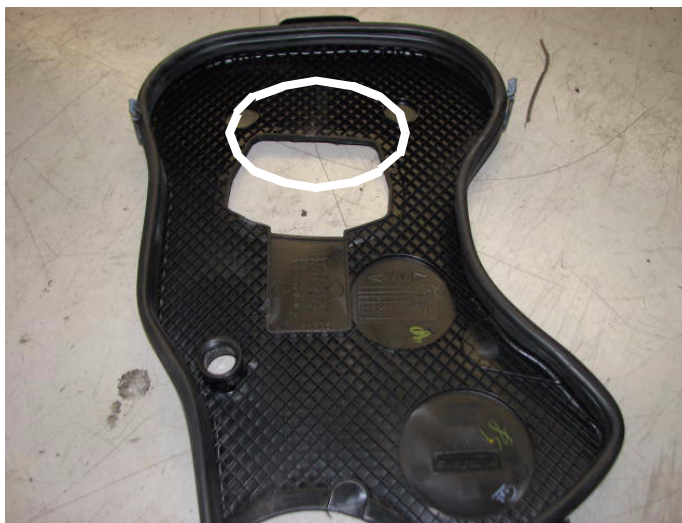
10. Looking closely at the area indicated in the illustration, inspect the timing cover for contact marks from the timing belt or cam sprockets. If evidence is found confirming the source of the noise, continue to the next page.
