MEDIC UPDATE

TECHNICAL SERVICE BULLETIN

SUBJECT : A/C CONDENSER DAMAGE		No: TSB-00-55-001REV	
		DATE: May, 2000	
		MODEL See below	
CIRCULATE TO:	<input type="checkbox"/> GENERAL MANAGER	<input checked="" type="checkbox"/> PARTS MANAGER	<input checked="" type="checkbox"/> TECHNICIAN
<input checked="" type="checkbox"/> SERVICE ADVISOR	<input checked="" type="checkbox"/> SERVICE MANAGER	<input checked="" type="checkbox"/> WARRANTY PROCESSOR	<input type="checkbox"/> SALES MANAGER

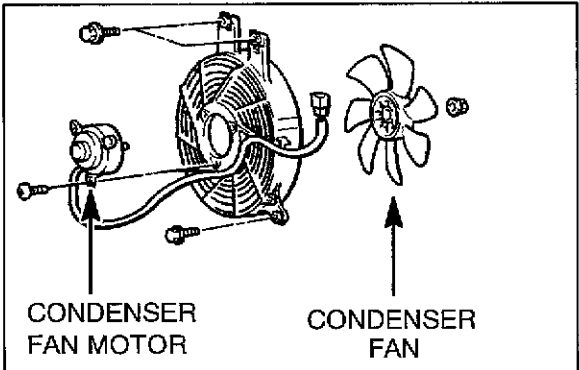
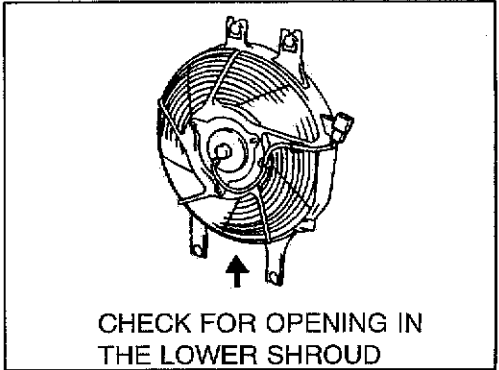
059341

During A/C condenser fan operation, road debris (such as asphalt or small rocks) could be pushed into the condenser fan. Damage can result due to insufficient opening in the fan shroud for the debris to escape. As a result, the condenser and/or the condenser fan may become damaged.

Inspect the replacement parts. If the replacement parts do not have an opening in the lower shroud for debris to escape, go to Step 3 for fan shroud modification instructions.

If the condenser fan is not damaged, do not replace it. Go to Step 3 for shroud modification instructions.
