TECHNICAL SERVICE BULLETIN

SUBJECT: AIR CONDITIONER PULSATING OR RATTLE NOISE			No: TSB-01-55-006
			DATE: June, 2001
			MODEL: See below
CIRCULATE TO:	<input type="checkbox"/> GENERAL MANAGER	<input checked="" type="checkbox"/> PARTS MANAGER	<input checked="" type="checkbox"/> TECHNICIAN
<input checked="" type="checkbox"/> SERVICE ADVISOR	<input checked="" type="checkbox"/> SERVICE MANAGER	<input checked="" type="checkbox"/> WARRANTY PROCESSOR	<input type="checkbox"/> SALES MANAGER

1997-2001 Montero Sport

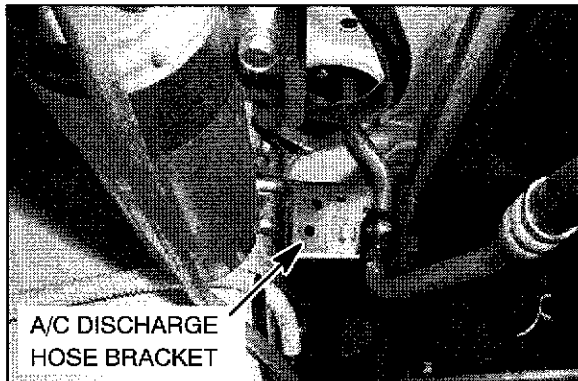
On vehicles built before 6/00, a **rattle** noise may be heard when the A/C is on, due to the A/C discharge hose bracket vibrating at the engine block. To eliminate this noise, remove the A/C discharge hose bracket as described in this bulletin.

1. Vehicles Built Before 6/00:

To eliminate a **rattle** noise when the A/C is on, remove the A/C discharge hose bracket.

- a. After removing the bracket, be sure that the A/C discharge hose does not contact any surrounding parts.

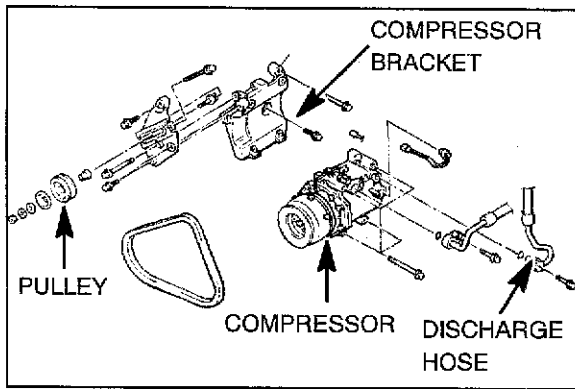
On vehicles built after 12/97, a **pulsating** noise may be heard when the A/C is on, due to A/C compressor bracket vibration. To eliminate this noise, install the cast-iron A/C compressor bracket listed in this bulletin. This bracket has an extra mounting location to help reduce vibration.

2. **Vehicles Built After 12/97:**

To eliminate a **pulsating** noise when the A/C is on, inspect the A/C bracket. If the bracket is aluminum, replace it with a cast iron bracket and bolt listed in the PARTS INFORMATION section of this bulletin. Refer to Group 55 of the appropriate service manual.

All 2000 and 2001 models produced before 4/12/01 (VIN 1P061090) have the aluminum A/C bracket. Install the cast iron bracket on these vehicles.
