SUBJECT: EXHAUST NOISE			No: TSB-03-15-002
			DATE: December, 2003
			MODEL: See below
CIRCULATE TO:	<input type="checkbox"/> GENERAL MANAGER	<input checked="" type="checkbox"/> PARTS MANAGER	<input checked="" type="checkbox"/> TECHNICIAN
<input checked="" type="checkbox"/> SERVICE ADVISOR	<input checked="" type="checkbox"/> SERVICE MANAGER	<input type="checkbox"/> WARRANTY PROCESSOR	<input type="checkbox"/> SALES MANAGER

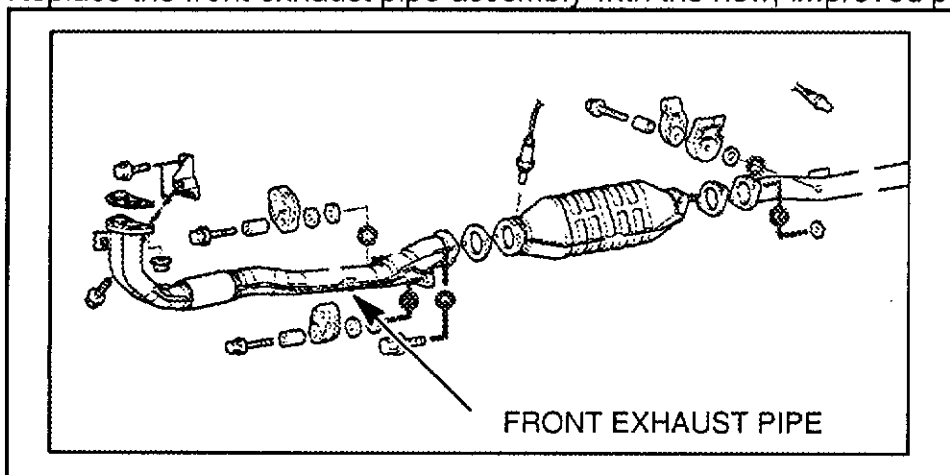
066081

Some affected vehicles may experience abnormal exhaust noise during acceleration. Customers may describe the noise as "like marbles in the exhaust" or "a pinging noise." This noise may be due to the mix of exhaust gases resulting from the internal construction of the front exhaust pipe. Installing a new front exhaust pipe assembly with modified internal construction will prevent the noise. The internal design of the new front exhaust pipe corrects the exhaust gas flow for optimum noise reduction.

Replace the front exhaust pipe assembly with the new, improved parts listed below.
