SUBJECT : NO ENGINE CRANK - LOSS			No: TSB-05-16-001
OF COMMUNI	D	DATE: December, 2005	
FRONT CONTR		M	ODEL: 2006 Raider
CIRCULATE TO:	[] GENERAL MANAGER	[X] PARTS MANAGER	[X] TECHNICIAN
[X] SERVICE ADVISOR	[X] SERVICE MANAGER	[X] WARRANTY PROCESSOR	[] SALES MANAGER

TECHNICAL SERVICE BULLETIN

2006 Raider

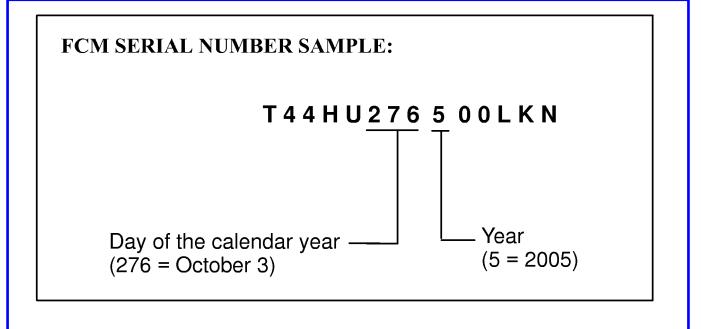
1.Locate the FCM serial number on the FCM part number label (on outside of the FCM module).

The 6th, 7th, and 8th digits in the serial number identify the day of the calendar year (Julian date) that the FCM was manufactured.

The 9th digit identifies the year that the FCM was manufactured.

Determine the date that the FCM was manufactured, based on the FCM serial number.

a.If the FCM was manufactured **<u>before</u>** October 3, 2005, continue with Step 2.

b.If the FCM was manufactured <u>on or after</u> October 3, 2005, **STOP**. Do not continue with this bulletin procedure. Refer to Group 13C in the Raider service manual for FCM diagnosis.
