SUBJECT:
DTC P0171 SYSTEM TOO LEAN

No: **TSB-06-13-009**

MODEL: **2004-06 Lancer 2.0L**

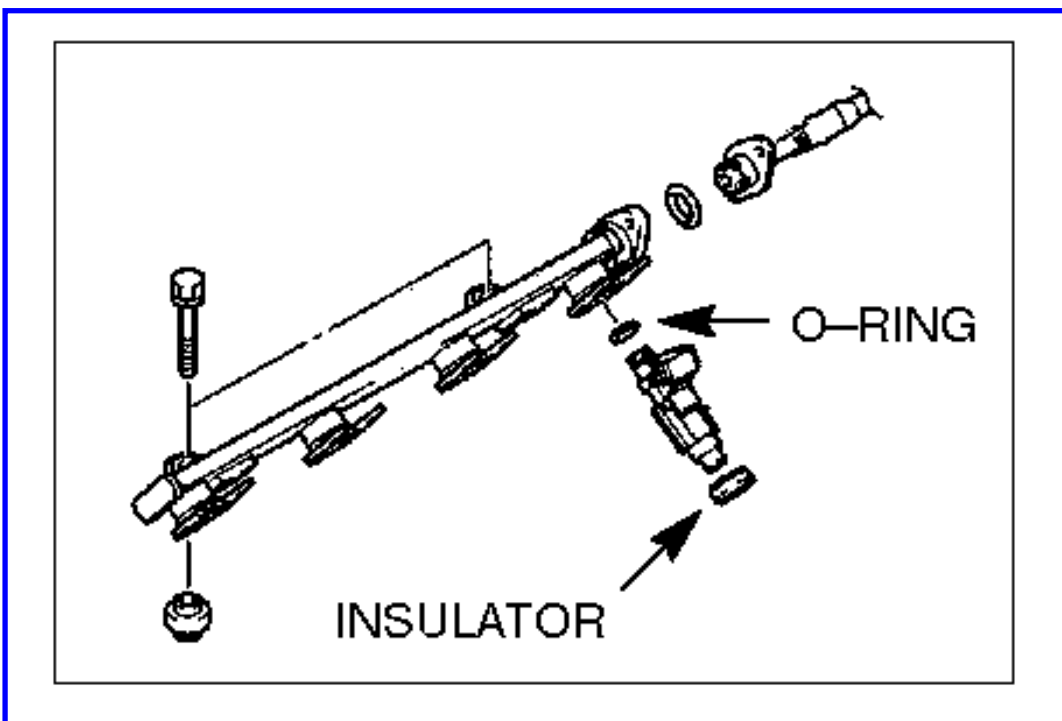
The MIL may come on and DTC P0171 "System Too Lean" may set in the PCM. This condition may be due to vacuum leakage around a fuel injector insulator. To eliminate this condition, install a new, improved O-ring (listed in the PARTS INFORMATION section of this bulletin) on all fuel injectors. When installing the injectors, it is critical that there is no air leakage between the fuel injector and the insulator.

Replace the O-ring and insulator on all fuel injectors, using the parts listed below.
