MEDIC UPDATE
TECHNICAL SERVICE BULLETIN

SUBJECT:			No: TSB-07-11-001
HARD TO START ENGINE DTC P0340 (and P0335)			DATE: January, 2007
			MODEL: 2002-07 Lancer 2.0L
CIRCULATE TO:	<input type="checkbox"/> GENERAL MANAGER	<input checked="" type="checkbox"/> PARTS MANAGER	<input checked="" type="checkbox"/> TECHNICIAN
<input checked="" type="checkbox"/> SERVICE ADVISOR	<input checked="" type="checkbox"/> SERVICE MANAGER	<input checked="" type="checkbox"/> WARRANTY PROCESSOR	<input type="checkbox"/> SALES MANAGER

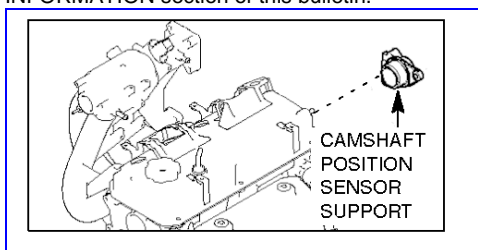
The engine may be hard or impossible to start and MFI DTC P0335 and possibly P0340 may be stored due to abnormal wear to the camshaft position sensor support. Oil grooves have been added to the camshaft position sensor support to improve lubrication.

If a customer has a vehicle with the above condition, replace the camshaft position sensor support with the new part listed in the PARTS INFORMATION section of this bulletin.
