### TECHNICAL SERVICE BULLETIN

SUBJECT:			No: <b>TSB-07-13-003REV</b>
<b>WHISTLE NOISE FROM ENGINE COMPARTMENT</b>			DATE: <b>April, 2007</b>
			MODEL: <b>2007 Raider 3.7L</b>
CIRCULATE TO:	<input type="checkbox"/> GENERAL MANAGER	<input checked="" type="checkbox"/> PARTS MANAGER	<input checked="" type="checkbox"/> TECHNICIAN
<input checked="" type="checkbox"/> SERVICE ADVISOR	<input checked="" type="checkbox"/> SERVICE MANAGER	<input checked="" type="checkbox"/> WARRANTY PROCESSOR	<input type="checkbox"/> SALES MANAGER

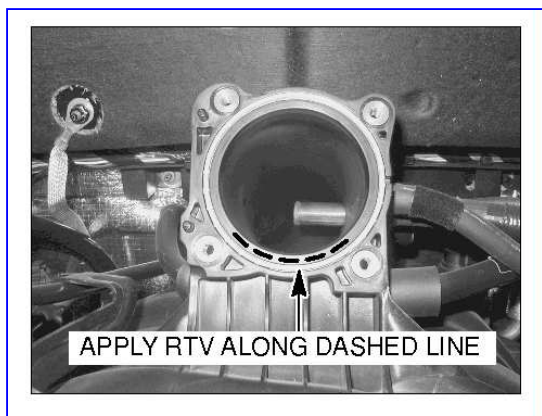
► A slight **high frequency (pitch)** whistle-like sound may be heard while driving at any ambient temperature or engine temperature. The noise is most noticeable under load, with light throttle between 1,200 to 2,000 RPM.

7. Apply a **small diameter bead (about 1 mm)** of RTV to the intake manifold-to-throttle body joint, **inboard of the o-ring**. The RTV is to be applied to the lower section of the joint between the lower two throttle body bolt attachment holes as shown.

8. Reinstall the throttle body. Tighten the four attachment bolts to 60 in lbs (7 Nm).
9. Wipe off all excessive RTV from the inside of the joint.
10. Reinstall the air intake tube at the throttle body.
