# MEDIC UPDATE

## TECHNICAL SERVICE BULLETIN

SUBJECT:		No: <b>TSB-07-13-010</b>	
<b>DTCs P0657, P1590, U0101, P0201 - P0206 &amp; POSSIBLE NO START</b>		DATE: <b>December, 2007</b>	
		MODEL: <b>See Below</b>	
CIRCULATE TO:	<input type="checkbox"/> GENERAL MANAGER	<input checked="" type="checkbox"/> PARTS MANAGER	<input checked="" type="checkbox"/> TECHNICIAN
<input checked="" type="checkbox"/> SERVICE ADVISOR	<input checked="" type="checkbox"/> SERVICE MANAGER	<input checked="" type="checkbox"/> WARRANTY PROCESSOR	<input type="checkbox"/> SALES MANAGER

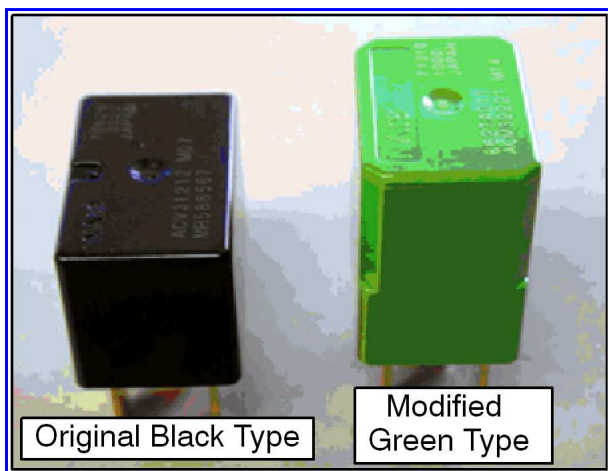
1. Identify which type of relay is fitted in the relay box. If the vehicle is fitted with the "Original Black Type," continue with the following steps. If it is fitted with the "Modified Green Type," diagnose the condition as per the service manual.
2. Using the MUT[III], read DTCs and record Freeze Frame Data. Note if the data shows the intake air temperature at approximately -5°F (-20°C) or colder.
3. Erase any DTCs and start the vehicle.
4. Check for provisional DTCs.

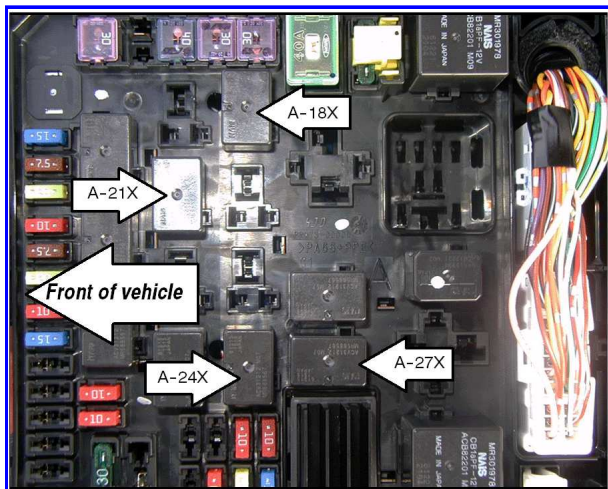
**NOTE: ONLY INSTALL A NEW RELAY IN LOCATIONS INDICATED IN THE PHOTO.**

6. Replace the following relays with the updated type from the Parts Information section of this bulletin.

- A-18X A/T Control Relay
- A-21X Throttle Valve Control Servo Relay
- A-24X Injector Relay
- A-27X Starter Relay
