## SB-10056718-4325

TSB140117

Fault Codes 555 and 556 Caused by Dust and Debris Ingestion on Ford® F-650 and F-750 Chassis

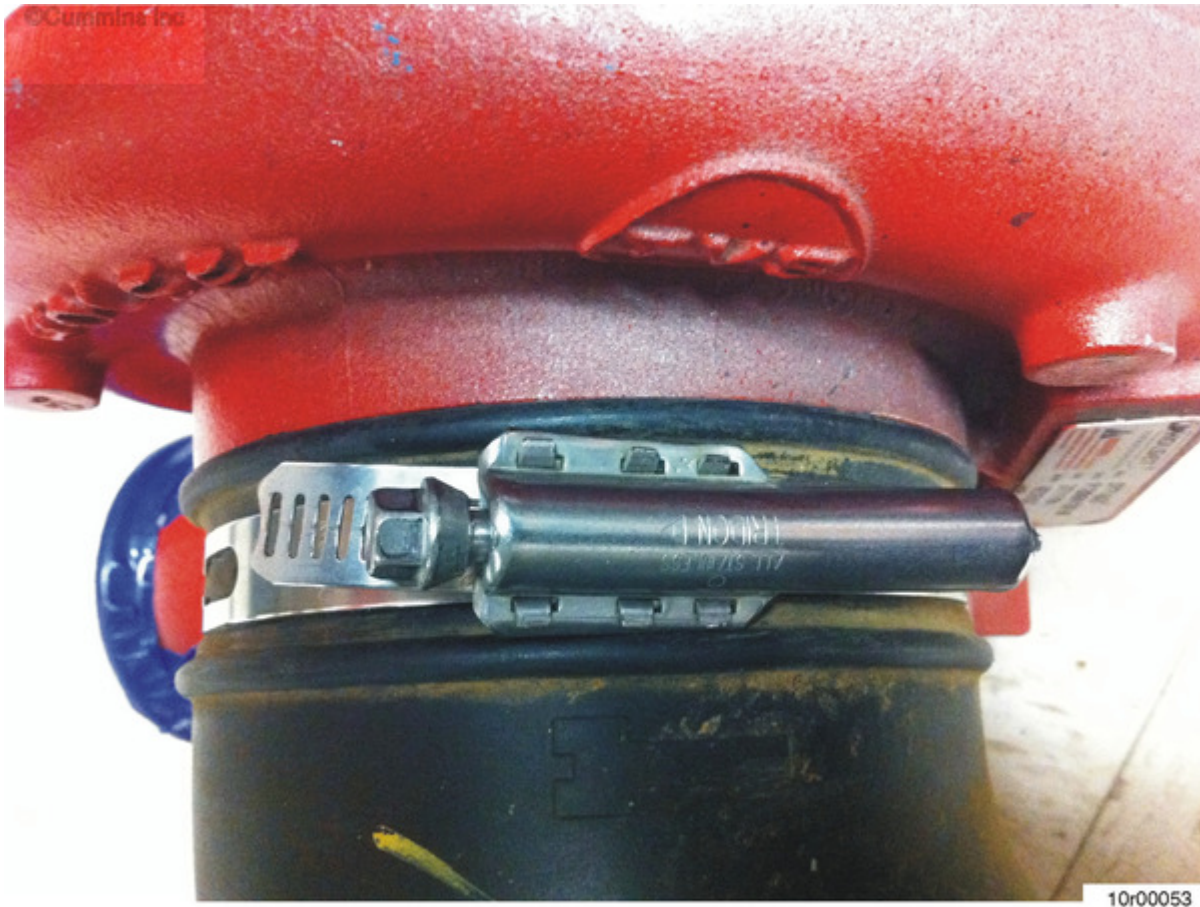
If the clamp is **not** at proper torque, there will be a visible gap between the clamp tightening bolt and the spring case of the clamp.

See Figure 1 for clamp **not** at proper torque.

Figure 1: Gap indicating a clamp not at proper torque.

When installing air intake tube between air filter housing and turbocharger compressor inlet, tighten both clamps to specified torque value.

9 N·m [ 80 in-lb ]

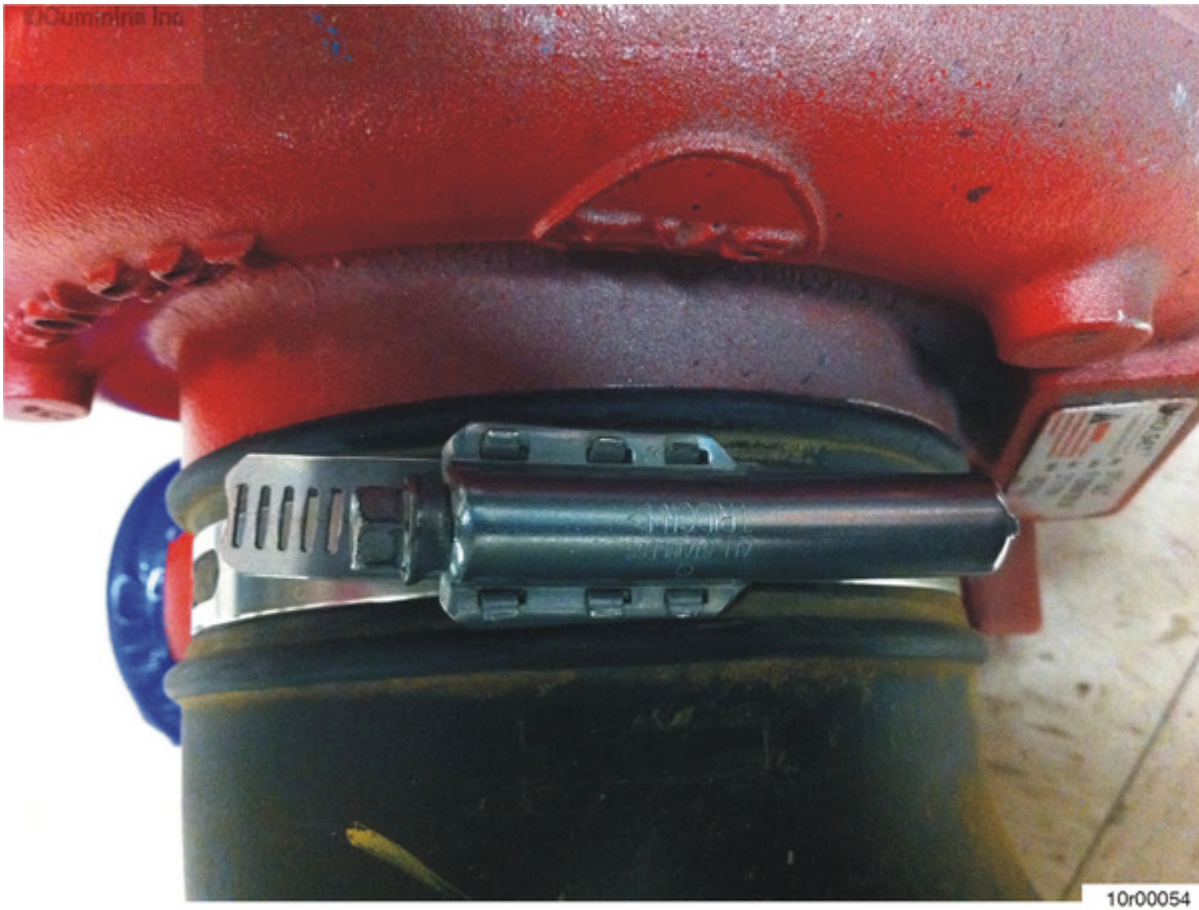
See Figure 2 for clamp at proper torque.

Figure 2: No gap present when clamp is at proper torque.

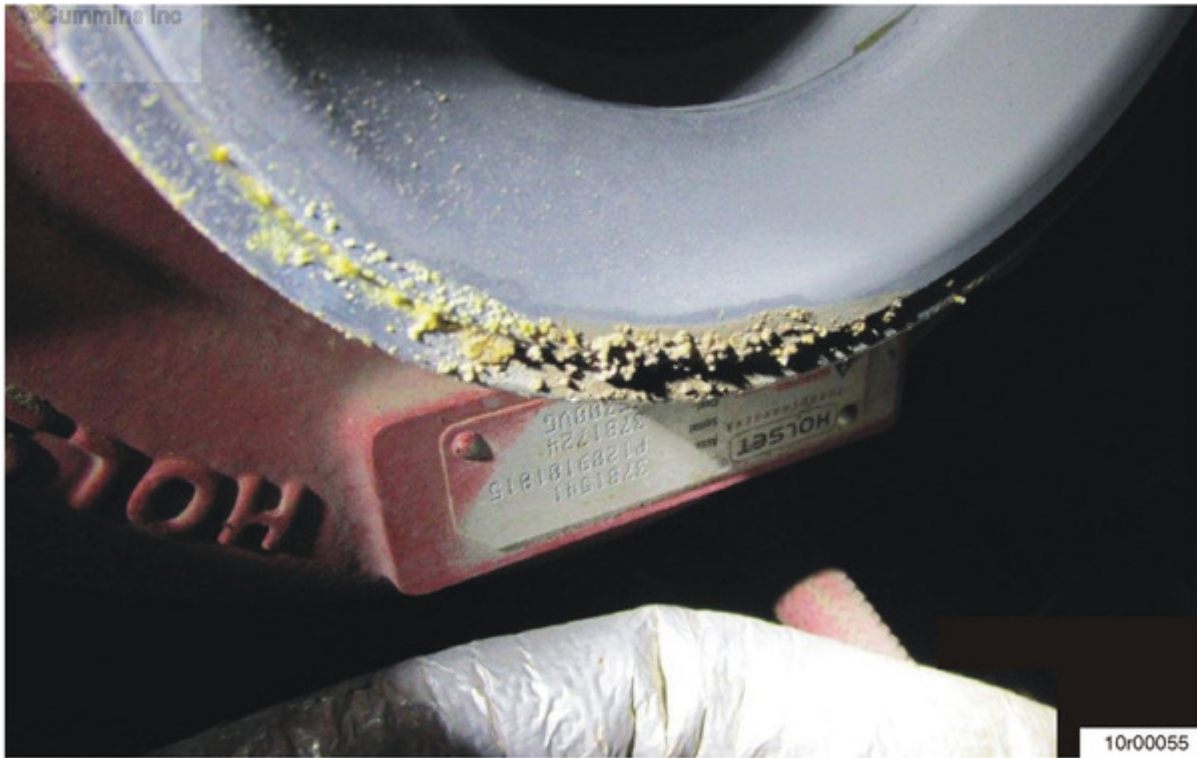
The piston rings have worn or broken due to dust and debris entering at the connection point between the turbocharger compressor inlet and the clean air intake hose; the result of the clamp at this connection point **not** being properly tightened

If clamp has already been removed, see Figures 3 and 4 that show dust and debris buildup where clamp seals at turbocharger compressor inlet.

Figure 3: Buildup of dirt and debris on turbocharger compressor inlet.

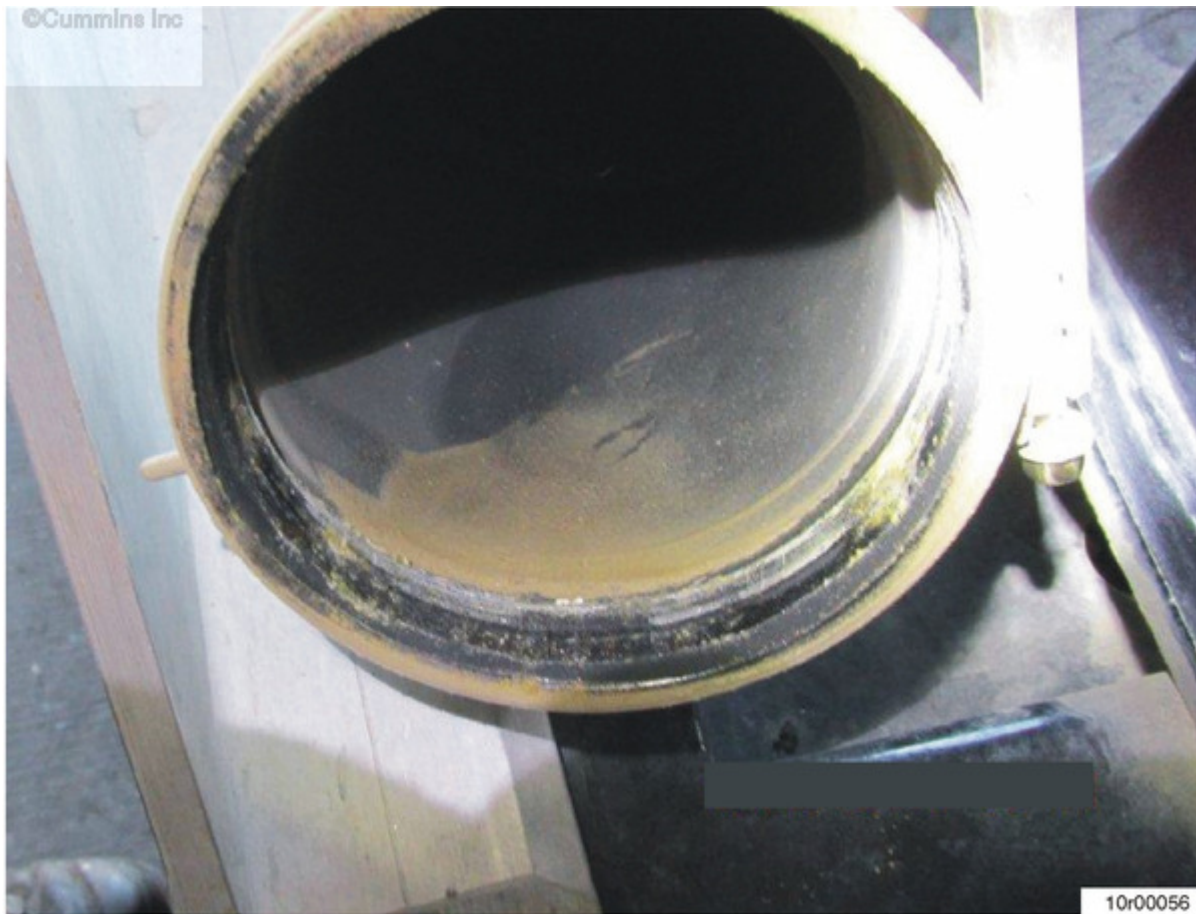
Figure 4: Dust and debris entering connection point at turbocharger compressor inlet.
