Subject: Upfitter Auxiliary

Switches (RPO 9L7)

Models Chevrolet Silverado

Bulletin #110L Page 1 February 10, 2017

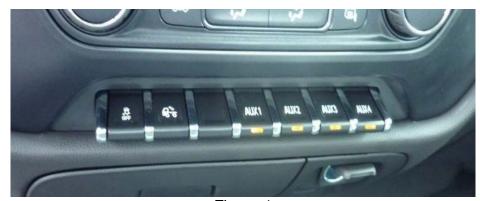
Figure 1 (4 switch configuration shown)

For the 2014/15 Full-size trucks (1500 fleet/work 2500/3500HD), built with the regular production option (RPO) 9L7 (auxiliary switch bank), this switch bank replaces the standard switch bank located just below the Climate Controls (refer to figure 1) and is intended specifically for adding controlled features/functions from inside the cab.

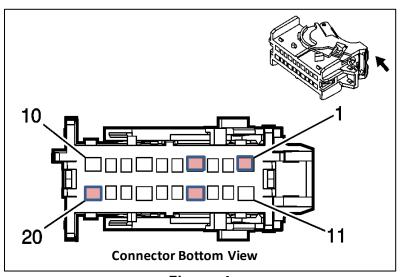
Figure 4

Pin #1, 4, 14 and 20 are used for Upfitter added/configured circuits

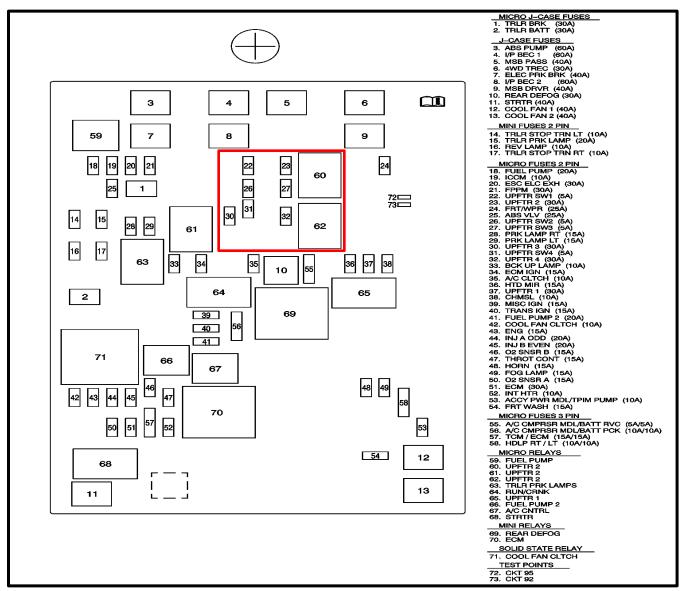
NOTE: The red squared area in Figure 5 reflects the fuses involved in the possible fuse reconfiguration used for the powering of the AUX switches.

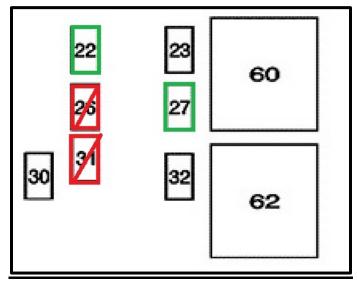
Figure 6 shows the fuses configured for all switches (1, 2, 3 & 4) for battery powered. This is the default fuse location from vehicle manufacturing (note fuse locations 26 & 31 are unpopulated).

Never populate both fuse locations for either pairing of AUX switches. This is to mean do NOT install fuses in both locations of 22 and 26 or in both locations of 27 and 31.

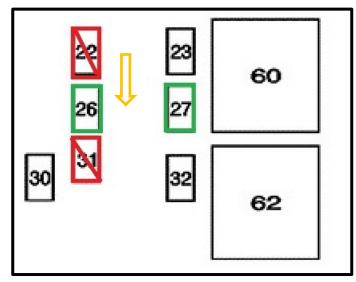
Figure 7 shows the fuses configured for switches 1 & 2 to be Ignition powered and switches 3 & 4 being battery powered. This configuration is accomplished by **MOVING** the fuse from location 22 **TO** location 26 (leaving locations 22 & 31 unpopulated)

Never populate both fuse locations for either pairing of AUX switches. This is to mean do NOT install fuses in both locations of 22 and 26 or in both locations of 27 and 31.

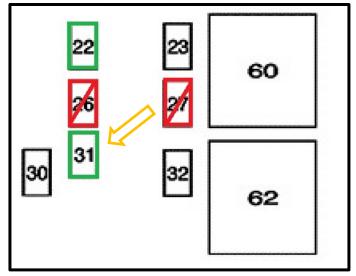
Figure 8 shows the fuses configured for switches 1 & 2 to be Battery powered and switches 3 & 4 being Ignition powered. This configuration is accomplished by **MOVING** the fuse from location 27 **TO** location 31 (leaving locations 26 & 27 unpopulated)

Never populate both fuse locations for either pairing of AUX switches. This is to mean do NOT install fuses in both locations of 22 and 26 or in both locations of 27 and 31.

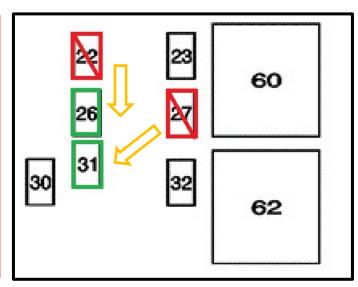
Figure 9 shows the fuses configured for all switches (1, 2, 3 & 4) to be Ignition powered. This configuration is accomplished by **MOVING** the fuse from location 22 **TO** location 26 and **MOVING** 27 **TO** 31 (leaving fuse locations 22 and 27 unpopulated)

Never populate both fuse locations for either pairing of AUX switches. This is to mean do NOT install fuses in both locations of 22 and 26 or in both locations of 27 and 31.

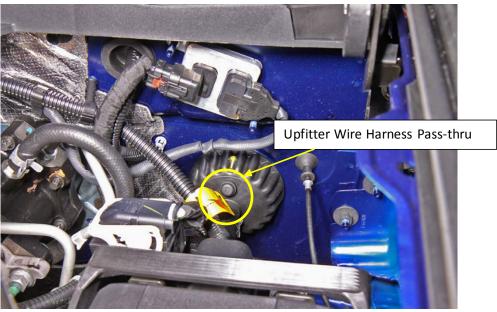
Figure 10 shows the location of the upfitter wire harness pass through
