UI Bulletin #110M

Subject: **Upfitter Auxiliary Switches (RPO 9L7)**

Models Affected: Chevrolet Silverado
GMC Sierra Light Duty Models (1500-3500) *
(does not include the new 1500 series body styles)

Model Years: 2014 – 2019

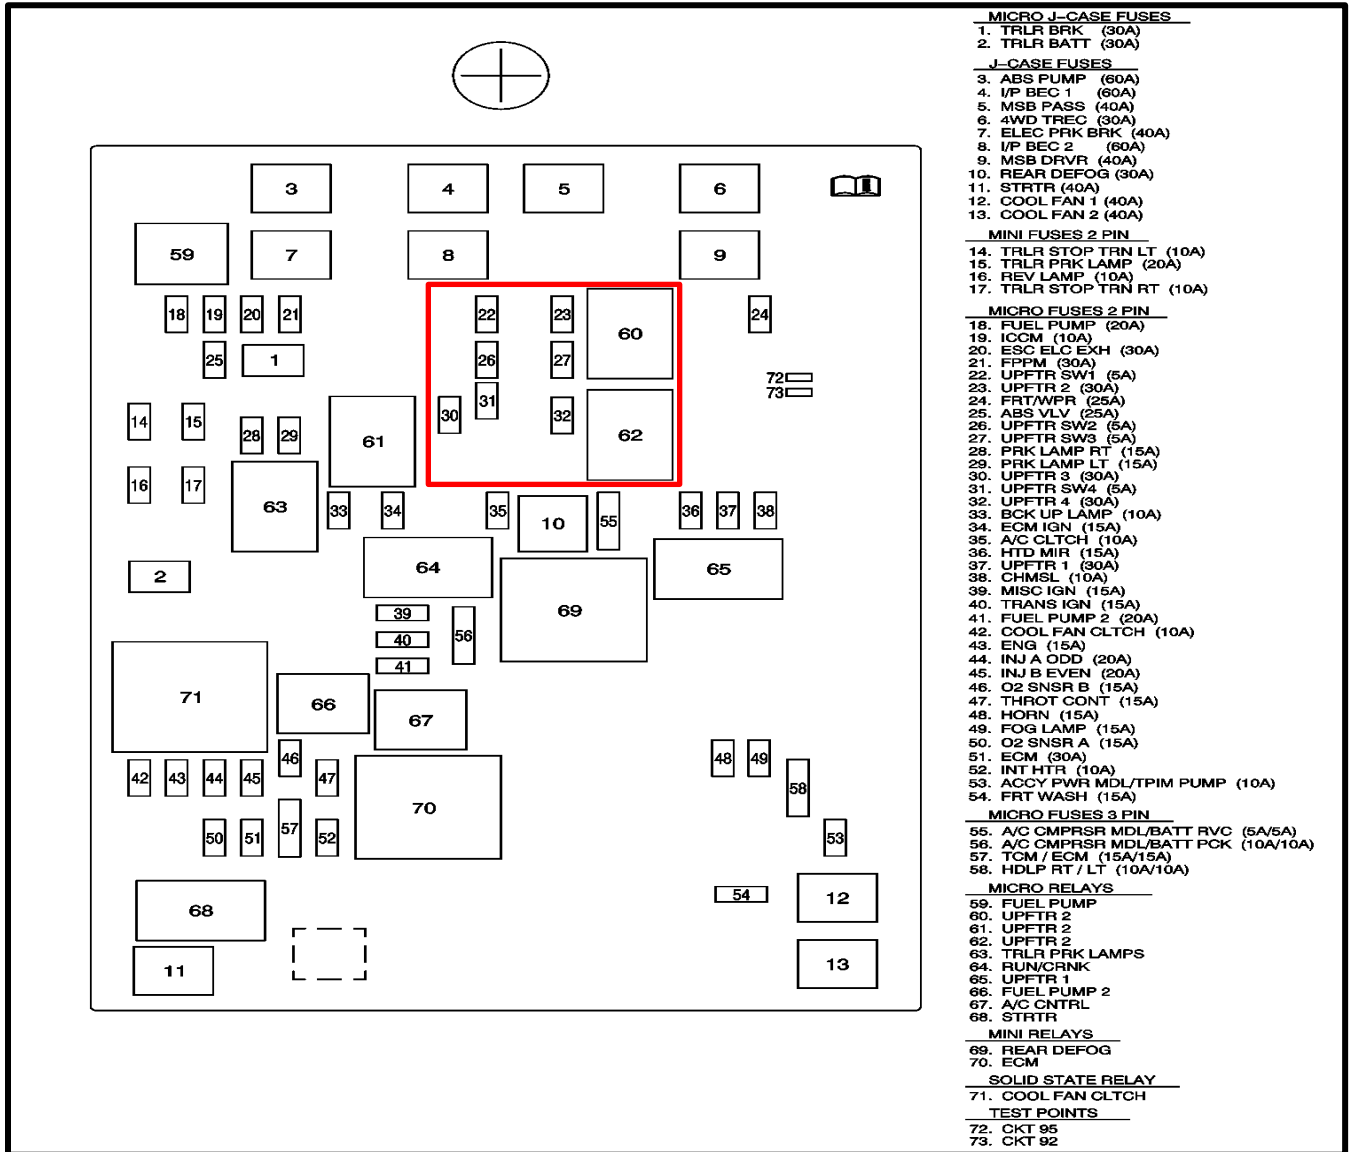
NOTE: The red squared area in Figure 5 reflects the fuses involved in the possible fuse reconfiguration used for the powering of the AUX switches.

Never populate both fuse locations for either pairing of AUX switches. This is to mean do NOT install fuses in both locations of 22 and 26 or in both locations of 27 and 31.

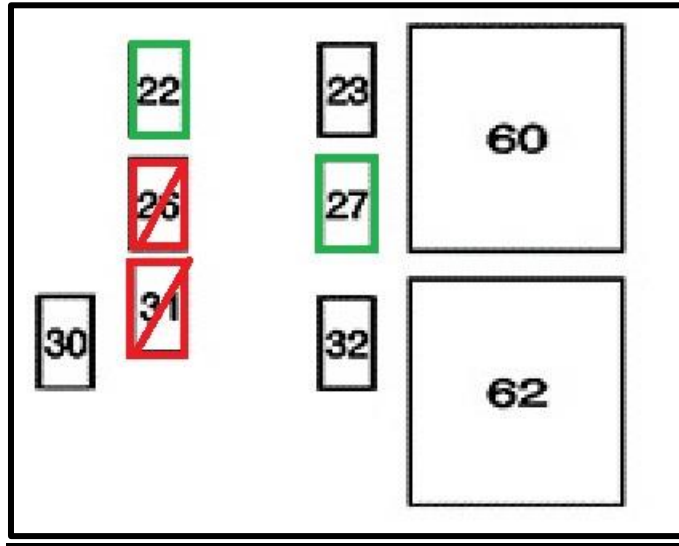
Figure 6 shows the fuses configured for all switches (1, 2, 3 & 4) for battery powered. This is the default fuse location from vehicle manufacturing (note fuse locations 26 & 31 are unpopulated).

Never populate both fuse locations for either pairing of AUX switches. This is to mean do NOT install fuses in both locations of 22 and 26 or in both locations of 27 and 31.

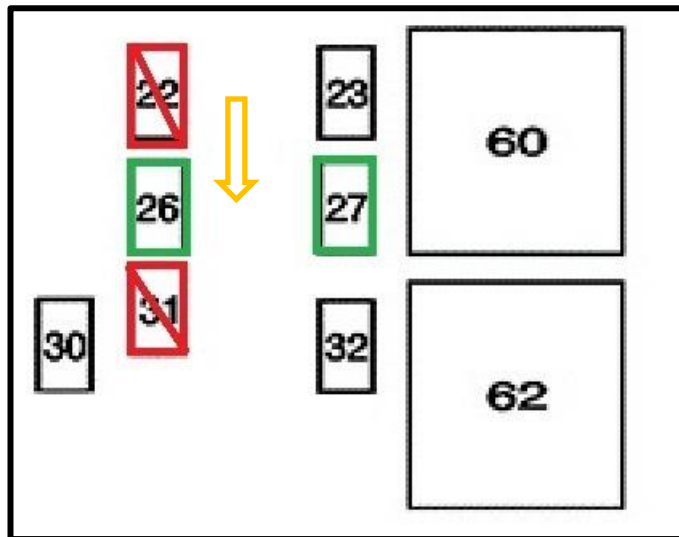
Figure 7 shows the fuses configured for switches 1 & 2 to be Ignition powered and switches 3 & 4 being battery powered. This configuration is accomplished by **MOVING** the fuse from location 22 **TO** location 26 (leaving locations 22 & 31 unpopulated)

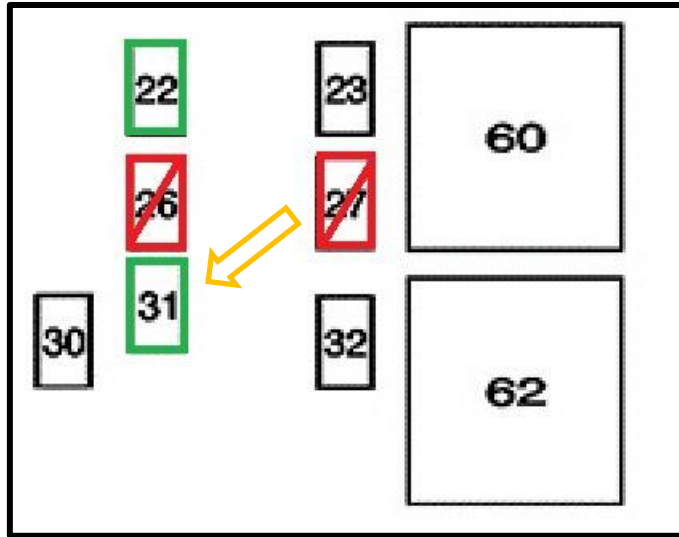
Figure 8 shows the fuses configured for switches 1 & 2 to be Battery powered and switches 3 & 4 being Ignition powered. This configuration is accomplished by **MOVING** the fuse from location 27 **TO** location 31 (leaving locations 26 & 27 unpopulated)

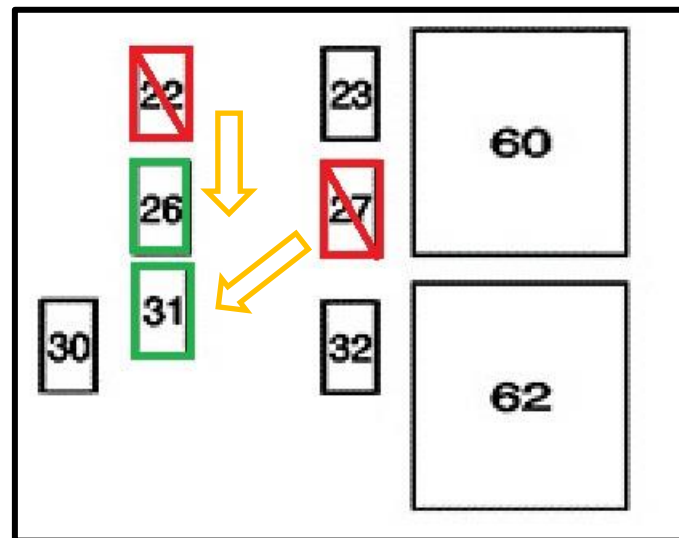
Figure 9 shows the fuses configured for all switches (1, 2, 3 & 4) to be Ignition powered. This configuration is accomplished by **MOVING** the fuse from location 22 **TO** location 26 and **MOVING** 27 **TO** 31 (leaving fuse locations 22 and 27 unpopulated)
