## Global A Electrical Architecture Security Overview

# Global A Electrical Architecture Security Overview

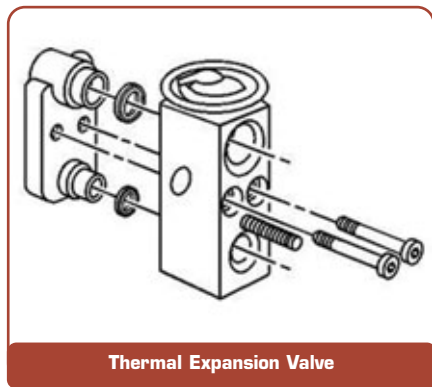
Some owners of GM vehicles may comment that their A/C is inoperative, operates intermittently or is noisy. No DTCs are set. After further investigation and diagnosis, technicians may be replacing the Thermal Expansion Valve (TXV). However, engineering analysis reveals that the vast majority of TXVs that are replaced work correctly (No Trouble Found).

## TXV FAILURE MODES

### A/C Not Operative or Intermittent

Possible Causes:

Before replacing TXVs, always follow the A/C Performance Diagnostic in the Service Information to verify the valve performance and review the following diagnostic tips.

**TIP:** Do not replace the TXV until you verify all previous steps and you can eliminate all other failure modes.

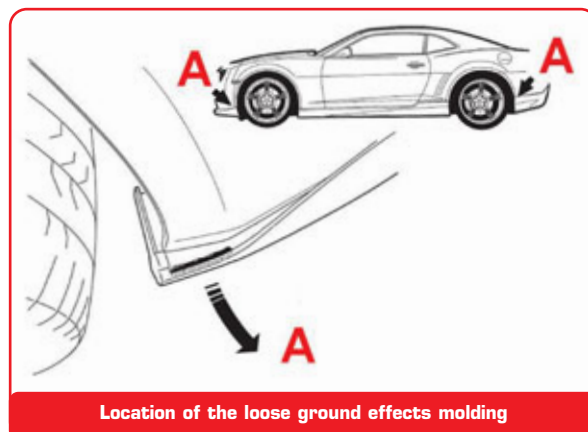
A GM Accessories ground effects kit is available for the 2010 Camaro. On some vehicles that have the kit installed, the corners of the kit may separate from the body.

If this condition is evident, a service fix should be performed. This service fix only applies to reattaching the corners of the ground effects kit and is not to be used for any other attachment concerns with the ground effects kit.

The procedure involves applying primer and plastic adhesive to the ground effect molding.

Refer to PIC5262 in the Service Information for service fix instructions and the recommended products to use during the procedure.

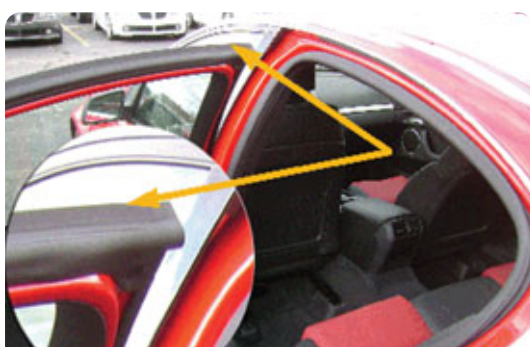
On some 2008-2009 Pontiac G8 models, water may be found on the interior of the vehicle near one of the rear doors.

If diagnosis of the water leak in the rear of the passenger compartment points to the front of one of the rear door seals, follow this procedure:

Location of water leak on the rear door

Allow the silicone to dry, and then reinstall the weather-stripping, making sure to properly position it in place. Retest for water leaks to confirm the vehicle is repaired.

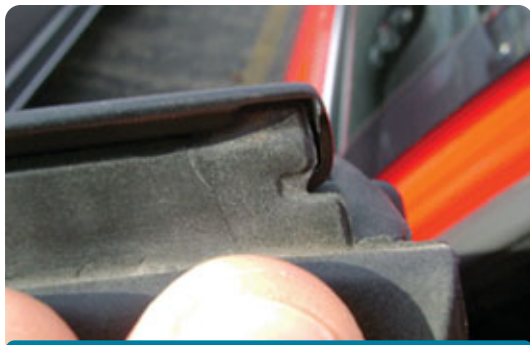
Rear door weather strip
