Fuel Contamination in Returnless Fuel Systems

GM TECH *Link*

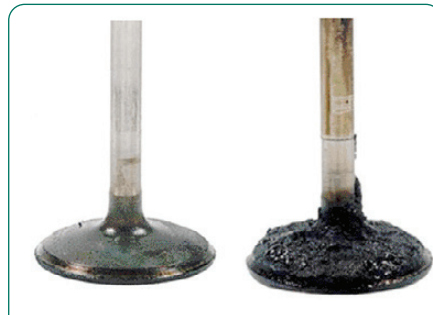
If sticking valves are a concern after cleaning the fuel system, do not replace the cylinder head or valves. Clean the valves using the cleaning procedures listed in #PIP3146. The vehicle should be driven a minimum of 50 miles (80 km) before evaluating the vehicle again in order to allow the fuel additive to work.

Intake valve (right) using gasoline with the legal minimum additive.

TIP: The entire fuel system must be flushed and the fuel tank removed, emptied and cleaned. If the fuel tank is only drained, the condition may return within a few hundred miles.

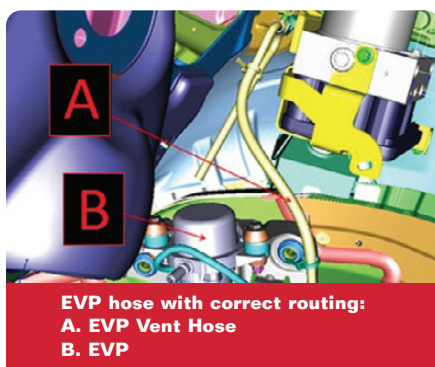
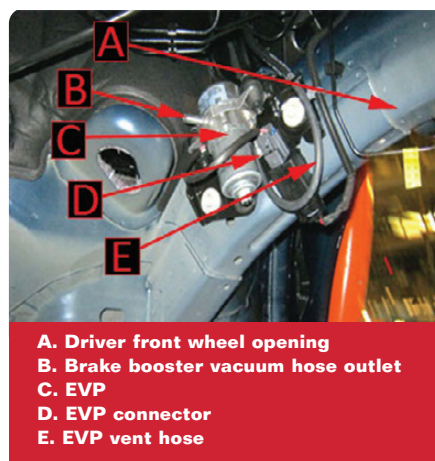
If the hose holds vacuum, check the routing of the hose. It may be misrouted behind the EVP mounting bracket, into an opening in the frame rail, or trapped under the ABS

bracket. The hose should be routed upward and behind the Brake Pressure Modulator Valve (BPMV) and to the right of the brake booster. Reroute and secure the hose as needed.

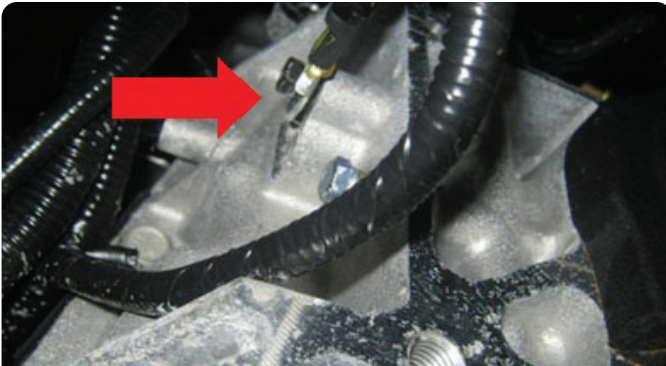
Check for a loose ground at G113.

If one or all of these conditions are present, check for a loose ground at G113. If the ground is loose, check the mounting bolt for G113. This is the main ground wire located on the rear of the transmission bell housing. This can easily be checked by grabbing the wire and trying to move it by hand.

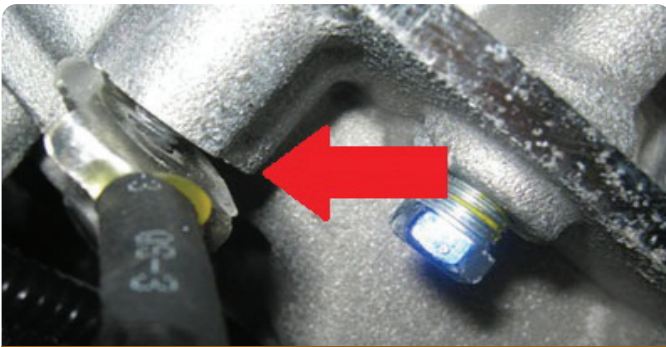
A shorter bolt may be needed if the mounting bolt is tight but the ground eyelet is loose.

If the mounting bolt is tight but the G113 ground eyelet is still loose, remove the mounting bolt and install a shorter-size bolt with the same threads. Some vehicle drive units had a pilot hole that was not fully machined and a shorter bolt is needed to address these conditions.

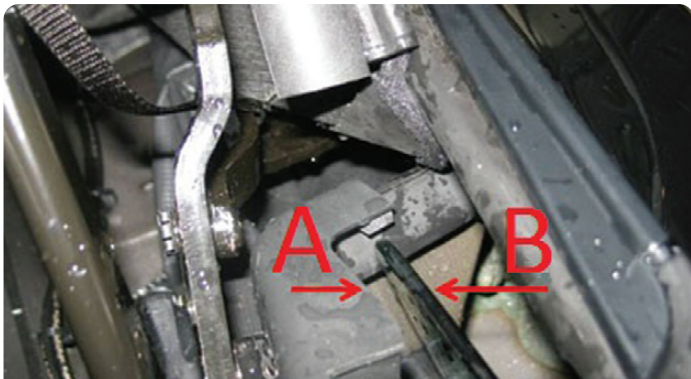
Everything to the inside of the quarter glass is considered a dry area; water should not be in the dry area. By design, water may be on the outside, or wet area, of the quarter glass and in the area of the quarter glass regulator from which the front drain spills.

A. Dry area on the inside of the quarter glass
B. Wet area on the outside of the quarter glass

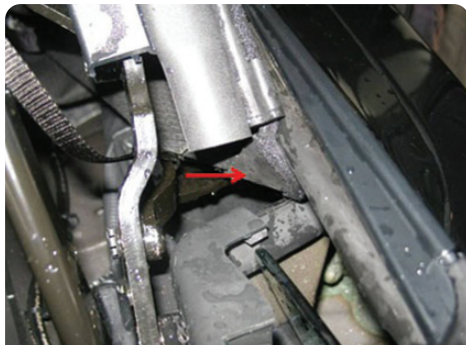
Correct position of the plastic water diverter

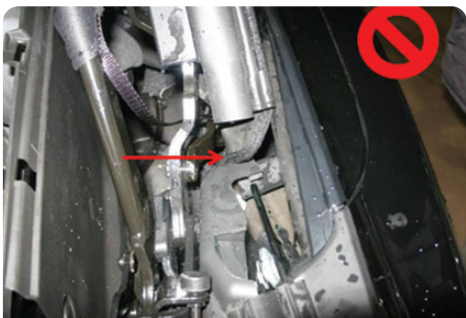
Incorrect position of the plastic water diverter

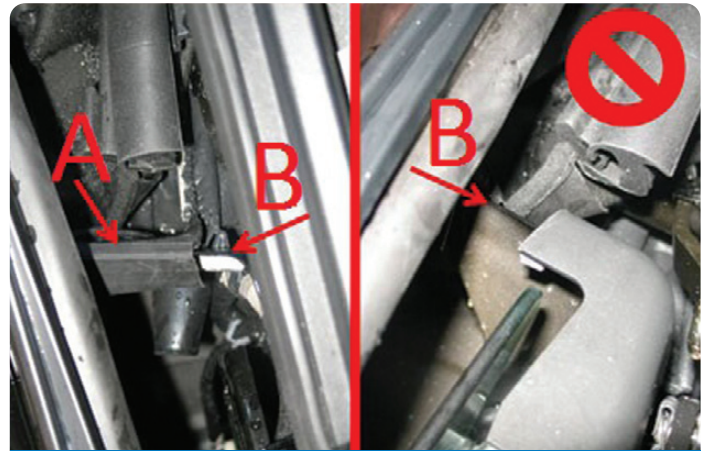
Water management bag (A) properly (left) and improperly (right) attached to the sheet metal panel (B).

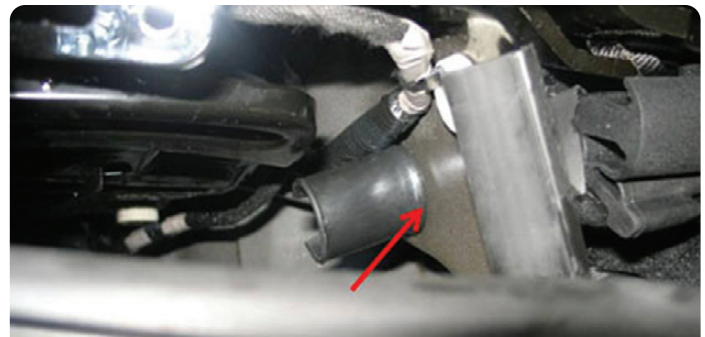
Front drain that is NOT fully seated in the sheet metal panel.

TIP: It is normal for the quarter glass window to contact this drain when the window is rolled down. Modifications should not be made for this. The drain will not fall out of the body sheet metal unless the drain is not fully seated.

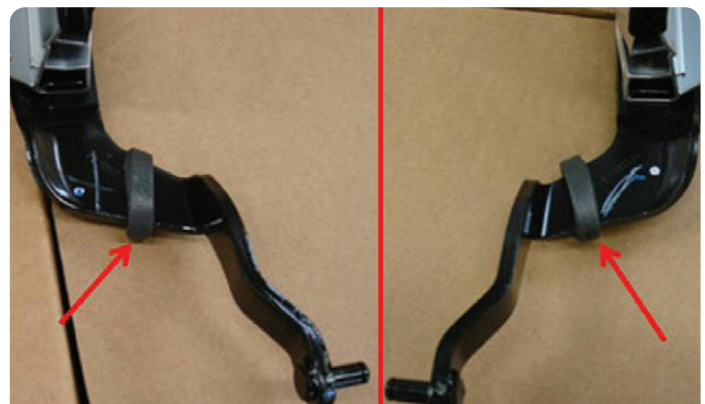
Foam tape on left and right side #5 bow brackets

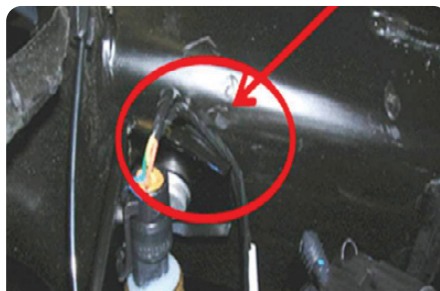
When checking for DTCs, the Electronic Suspension Control (ESC) module will have DTC C0696 or C0711 set. This condition may be caused by the wiring to the Automatic Level Control (ALC) pressure sensor being shorted to ground.

Pinched wire between the compressor assembly and frame.

Repair any damaged or shorted circuits and reposition the wiring. Be sure to position the wiring so it does not get damaged again during the compressor assembly installation.

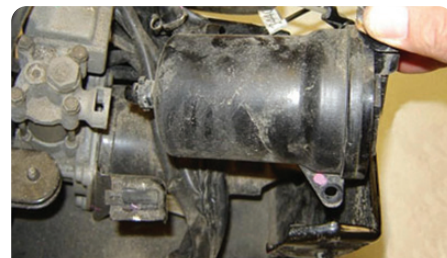
If a Service Suspension System message is displayed on the DIC with a low rear suspension ride height with a heavy payload and DTC C0711 is set, it also may be the result of moisture getting into the ALC pressure sensor. Moisture in the sensor will cause an internal fault.

For sensor replacement, install a complete air filter, dryer, and sensor assembly.
