### ARTICLES CONTAINED IN THIS ISSUE

QUALITY DRIVEN® SERVICE

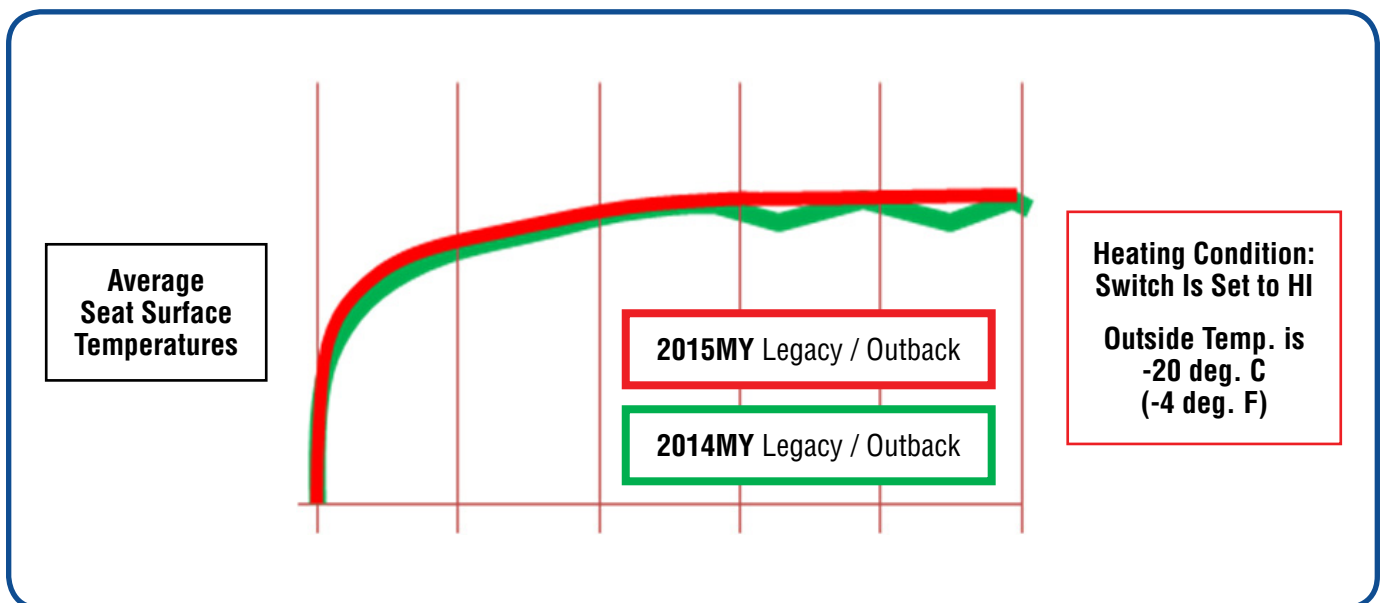
The front seat heater system used in the 2015MY Legacy / Outback is a new design compared to prior systems. It utilizes a thermistor sensor which allows the front seats to remain at warmer temperatures more consistently than the prior system. The new system is very different due to the change in sensors. The seat heater system on 2014MY and prior Legacy / Outback is a thermostat sensor-based system which makes the front seats heat up periodically and then cool down until the sensor indicates a need to turn the element on again. When this sensor-based system is operating, the temperature increases until the sensor reads the heating element has reached approximately 50 degrees C (roughly 122 degrees F). At that point, the element is turned off until the sensor reads approximately 40 degrees C (104 degrees F). At that temperature reading, the element is turned back on again to re-heat the seat resulting in an approximate 18-degree range. This cycle continues as long as the seat heater switch is on in either the low or high position.

In comparison, the thermistor sensor used in the new system also has periodic on and off cycles, but the operating range (temperature difference) is much smaller with an upper limit temperature which is slightly lower. The new system turns on the element until the thermistor sensor reads approximately 38 degrees C (roughly 100 degrees F) then cycles the element off until the temperature (at the thermistor) reaches approximately 37 degrees C (roughly 98 degrees F) before the element cycles on again, yielding only an approximate 2-degree range. As you can see, the upper and lower temperature range on the new system is significantly reduced. However, this is an apples and oranges comparison as the actual seat temperature felt is very similar. As you can see on the chart below, the average surface temperature of the front seat for each system ends up being very close. The RED line on the graph shows the temperature on front seat surface of the new 2015MY Legacy / Outback while the GREEN line represents the previous model year. You can see the fluctuations of the previous system have been virtually eliminated and the temperature stability enhancement the new system provides.

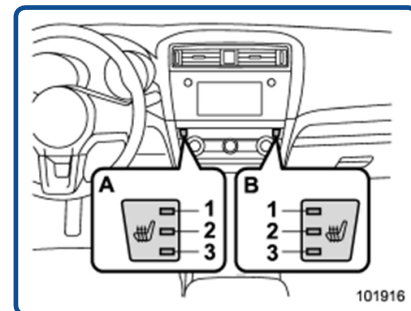
There are three levels of front seat heating available for 2015MY Legacy and Outback, HIGH (1), MID (2) and LOW (3). The difference among these modes is an upper limit temperature change of about 2 to 4 degrees C. Similar to the older system the speed at which the seat actually heats up varies with the level settings. The high setting will heat the seat the quickest, mid will increase the temperature more gradually and low will increase it at the slowest rate.

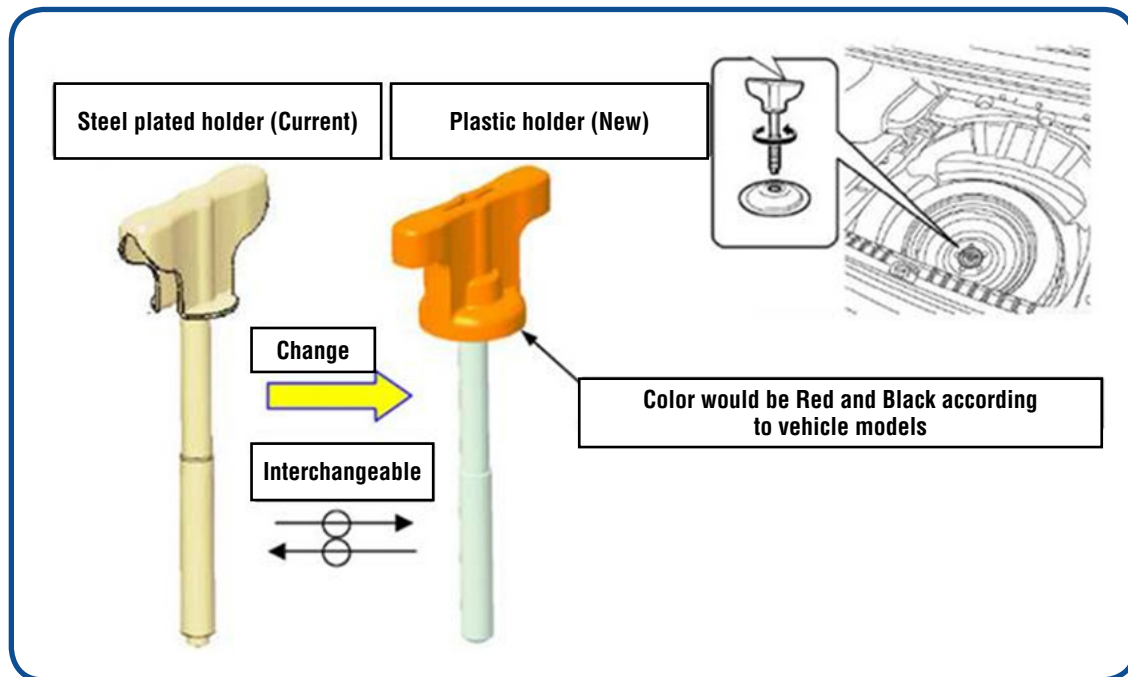
Be advised that during the upcoming fall months, there will be a running change in production to the spare tire hold-down bolt on all FHI-built models. SIA built vehicles already incorporated a similar change starting with 2015 MY production. The “handle” portion of the bolt will change from metal to plastic as shown in the photo below. The current “metal” and new “plastic” version are interchangeable.
