ARTICLES CONTAINED IN THIS ISSUE

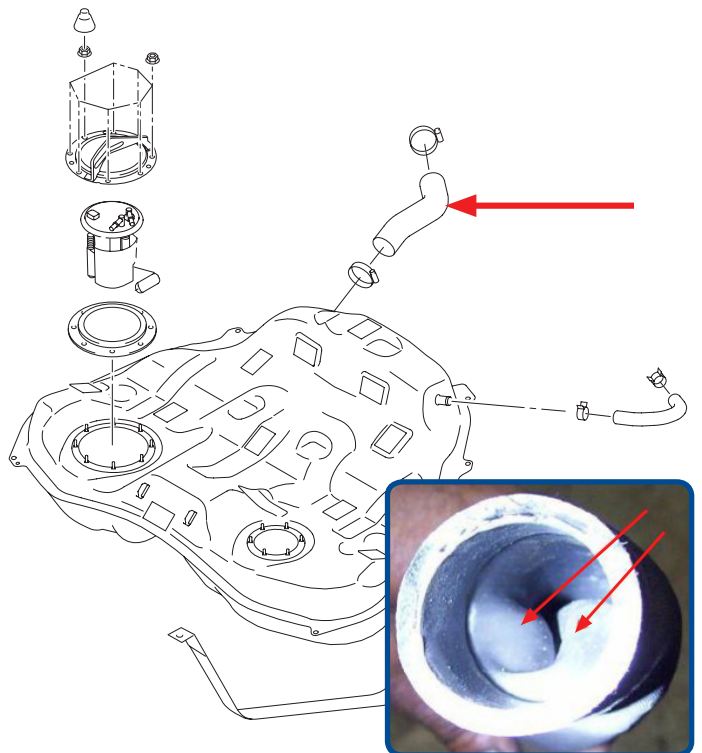
If you have a customer concern of difficulty filling the fuel tank, please be aware it may be the filler neck hose. We have had situations of fuel tanks being replaced for this concern because the hose was not removed with the fuel tank and inspected for obstructions.

Because of lighting and location, a quick look at the outside of the hose may not show any problem. The hose needs to be removed and light needs to be directed into the hose on both ends in order to see the obstruction. Originally, this issue was only found on 2010-2012 Legacy and Outback models but recently, we have confirmed reports of this same issue on 2013 models as well. When presented with this complaint on any model year Subaru, it is always a good idea to inspect this hose prior to removing the fuel tank.
